HARTZELL PROPELLER INC.  
**ALERT SERVICE BULLETIN**

**HC-ASB-61-279**

**Propeller - Propeller Mounting Bolt Inspection**

October 4, 2005

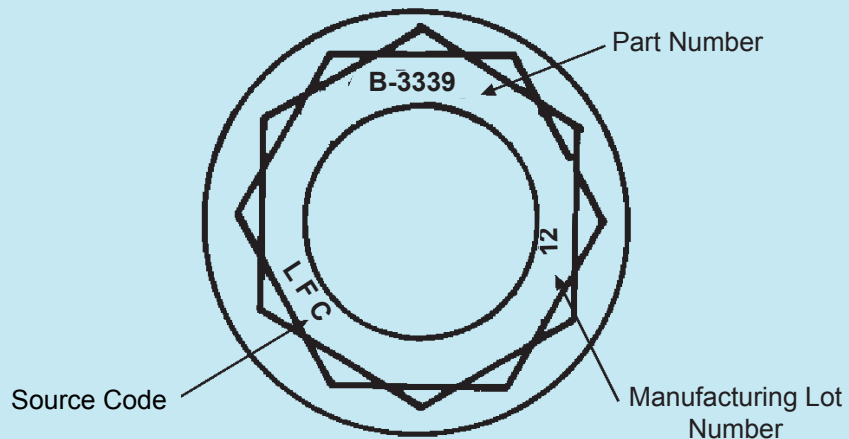
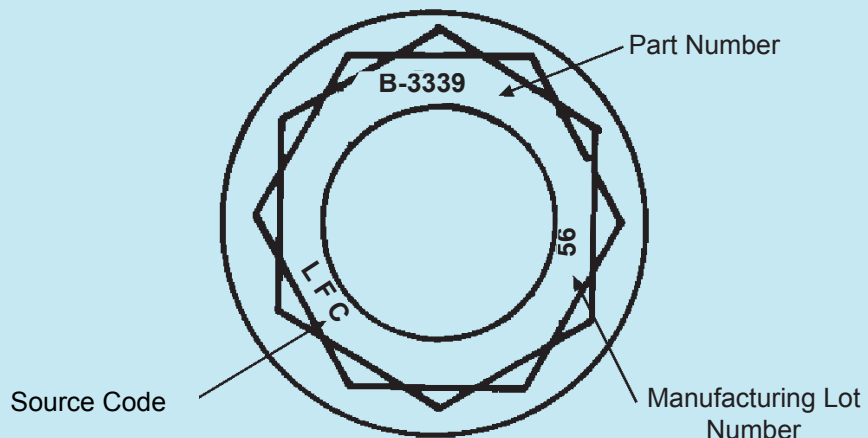
Bolt Head Identification  
Figure 1

- (1) Hartzell propeller models HC-B(3,4,5)( ) (P,N)-( ) ( ) that were installed on an aircraft with B-3339 mounting bolts from LFC manufacturing lot number 12 or lot 56 are affected by this Alert Service Bulletin. B-3339 mounting bolts from LFC manufacturing lot 12 and lot 56 may be found in inventory between February 13, 2004 and July 5, 2006. Refer to Figure 1.

- (1) One propeller mounting bolt from the LFC manufacturing lot 56 yielded during the propeller installation torquing sequence.
- (2) Analysis of the affected bolt revealed that the hardness characteristics of the bolt were too low, indicating a manufacturing defect in the bolt.

- (3) Additional B-3339 propeller mounting bolts from the LFC manufacturing lot 56 were discovered to have low hardness.
- (4) The B-3339 propeller mounting bolts from the LFC manufacturing lot number 12 revealed substantial pitting.

- (1) Gain access to the B-3339 propeller mounting bolts.
- (2) Visually inspect the head of each B-3339 propeller mounting bolt for identification marks. Refer to Figure 1 for the location of the identification mark.

- (c) Remove one mounting bolt at a time and closely inspect each bolt identification.
- 1 Replace all propeller mounting bolts that have identification marks "LFC" and manufacturing lot number "12" or "56" on the head of the bolt in accordance with the Compliance section of this Alert Service Bulletin. Refer to Figure 1.
    - a Propellers with three or more LFC manufacturing lot number 56 bolts must replace all eight mounting bolts.
    - b Propellers with LFC manufacturing lot number 12 bolts must replace the lot 12 bolts only.
- (d) Re-torque all of the propeller mounting bolts in proper sequence, in accordance with the Installation and Removal chapter of the applicable Hartzell Propeller Owner's Manual.
- (e) Safety the mounting bolts with 0.032 inch (0.81 mm) minimum diameter stainless steel wire (two bolts per safety).
