HARTZELL PROPELLER INC.
SERVICE BULLETIN
TRANSMITTAL SHEET
HC-SB-61-227
Propeller - Hub Inspection

August 27, 2012

HARTZELL PROPELLER INC.
SERVICE BULLETIN
HC-SB-61-227
Propeller - Hub Inspection

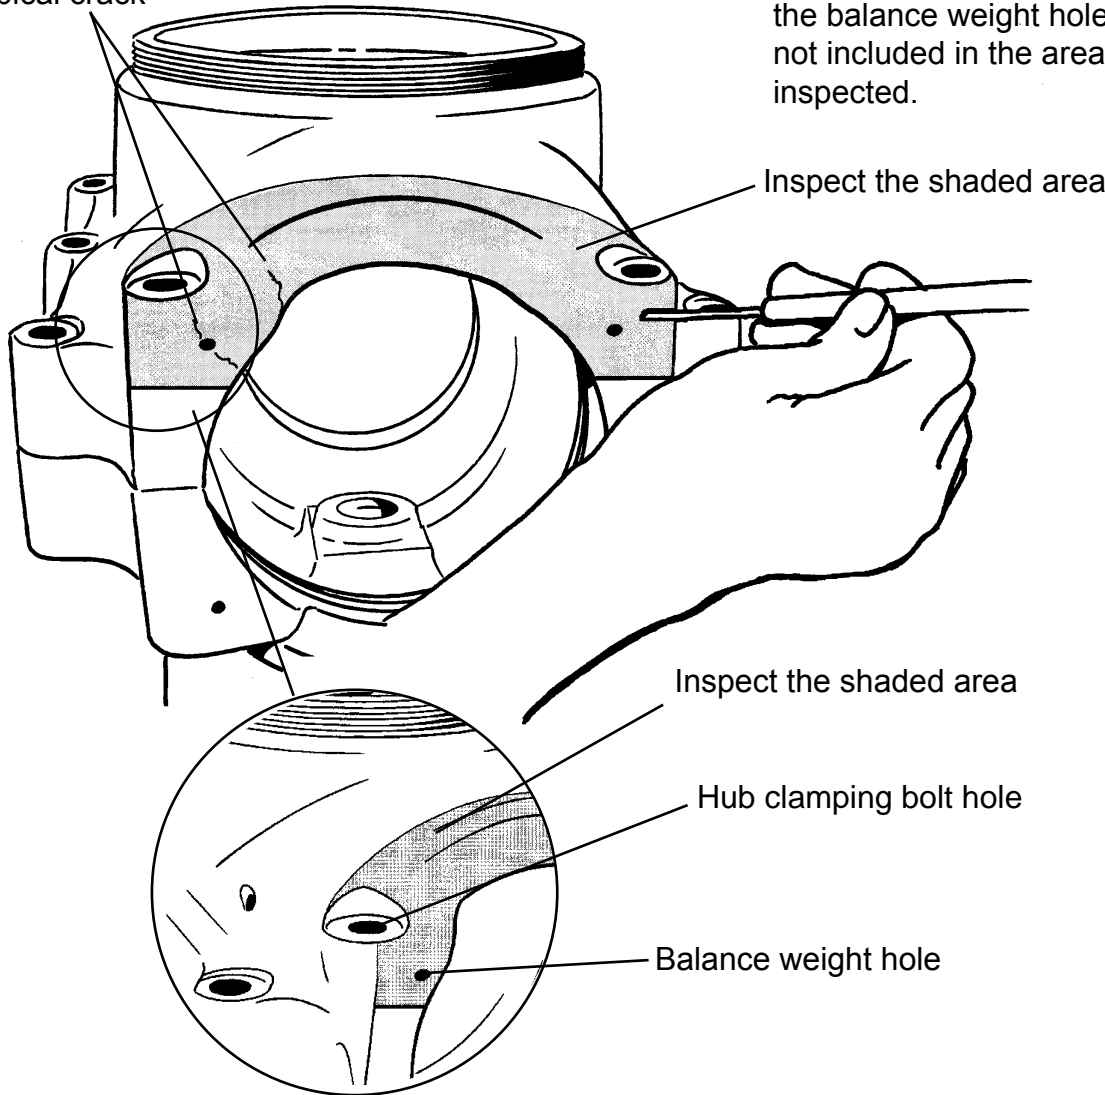
Socket Fillet Radius Inspection
Figure 3

- (1) There have been numerous occurrences of hub fillet radius cracks, including incidents of in-flight blade separation in Hartzell two blade "compact" series aluminum hub propellers. Cracks were typically discovered during an inspection following reports of abnormal vibration or grease leakage. Cracks typically initiate in the same region of the hub in the area adjacent to the blade called the "fillet radius". As the cracks propagate toward the center of the hub, their progression accelerates and may result in the failure of one hub half that can progress to blade separation.

Typical crack

NOTE: The hub clamping bolt holes and the balance weight holes are not included in the areas to be inspected.

Circled areas encompass the "fillet radius", must be inspected.

Hubs with no "A" or "B" serial number suffix, and hubs listed in Table 1: Inspect highlighted area on each blade socket (forward hub half) during on-wing inspection, and four points (both hub halves) during overhaul inspection.

(f) Perform eddy current inspection in accordance with procedures in Hartzell Standard Practices Manual 202A. See Figure 3.

- (5) If a crack indication is found, hub replacement is required before further flight. Report any findings of a cracked hub to the Hartzell Propeller Product Support Department.
- (6) If no crack indications are found,
 - (a) After the first inspection only, permanently identify the hub to indicate compliance with this Service Bulletin. Use a metal impression stamp (0.125 inch [3.175 mm]), round bottom characters) to stamp the letter E at the end of the propeller serial number. For example, propeller serial number DN1234 would be changed to DN1234E. This change is to be noted in the propeller logbook so that it provides further indication that this Service Bulletin is applicable.
