**HARTZELL PROPELLER INC.**  
**SERVICE BULLETIN**  
**TRANSMITTAL SHEET**  
**HC-SB-61-304**

**Propeller - Introduction of an Improved Blade**

August 1, 2012

- (1) Hawker Beechcraft King Air B100 aircraft with Hartzell steel hub propeller HC-B4TN-5(C,F)/T10173F(N)(B,K)-12.5 are affected by this Service Bulletin.
- (2) Applications that have complied with the blade replacement instructions in a previous version of this Service Bulletin are not affected by this revision.
- (3) T10173F(N)(B,K)-12.5 blades in stock/inventory are affected by this Service Bulletin.

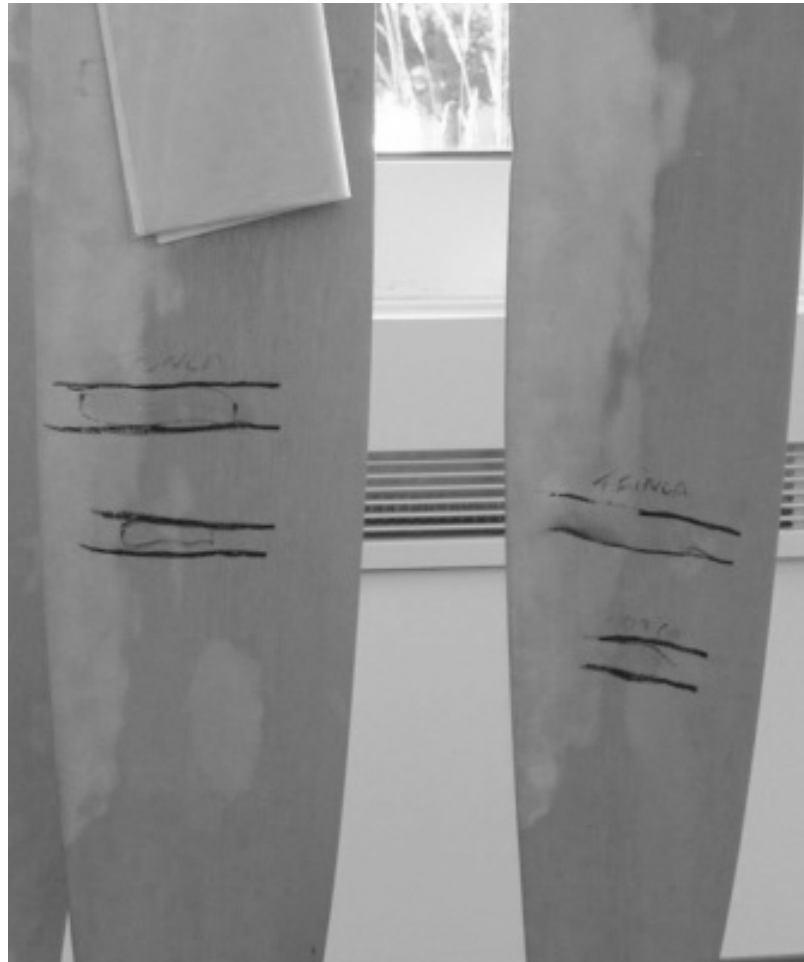
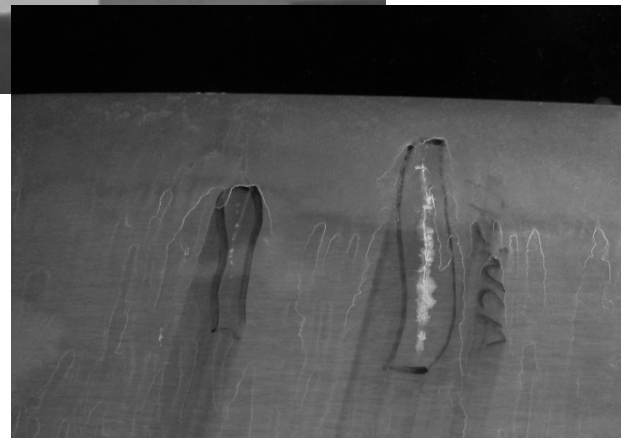
**Figure 1**

- (1) There have been sporadic reports of blade flutter during landing while using propeller reversing. An investigation identified a greater likelihood for this occurrence with blades nearing dimensional minimums.
  - (a) This same occurrence of blade flutter is also possible with blades near original manufacturing specifications.
  - (b) This condition can cause cracked and/or failed blades. Refer to Figure 1.

- (2) Blade Flutter can be identified by a large increase in sound level during application of reverse.
- (3) Blade replacement in accordance with the Compliance section of this Service Bulletin will minimize the tendency for flutter.
- (4) Replacement of all T10173F(N)(B,K)-12.5 blades with improved T10173AN(B,K)-12.5 blades is terminating action for this Service Bulletin.
- (5) Regulatory action is unknown.

Cracks are located between the markings on the blades shown.

**Examples of Cracked Blades Caused by this Condition**

- (1) If there is evidence of blade flutter, avoid operations (reversing) that are likely to produce flutter and replace blades at first opportunity in accordance with this Service Bulletin and Hartzell Propeller STC SA02539CH-D.

- (2) Replace all affected blades, even those without evidence of blade flutter, with the improved T10173AN(B,K)-12.5 blades at next overhaul in accordance with Hartzell Service Letter HC-SL-61-61Y, or at next major disassembly, and no later than 3000 flight hours or 60 calendar months from August 1, 2012, whichever occurs first.

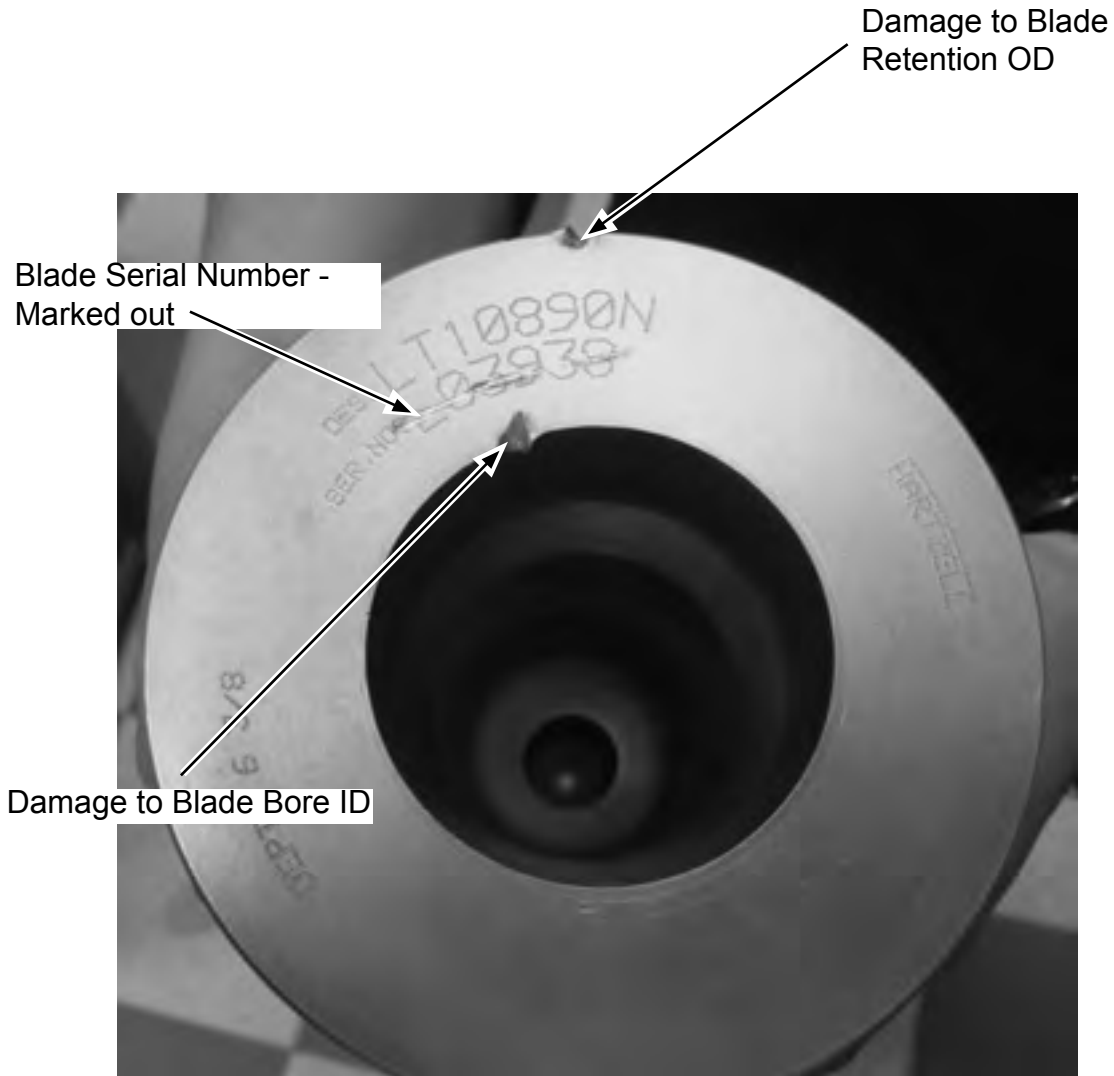
**Blade Butt Showing Damage to Prevent Further Use of the Blade**  
**Figure 2**

**Note:** The blade shown is not an affected blade. This blade is shown as an example only of the damage that should be made to retire the blade.

- 1      The retired blades cannot be modified or returned to service for use in any application, including experimental applications.
- 2      Each blade must be damaged in such a way that prevents further use of the blade.
  - 1      Using a tool, damage the ID of the blade bore and the OD of the blade retention surface. Damage must be sufficient to prevent installation of the blade bearing and the blade clamp. Refer to Figure 2.
  - 2      Mark out the blade serial number, so that the number is still legible.
  - 3      Take a photograph of the blade butt to show the damage, the blade model number, and the blade serial number. Refer to Figure 2.
  - 4      Send the photo via email to [techsupport@hartzellprop.com](mailto:techsupport@hartzellprop.com) in accordance with the Appendix to this Service Bulletin. **DO NOT RETURN THE BLADE.**
