**HARTZELL PROPELLER INC.**  
**SERVICE LETTER**  
**HC-SL-30-246**  
**De-Ice - Spare Parts Release**

Hartzell PHC-J3YF-2( )/FC7663K-2R aluminum hub, compact propellers installed on Raytheon 58 Barons equipped with propeller de-ice are affected by this Service Letter.

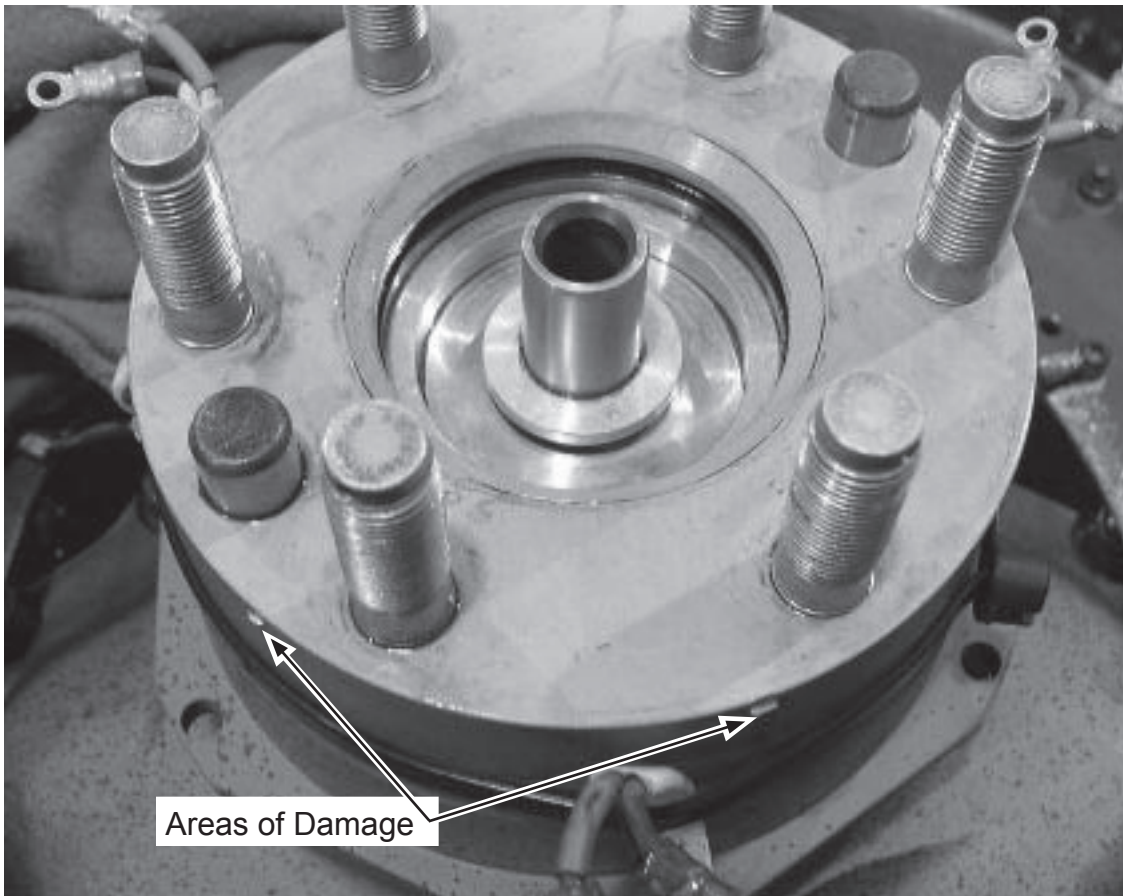
- (2) Numerous reports have been received concerning the propeller hub damage. Investigation indicates that the damage was caused by contact between the hardware used to attach the slip ring to the de-ice split mounting plate and the propeller hub. The diameter of the hardware specified for attaching the slip ring to the de-ice split mounting plate may be too large resulting in the contact.

- (3) The damage appears as small indentations on the outside diameter of the propeller hub extension surface. See Figure 1.
- (4) New hardware is required for attaching the slip ring to the de-ice split mounting plate. Attachment of the slip ring to the de-ice split mounting plate using the new hardware prevents further damage to the propeller hub.

**Areas of Damage**  
**Figure 1**

- (a) Lightly file or polish the hub to remove the damage. Raised area must smoothly blend with the undamaged surrounding area and have a depth to width ratio of at least 10. Raised material is not permitted. Rework is permitted to a maximum depth of 0.020 inch (0.508 mm) with a surface finish of Ra100 or better.

- (3) If individual damage or rework depth is greater than 0.020 inch (0.508 mm) depth, hub must be retired from service in accordance with the Parts Retirement chapter of Hartzell Standard Practices Manual 202A (61-01-02).
