HARTZELL PROPELLER INC.
SERVICE BULLETIN
TRANSMITTAL SHEET
HC-SB-61-269
Propeller - Hub Inspection

HARTZELL PROPELLER INC.
SERVICE BULLETIN
HC-SB-61-269
Propeller - Hub Inspection

Revision 6, dated Aug 27/12

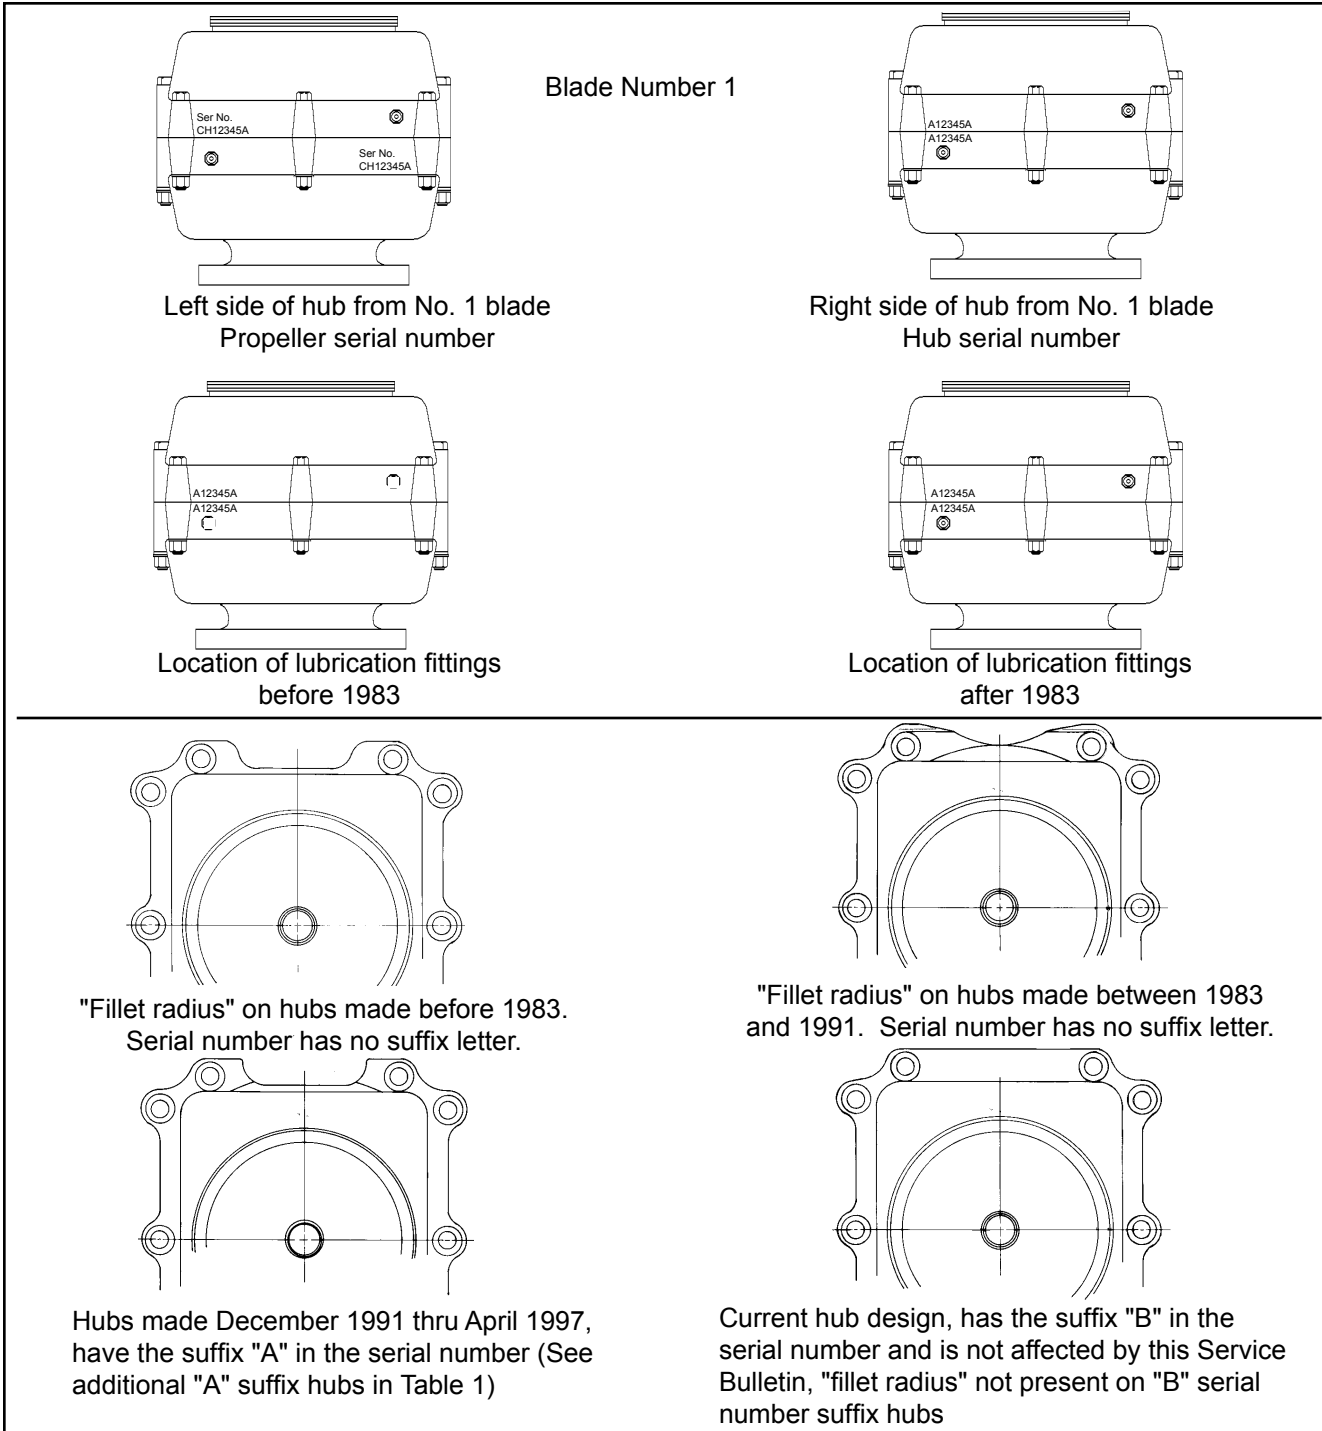
Hub Identification
Figure 2

NOTE 2: Hub and propeller serial numbers without suffix letter "A" or "B" were manufactured before 1991 and can be identified by two different styles of the fillet radius as shown in Figure 2. The "E" suffix letter is added to the hub with no suffix serial number to indicate that the initial eddy current inspection has been performed in accordance with this Service Bulletin and a repetitive eddy current inspection is required.
