# HARTZELL PROPELLER INC. SERVICE LETTER

## Propellers

### Propeller - Abnormal Vibration or Grease Leakage

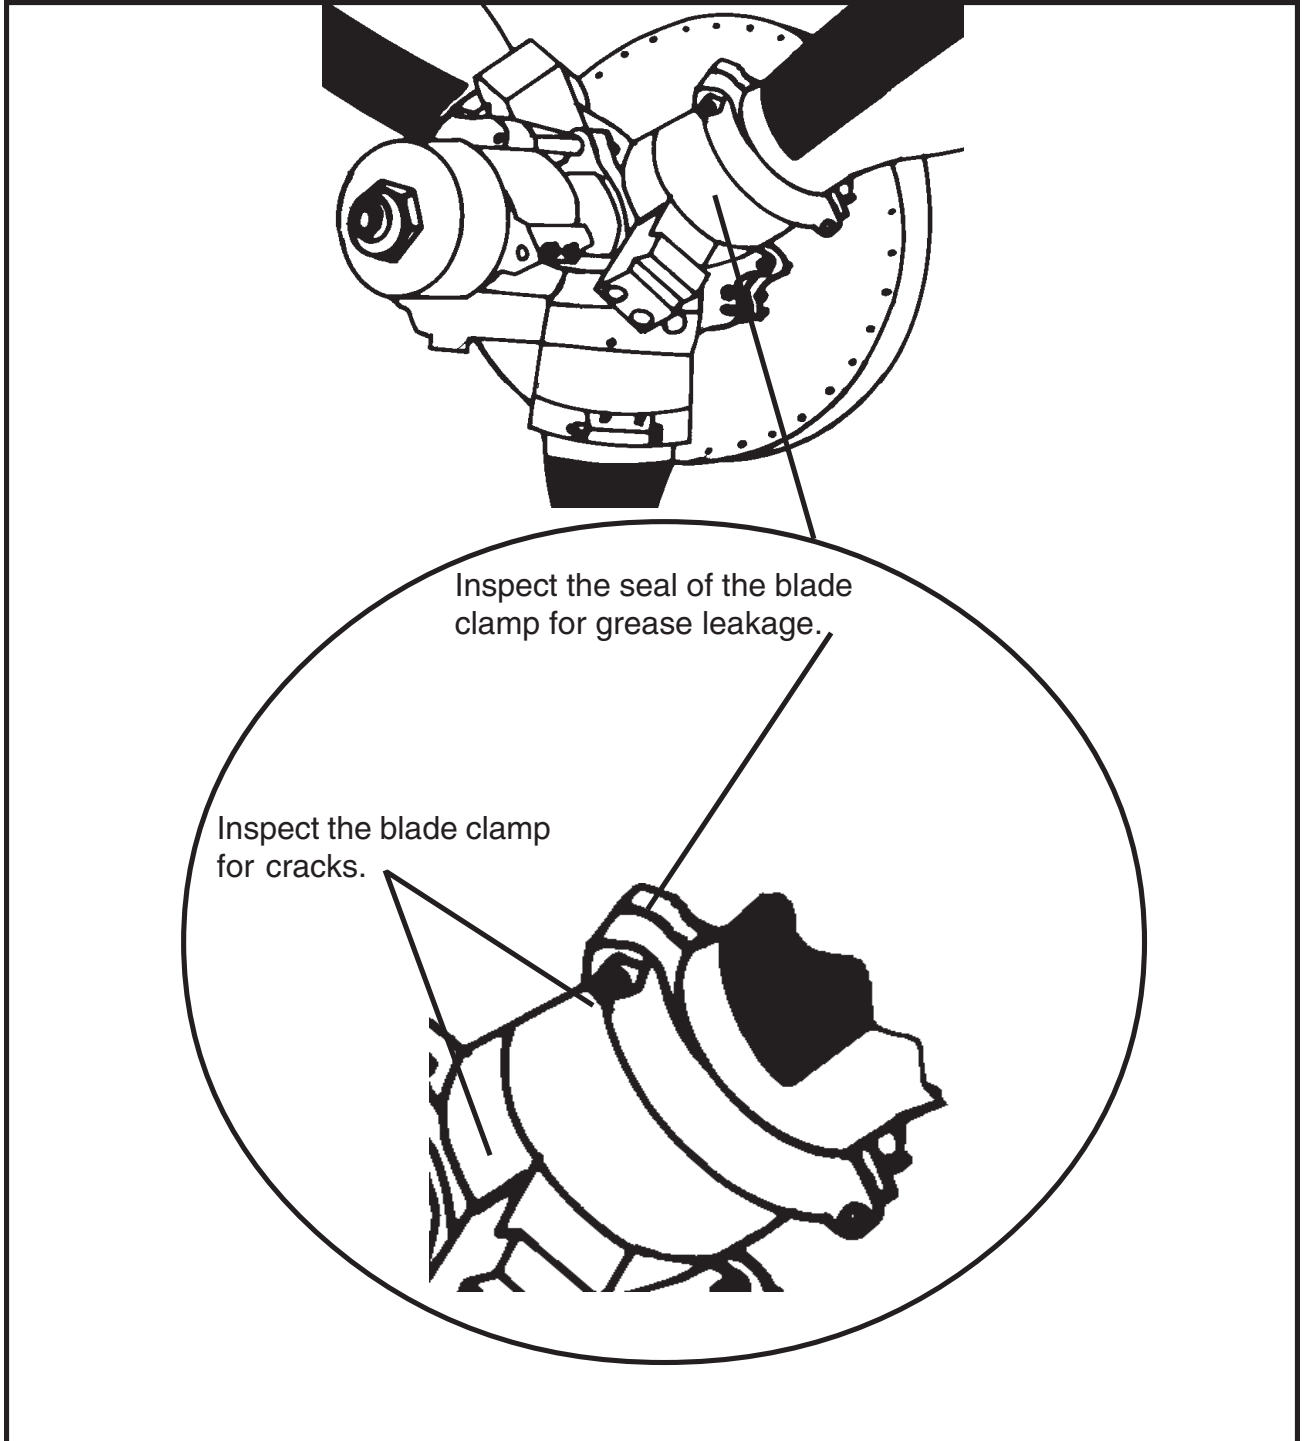
**Steel Hub Clamp  
Figure 1**

- (2) Perform visual inspection for cracks in the hub and blade retention areas.
  - (a) On steel hub propellers pay particular attention to the steel blade clamps, see Figure 1.
  - (b) On aluminum hub propellers pay particular attention to the blade retention areas of the hub, see Figure 2.

NOTE: Figures 1 & 2 show examples of past incidents where cracks have been found. The areas shown should not be the only area inspected.

- (3) Perform visual inspection of the hub and blade retention areas to locate the origin of leakage. If the origin of grease leakage is determined to be a noncritical part such as an O-ring or sealant, repairs can be accomplished during scheduled maintenance.
- (4) If suspected cracks are found, before further flight, perform additional inspections (by qualified personnel at an approved propeller repair station) to verify the condition. Such inspections typically include disassembly of the propeller with dye penetrant, eddy current, or magnetic particle inspection of parts in accordance with published procedures.
- (5) If cracks or failing components are found, parts must be replaced prior to further flight. Such incidents need to be reported to airworthiness authorities and Hartzell Propeller Inc.
