# ALERT SERVICE BULLETIN

HC-ASB-30-358

## Anti-ice - Travel Tube Bracket Weldment Replacement

February 01, 2016

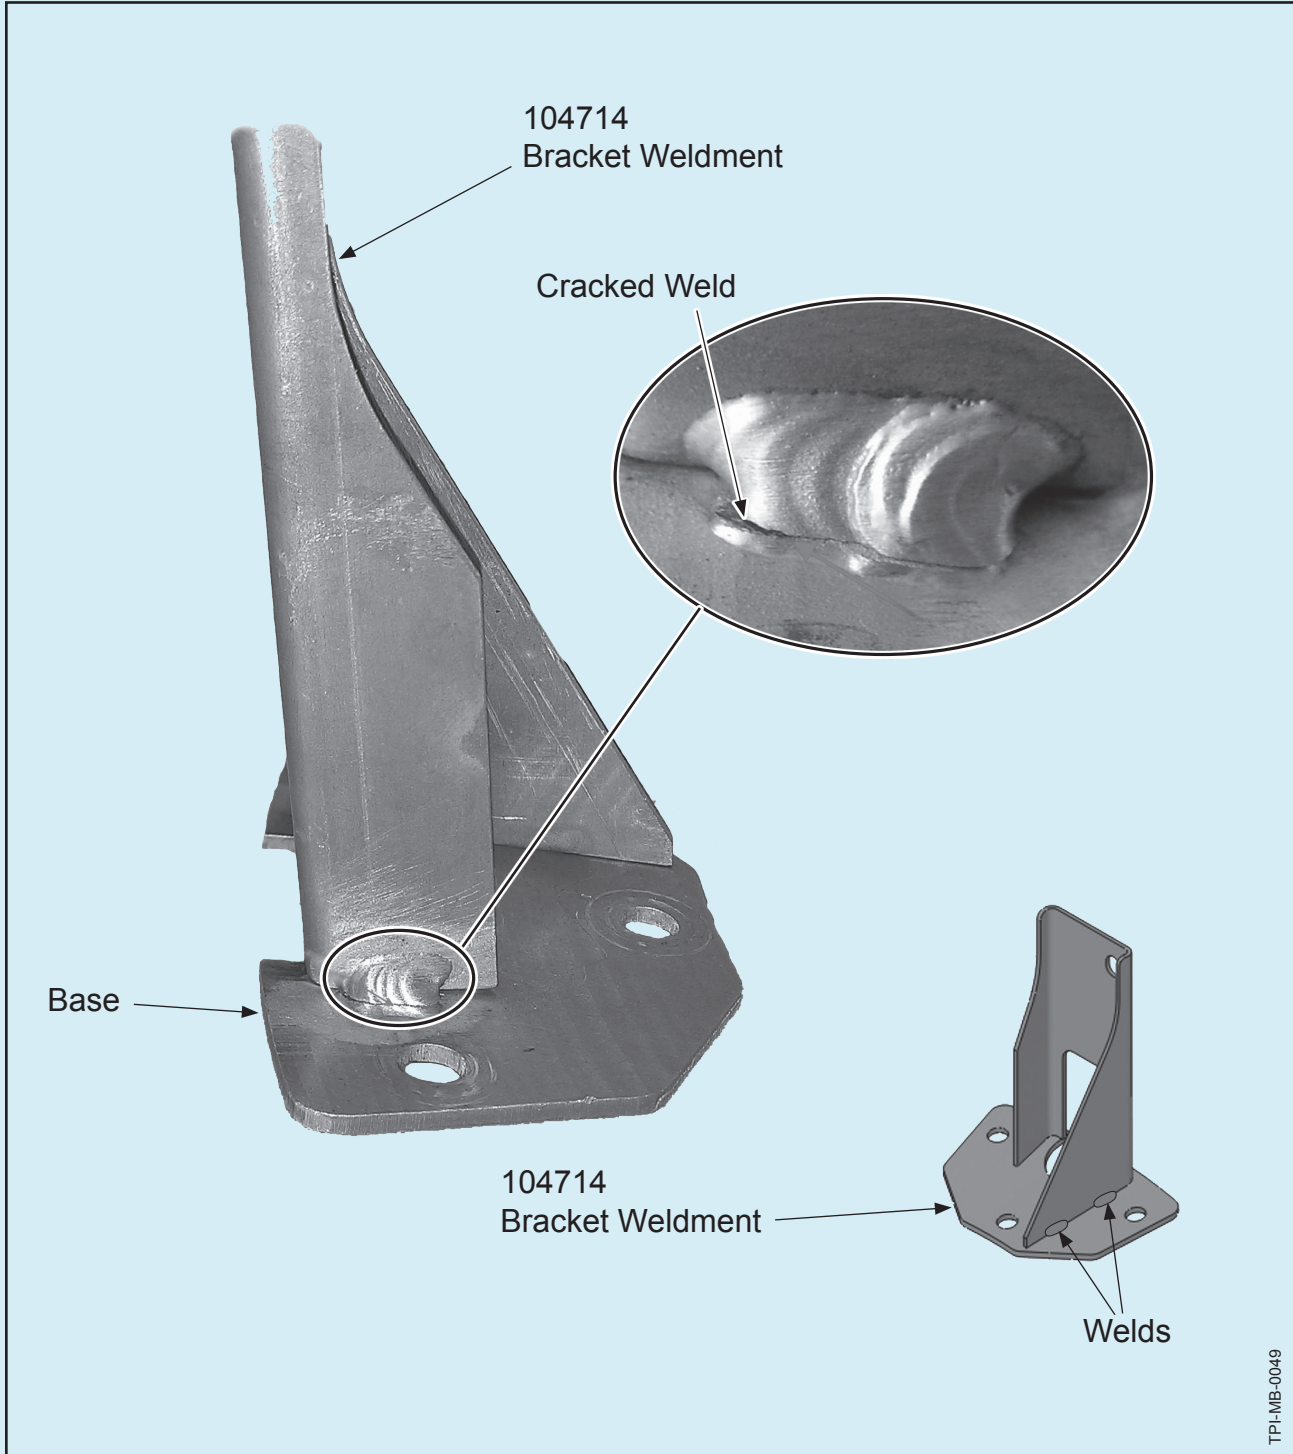
**104714 Bracket Weldment Inspection**  
**Figure 1**

- (1) Hartzell Propeller Inc. has received field reports of broken welds on the 104714 bracket weldments used to align the anti-ice fluid travel tubes on the affected propellers.
  - (a) Broken welds on the 104714 bracket weldments may prevent the correct alignment of the travel tube that dispenses anti-ice fluid onto the anti-icing boot on the blade.
- (2) Hartzell Propeller Inc. is introducing the 106107 anti-ice bracket to replace the 104714 bracket weldment used on the affected propellers.
  - (a) The 106107 anti-ice bracket is formed from a single piece of material with no welds for improved durability.
- (3) Regulatory action is not expected.

- (2) Remove the spinner dome in accordance with Hartzell Propeller Inc. Owner's Manual 139 (61-00-39).
- (3) Examine each 104714 bracket weldment on the affected propeller for cracked or broken welds at the base of the bracket. Refer to Figure 1.

- (a) If none of the 104714 bracket weldments have any cracked/broken welds, the propeller **passes** the bracket weldment inspection.
  - (b) If any of the 104714 bracket weldments have one (but no more than one) cracked/broken weld, the propeller **fails** the bracket weldment inspection.

- 1 If the cracked/broken weld is still securing the upper portion of the bracket to the base:
      - a Within 50 flight hours of the bracket weldment inspection, replace all three bracket weldments in accordance with section 3.B. of the Accomplishment Instructions in this Alert Service Bulletin.

- 2 If the cracked/broken weld has caused separation between the upper portion of the bracket and the base:
      - a Contact the Product Support Department at Hartzell Propeller Inc. before further flight.

- (c) If any of the 104714 bracket weldments have two or more cracked/broken welds, the propeller **fails** the bracket weldment inspection.
    - 1 Contact the Product Support Department at Hartzell Propeller Inc. before further flight.
