HARTZELL PROPELLER INC.
ALERT SERVICE BULLETIN
TRANSMITTAL SHEET
HC-ASB-61-351
Propeller - Piston Unit Replacement

March 7, 2014

HARTZELL PROPELLER INC.
ALERT SERVICE BULLETIN
HC-ASB-61-351
Propeller - Piston Unit Replacement

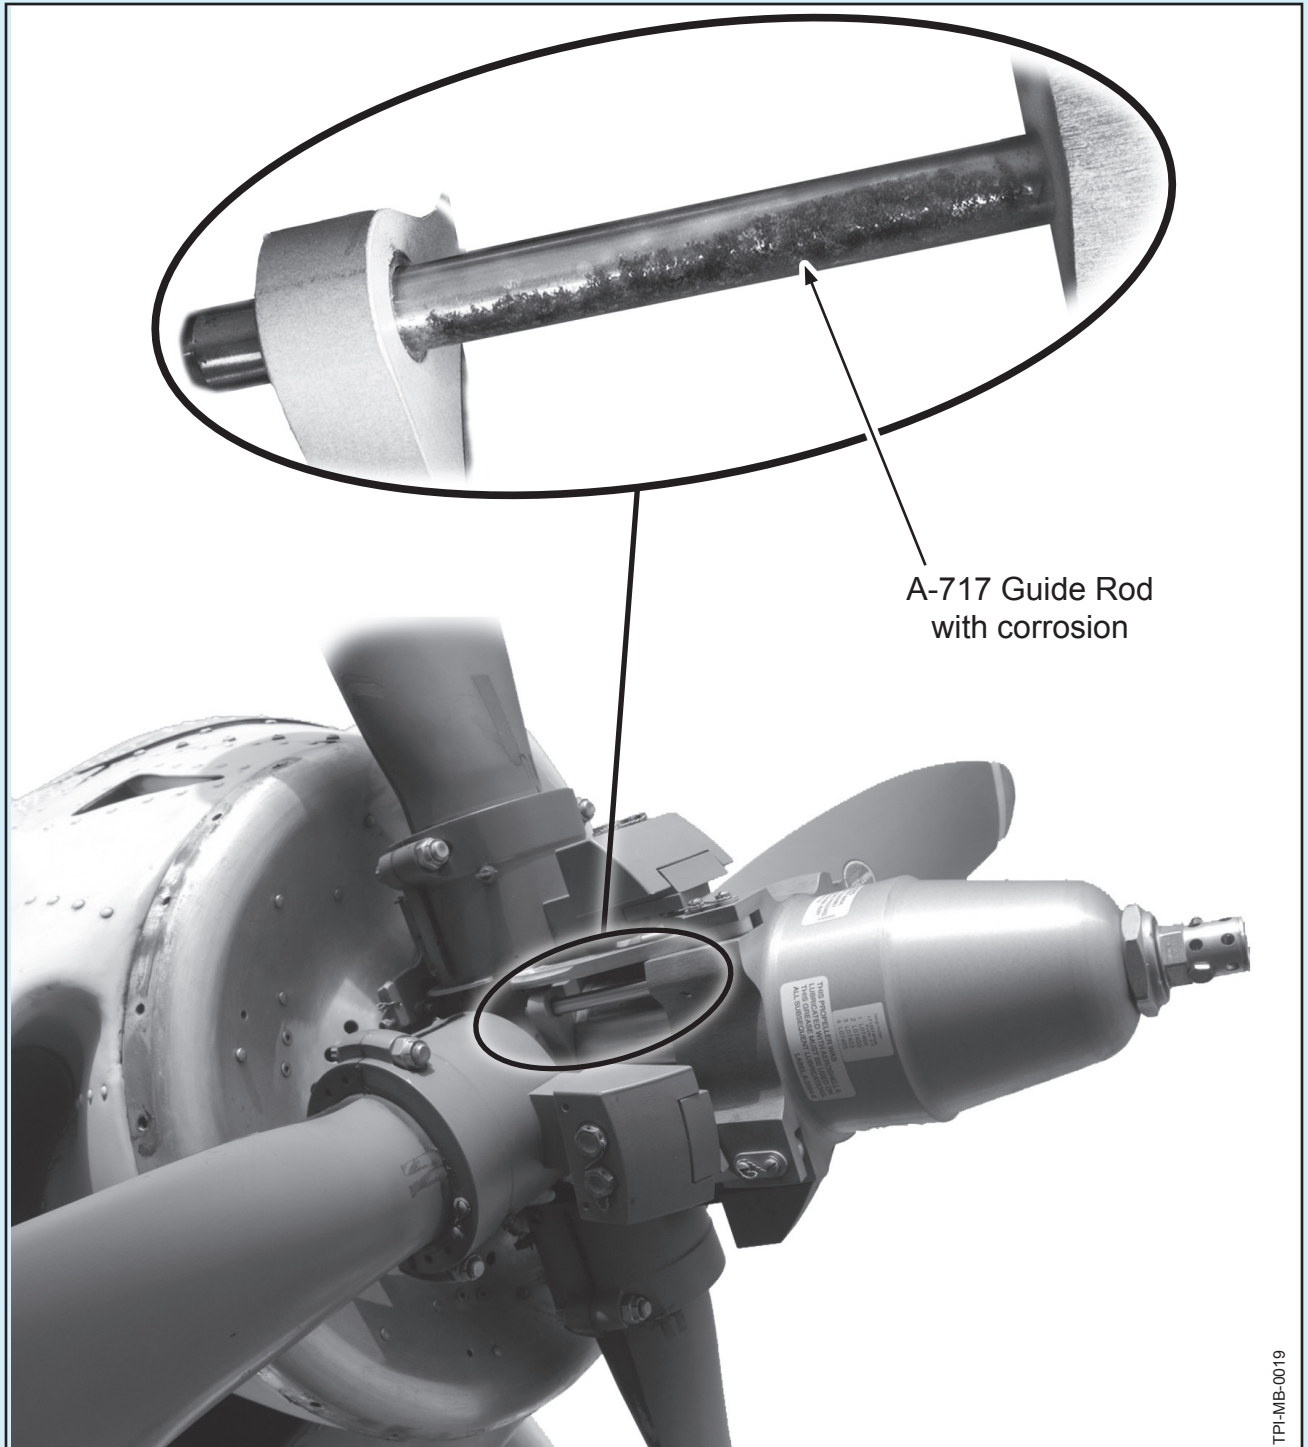
Visual Inspection of A-717 Guide Rods
Figure 1

- (1) Hartzell Propeller Inc. has received reports of corrosion on A-717 guide rods.
- (2) The A-717 guide rods manufactured by Hartzell Propeller Inc. between March 1, 2012 and October 22, 2013 may have been improperly processed. This could result in an insufficient layer of chrome, making the guide rod susceptible to corrosion.
- (3) Excessive corrosion may cause the guide rod(s) to bind in the guide collar. This condition may result in erratic operation during flight with a potential for an inability to reach a full feather blade angle.
- (4) Regulatory action is not expected.

A. Visual Inspection - Refer to Figure 1

- (1) This procedure may be completed on-wing without removal of the propeller, or before installation of the propeller.
- (2) Remove the spinner dome in accordance with the applicable Hartzell Propeller Inc. owner's manual.
- (3) Remove any lubricant/grease from the A-717 guide rods.
- (4) Visually examine the A-717 guide rods for any evidence of corrosion.
 - (a) If no corrosion is found, proceed to 3.A.(5).
 - (b) If corrosion is found, remove any high spots and/or loose particles of corrosion from the guide rods. Refer to Figure 2.

- 2 Use an abrasive pad such as Scotch-Brite to remove any high spots and/or loose particles of corrosion from the guide rods.
- (5) Apply a thin layer of corrosion inhibiting lubricant (dry film lubricant, lithium-based grease, etc.) to the entire surface of each A-717 guide rod.
