HARTZELL PROPELLER INC.
SERVICE LETTER
HC-SL-61-346
Spinner - Bulkhead Modification

- (1) This Service Letter provides Additional Maintenance Information (AMI).
- (2) This Service Letter provides instructions for adding drain holes to affected spinner bulkheads.

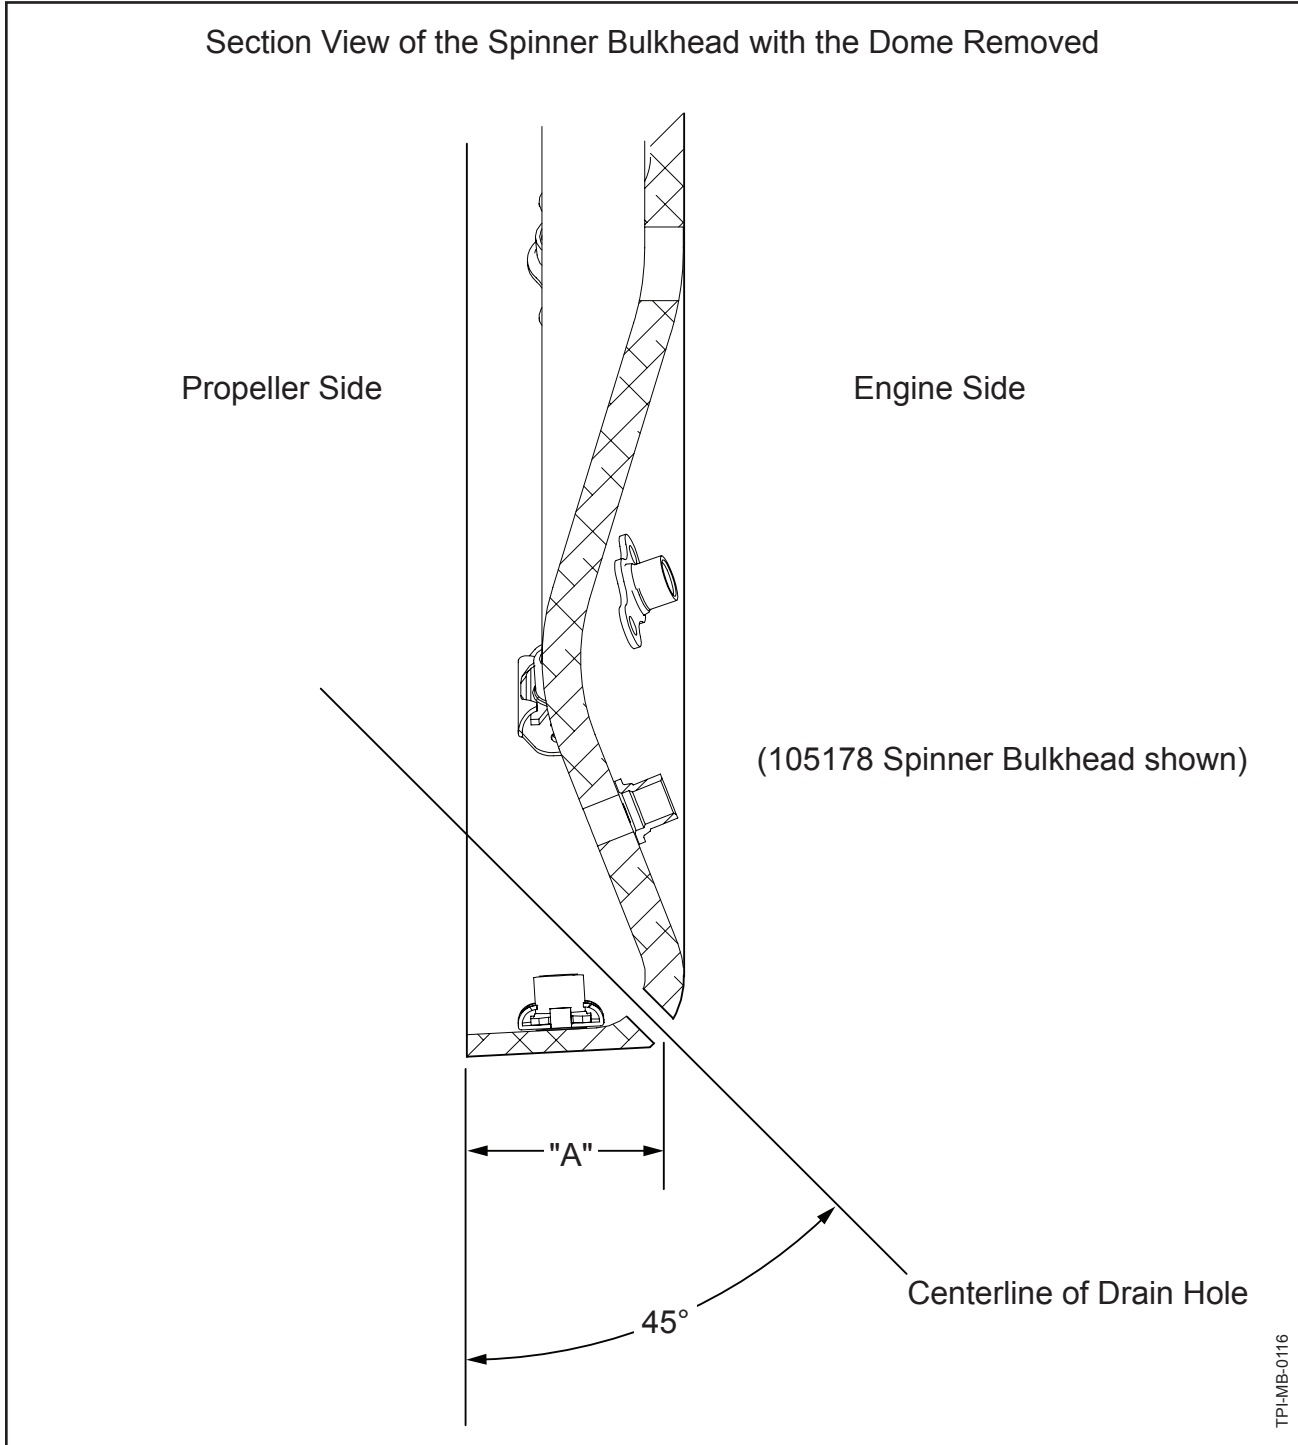
Spinner Bulkhead Drain Hole Location
Figure 1

- (1) Hartzell Propeller Inc. has received reports of water accumulating inside the spinner dome on spinner assemblies that use the affected spinner bulkheads.
 - (a) In certain conditions, the accumulated water can freeze and cause the propeller to be out of balance.
- (2) Hartzell Propeller Inc. has redesigned the 104154 and 105178 spinner bulkheads with evenly spaced drain holes to prevent water accumulation inside the spinner dome.
 - (a) Hartzell Propeller Inc. spinner assemblies 104552 and 105180 will include the redesigned 104154 and 105178 spinner bulkheads with drain holes when production/manufacturing changes are implemented.
 - (b) The spinner bulkhead modification procedure in this Service Letter provides instructions for drilling the drain holes in affected spinner bulkheads manufactured before the design change.
- (3) Regulatory action is not expected.

- (1) The following procedure may be performed on-wing by a certified aircraft mechanic with the appropriate rating or by a certified propeller repair station with the appropriate rating.
- (2) Remove the spinner dome in accordance with Hartzell Propeller Inc. Propeller Owner's Manual 147 (61-00-47).
- (3) Using a center punch, mark the location of the five holes to be drilled in the outside radius of the spinner bulkhead. Refer to Figure 1 and Table 1.
 - (a) The drain holes must be evenly spaced from each other at the midpoint between the blade cutouts.
 - (b) Refer to Table 1 for dimension "A"

- (4) Using a 0.250 inch diameter drill bit, drill five holes through the spinner bulkhead.
- (5) Deburr both the inside (engine-side) and outside (propeller-side) of the holes using a deburring tool.
 - (a) If the inside of the bulkhead is difficult to access, it may be deburred the next time the propeller is removed. The outside must be deburred to avoid damage to the spinner.
 - (b) Remove all metal shavings caused by drilling/deburring the drain holes.

Spinner Bulkhead	Dimension "A"	Additional Instructions
104154	1.050 ±0.010 inch (26.67 ±0.25 mm)	Center the hole between the fixed nutplates
105178	0.950 ±0.010 inch (24.13 ±0.25 mm)	Center the hole over the fixed nutplate
