**HARTZELL PROPELLER INC.**  
**ALERT SERVICE BULLETIN**  
**TRANSMITTAL SHEET**  
**HC-ASB-61-297**  
**Propeller - Hub Inspection**

August 27, 2012

- Adds an optional Terminating Action for conversion of hubs without an "A" or "B" serial number suffix
- Revises the document to latest caution and format requirements
- Revises the Compliance/Order Form in the document Appendix

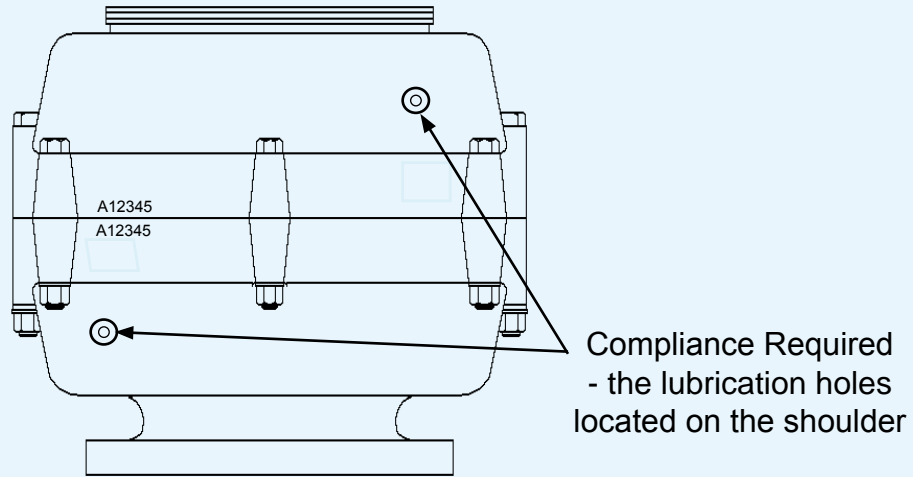
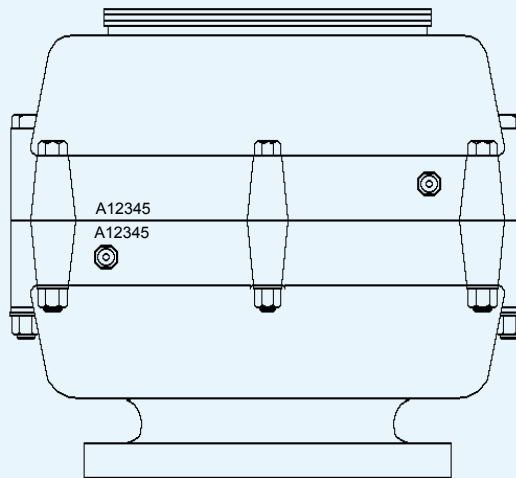
**Hub Identification  
Figure 2**

- (1) Hartzell left-hand rotating ( )HC-( )(2,3)Y(K,R)-2 two and three blade, aluminum hub, "compact" series propellers installed on a Lycoming 360 series engine on a Piper Seneca PA-34-200, a Piper Seminole PA-44-180, PA-44-180T, or a Beech 76, Duchess are affected by this Alert Service Bulletin. Propellers affected are limited to propellers having the propeller lubrication holes located on the shoulder of the hub blade socket.
- (a) A propeller with a suffix letter "A" or "B" at the end of the hub and propeller serial number or with a hub that has the lubrication hole located at the hub parting line are not affected by this Alert Service Bulletin. During 1983, the lubrication holes were relocated to the hub parting line. The location of the lubrication holes are shown in Figure 2.

**Location of lubrication fittings before 1983**

Compliance Not Required - the lubrication holes located at hub parting line

**Location of lubrication fittings after 1983**

- (3) There have been numerous occurrences of hub cracks initiating from the lubrication holes on "left-hand" rotating propellers, including incidents of in-flight blade separation in Hartzell two blade "compact" series aluminum hub propellers. The lubrication holes on the "left-hand" rotating propeller experience additional stresses not experienced in the lubrication holes on the "right-hand" rotating propeller.

- (4) Hub cracks have been discovered during an inspection following a report of abnormal vibration or grease leakage. Such a crack may typically initiate in the area around the lubrication holes. As a crack propagates across the blade socket, the progression accelerates and may result in separation of one blade from the propeller and may further progress to separation of the propeller or engine from the aircraft.

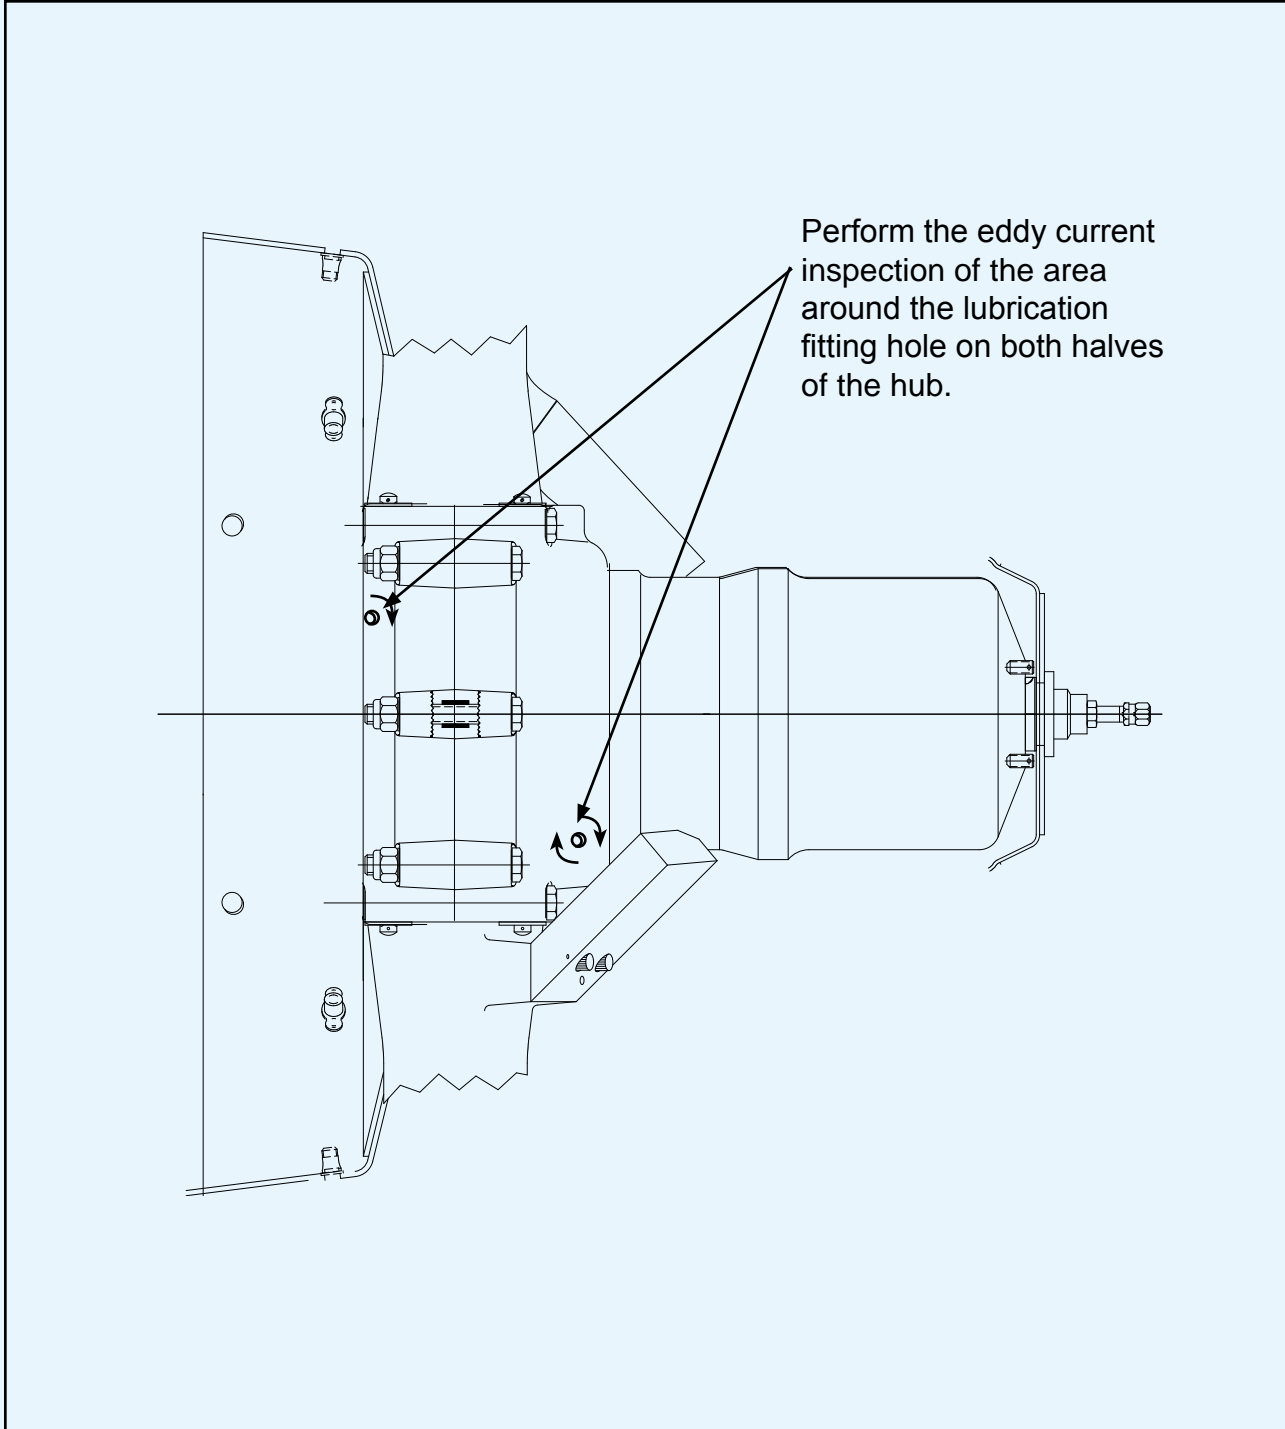
Figure 3

Lubrication Hole Inspection

- (b) Before any cleaning, visually inspect for a cracked hub in the area around the lubrication hole (a cracked hub can have traces of grease coming from a crack making the crack more visible).
- (c) Clean the surface of the hub to remove oil, grease, or other contaminants that may interfere with the efficiency of the eddy current inspection.

- (d) Perform the Aluminum Hub Lubrication Fitting Hole Inspection specified in Volume 2 of Hartzell Standard Practices Manual 202A (61-01-02). Refer to Figure 3.

- (4) If a crack indication is found, hub replacement is required before further flight. Report any findings of a cracked hub to the Hartzell Propeller Product Support Department.

- (a) If not previously stamped, permanently identify the hub to indicate a repetitive eddy current inspection is required. The letter "E" indicates a repetitive eddy current inspection is required in accordance with this Alert Service Bulletin.
