HARTZELL PROPELLER INC. SERVICE LETTER

Propeller - Abnormal Vibration or Grease Leakage

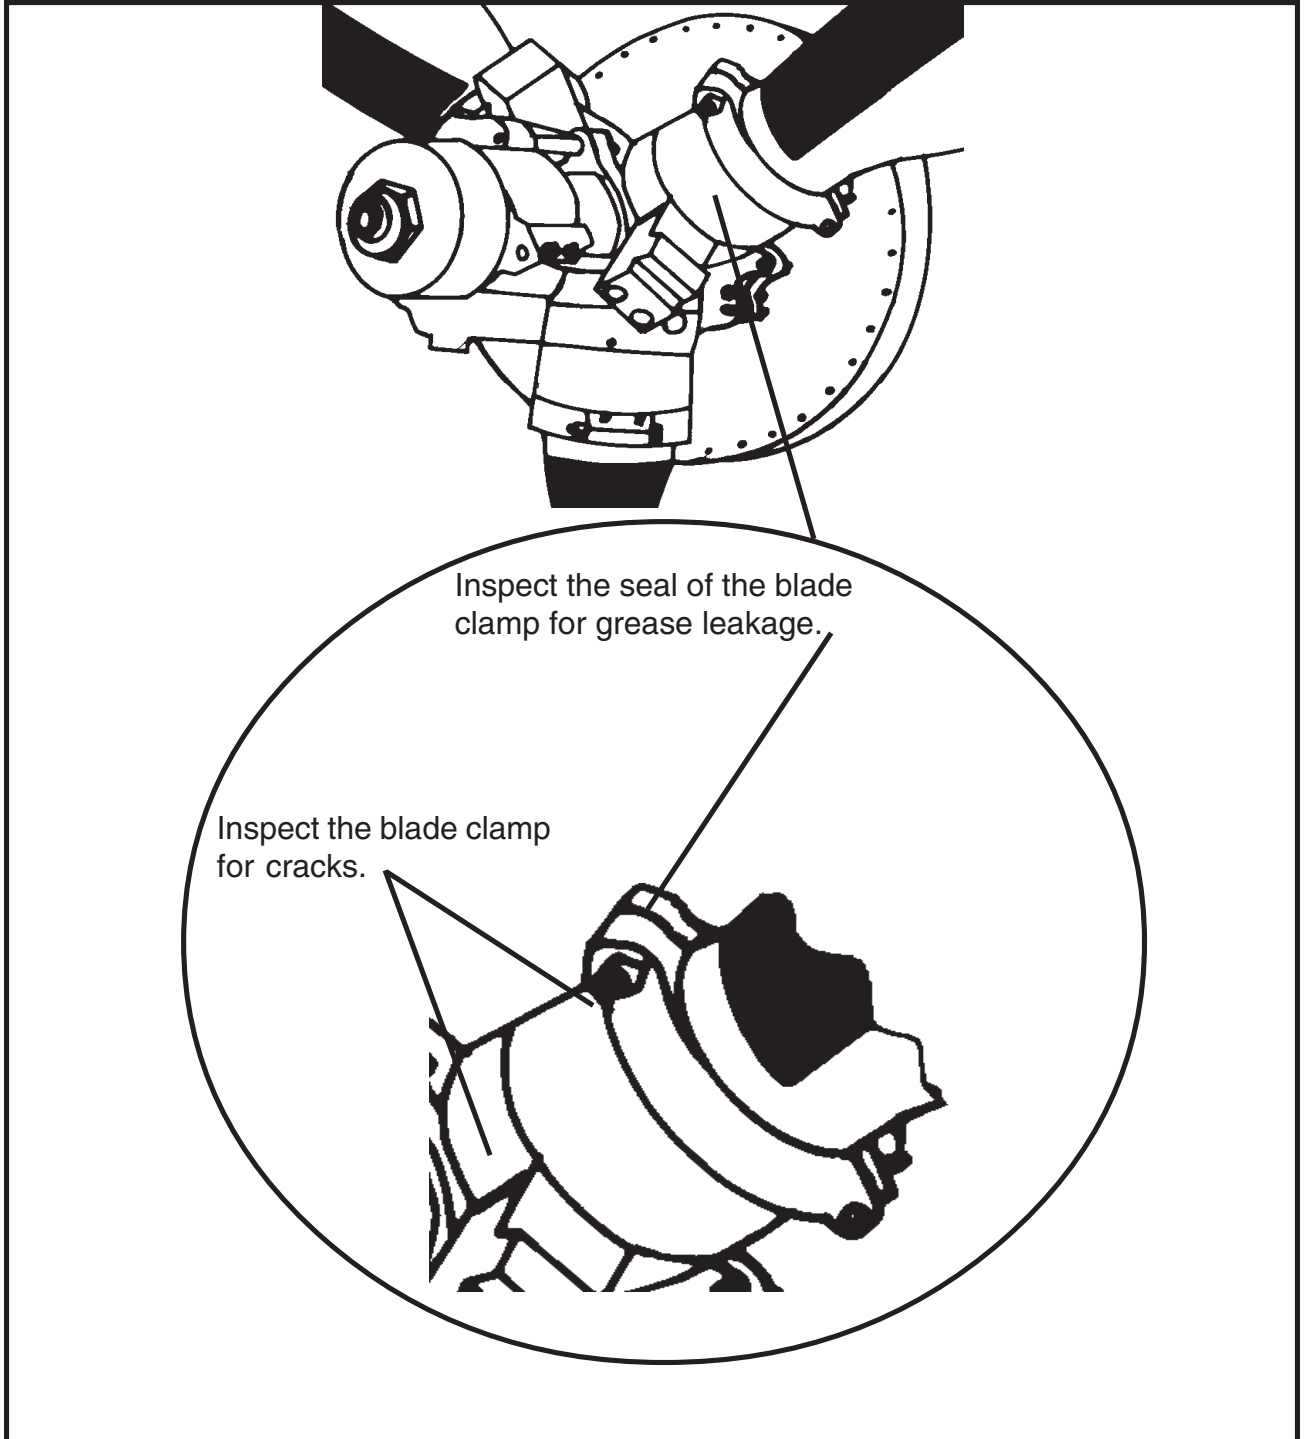
**Steel Hub Clamp
Figure 1**

- (2) Perform visual inspection for cracks in the hub and blade retention areas.
 - (a) On steel hub propellers pay particular attention to the steel blade clamps, see Figure 1.
 - (b) On aluminum hub propellers pay particular attention to the blade retention areas of the hub, see Figure 2.

NOTE: Figures 1 & 2 show examples of past incidents where cracks have been found. The areas shown should not be the only area inspected.

- (3) Perform visual inspection of the hub and blade retention areas to locate the origin of leakage. If the origin of grease leakage is determined to be a noncritical part such as an O-ring or sealant, repairs can be accomplished during scheduled maintenance.
- (4) If suspected cracks are found, before further flight, perform additional inspections (by qualified personnel at an approved propeller repair station) to verify the condition. Such inspections typically include disassembly of the propeller with dye penetrant, eddy current, or magnetic particle inspection of parts in accordance with published procedures.
- (5) If cracks or failing components are found, parts must be replaced prior to further flight. Such incidents need to be reported to airworthiness authorities and Hartzell Propeller Inc.
