## TRANSMITTAL SHEET HC-SL-61-254

## **Propeller - Propeller Operating Restrictions**

### HC-SL-61-254

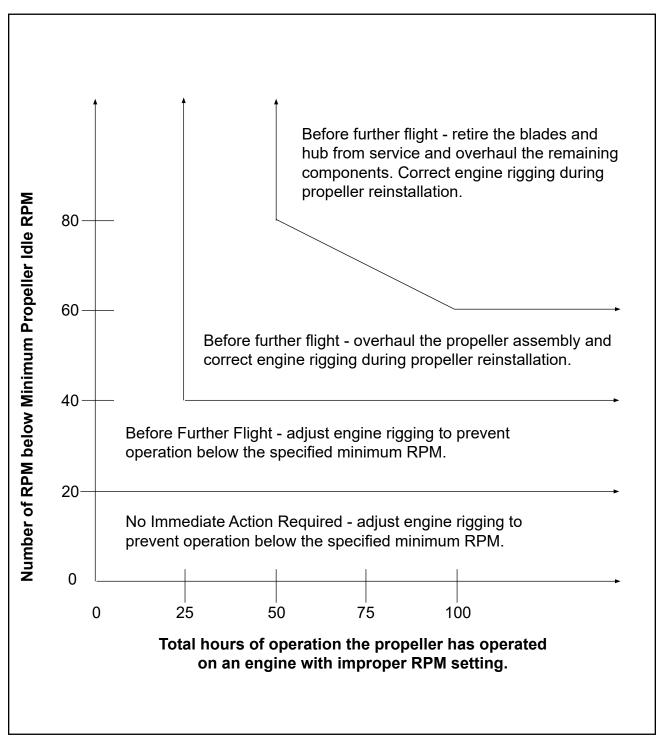
Corrective Action Required Figure 1

- (3) The corrective action will be based on the amount the RPM is below the minimum specified propeller RPM in the restricted RPM region and the total hours of operation of the propeller on an engine with improper RPM settings. The greater the amount of the RPM deviation and the longer it is permitted to exist, the more severe the corrective action required. The corrective actions may vary from no action required to scrapping of the blades, blade clamps (if applicable), and hub. Refer to Figure 1 for the required corrective action. Contact Hartzell if further clarification is required. Contact Hartzell when violating a propeller restriction that is other than what is described by Figure 1.

Figure 1 shows that with an RPM deviation of 60 RPM for 75 hours - the propeller assembly must be overhauled and engine rigging corrected before further flight.

- (d) If the propeller <u>can</u> be operated below the minimum specified propeller idle RPM:
  - 1 Refer to Figure 1 for corrective action requirements, and Figure 2 for an example of a ground idle RPM check evaluation.
  - The corrective action is based on the amount the RPM is below the minimum propeller idle RPM and the total hours of operation the propeller has accumulated.
    - Figure 1 applies to an aircraft that is operated in conventional service. "Hours of Operation" refers to the total number of hours the propeller is operated on an engine that has an improper RPM setting. It is not the number of hours the propeller is operated in a restricted range, which will be less than the total hours of operation.

- (a) The required corrective action is determined by both the amount and duration of RPM deviation.
  - A turboprop propeller with four or more blades may have a variety of operating restrictions and these different restrictions may have different operating margins.
  - The greater the amount of the RPM deviation and the longer it is permitted to exist, the more severe the required corrective action.
  - <u>3</u> The corrective action may vary from no action required, to retirement of the blades and the hub.
  - 4 The chart in Figure 1 specifies the required corrective action for operation below the minimum idle RPM.
  - <u>a</u> The chart in Figure 1 does <u>not</u> apply to other propeller restrictions that are above the minimum idle RPM.
  - If the corrective action requires a propeller overhaul, overhaul the propeller in accordance with the applicable propeller overhaul manuals.
