AD 94-11-04 Hub Arm Assembly

94-11-04 MITSUBISHI HEAVY INDUSTRIES, LTD.: Amendment 39-8920; Docket No. 94-CE-09-AD.

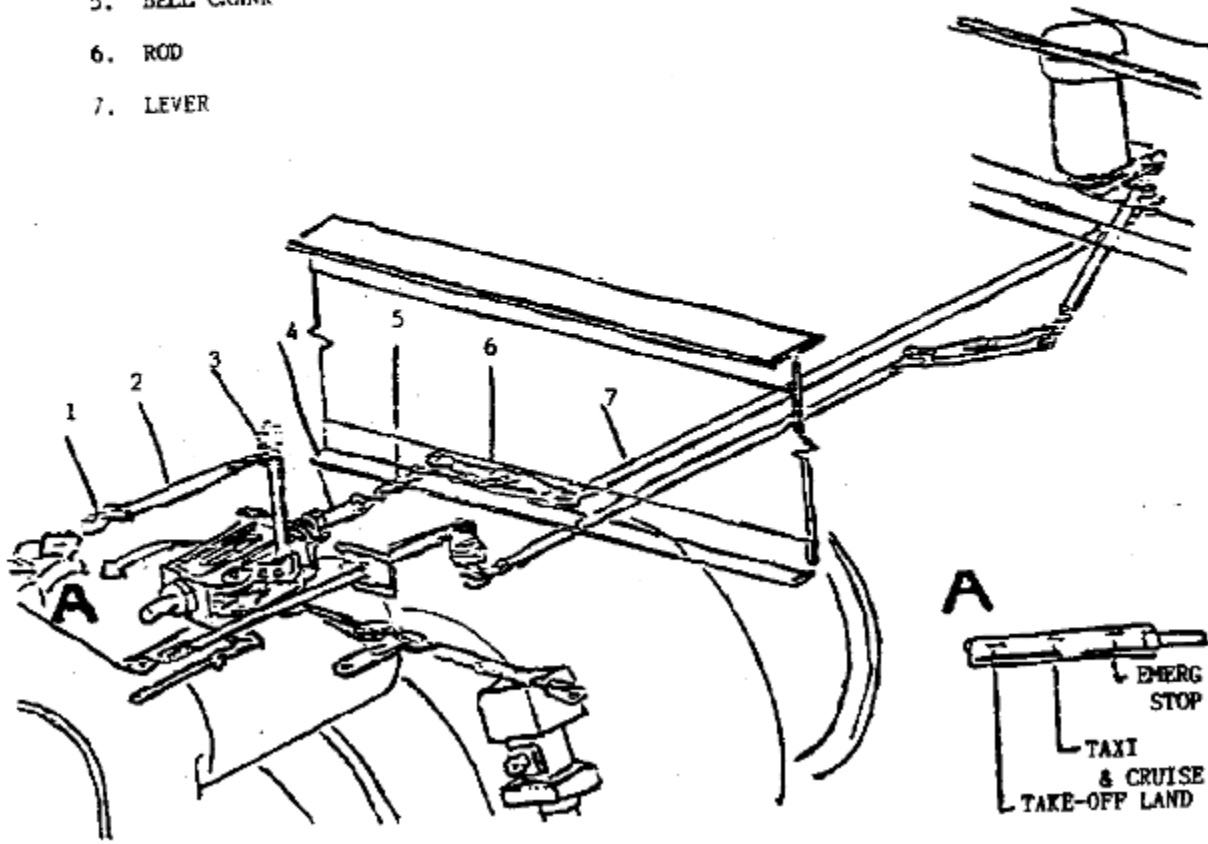
1. ROD
2. LEVER
3. CYLINDER ASSEMBLY
4. ROD (Reference dimension 3.39 inches \pm by 0.02 inches)
5. BELL CRANK
6. ROD
7. LEVER

To prevent propeller hub arm assembly failure because of high vibration frequencies during ground idle speed and possible separation of the propeller from the airplane, which could result in loss of control of the airplane, accomplish the following:

(b) Modify the airframe condition control linkage by adjusting Rod 1 and Levers 2 and 7 as specified in Figure 1 of this AD in accordance with Chapter 6, Section 9.2, of the applicable Mitsubishi MU-2 maintenance manual.
