**HARTZELL PROPELLER INC.**  
**SERVICE BULLETIN**  
**TRANSMITTAL SHEET**  
**HC-SB-61-287**

**Propeller - E10950 Blade Inspection, Rework, and Thrust  
Bearing Replacement**

June 5, 2009

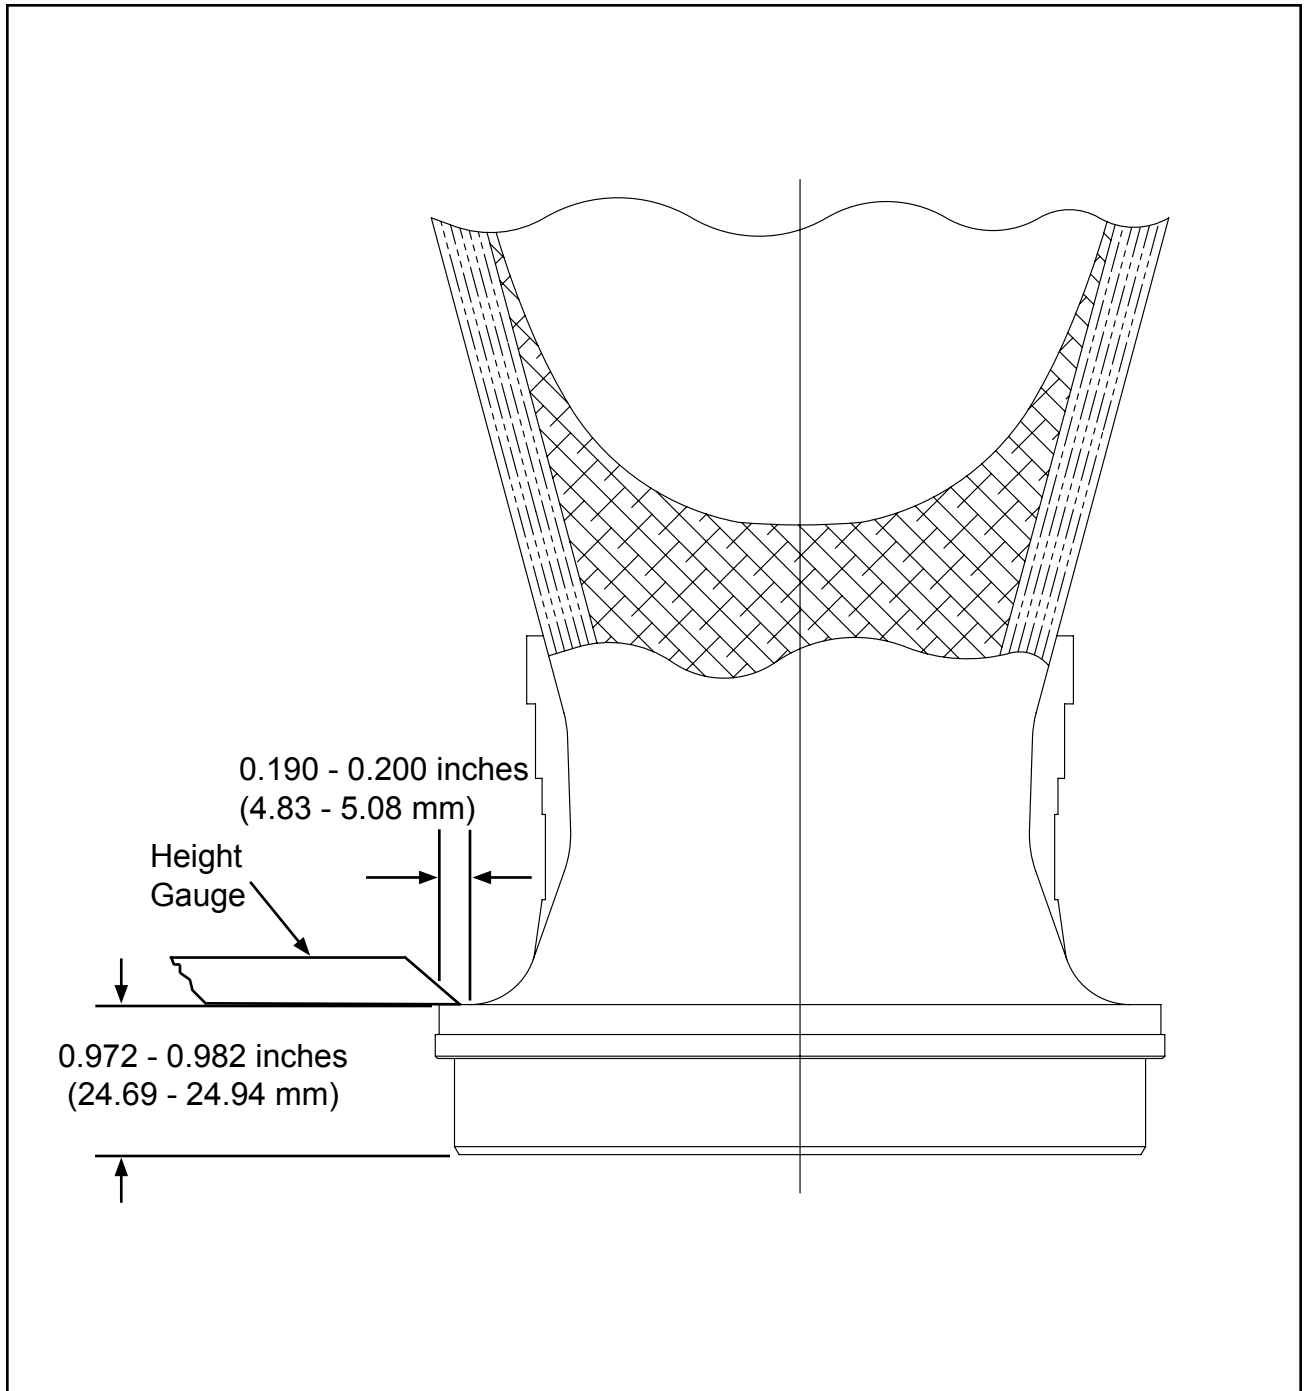
**Measuring the Blade Retention Shoulder Height  
Figure 1**

**NOTE:** The intent of the inspection is to determine if there are low spots that will prevent the blade thrust bearing from being properly seated on the blade retention shoulder.

- (a) Measure the blade retention shoulder in 45 degree increments on the outer 0.195 +/- 0.005 inches (4.95 +/- 0.12 mm) of the laminate diameter. Refer to Figure 1.
  - 1 If no area measures less than 0.972 inches (24.69 mm), perform the optical comparator inspection in accordance with Paragraph 3.C. of this Service Bulletin.
  - 2 If any part of the shoulder height measures less than 0.972 inches (24.69 mm) but more than 0.949 inches (24.10 mm), rework the blade retention radius in accordance with Paragraph 3.D. of this Service Bulletin.
  - 3 If any part of the shoulder height measures less than 0.949 inches (24.10 mm), return the blade to Hartzell Propeller Inc. for evaluation.

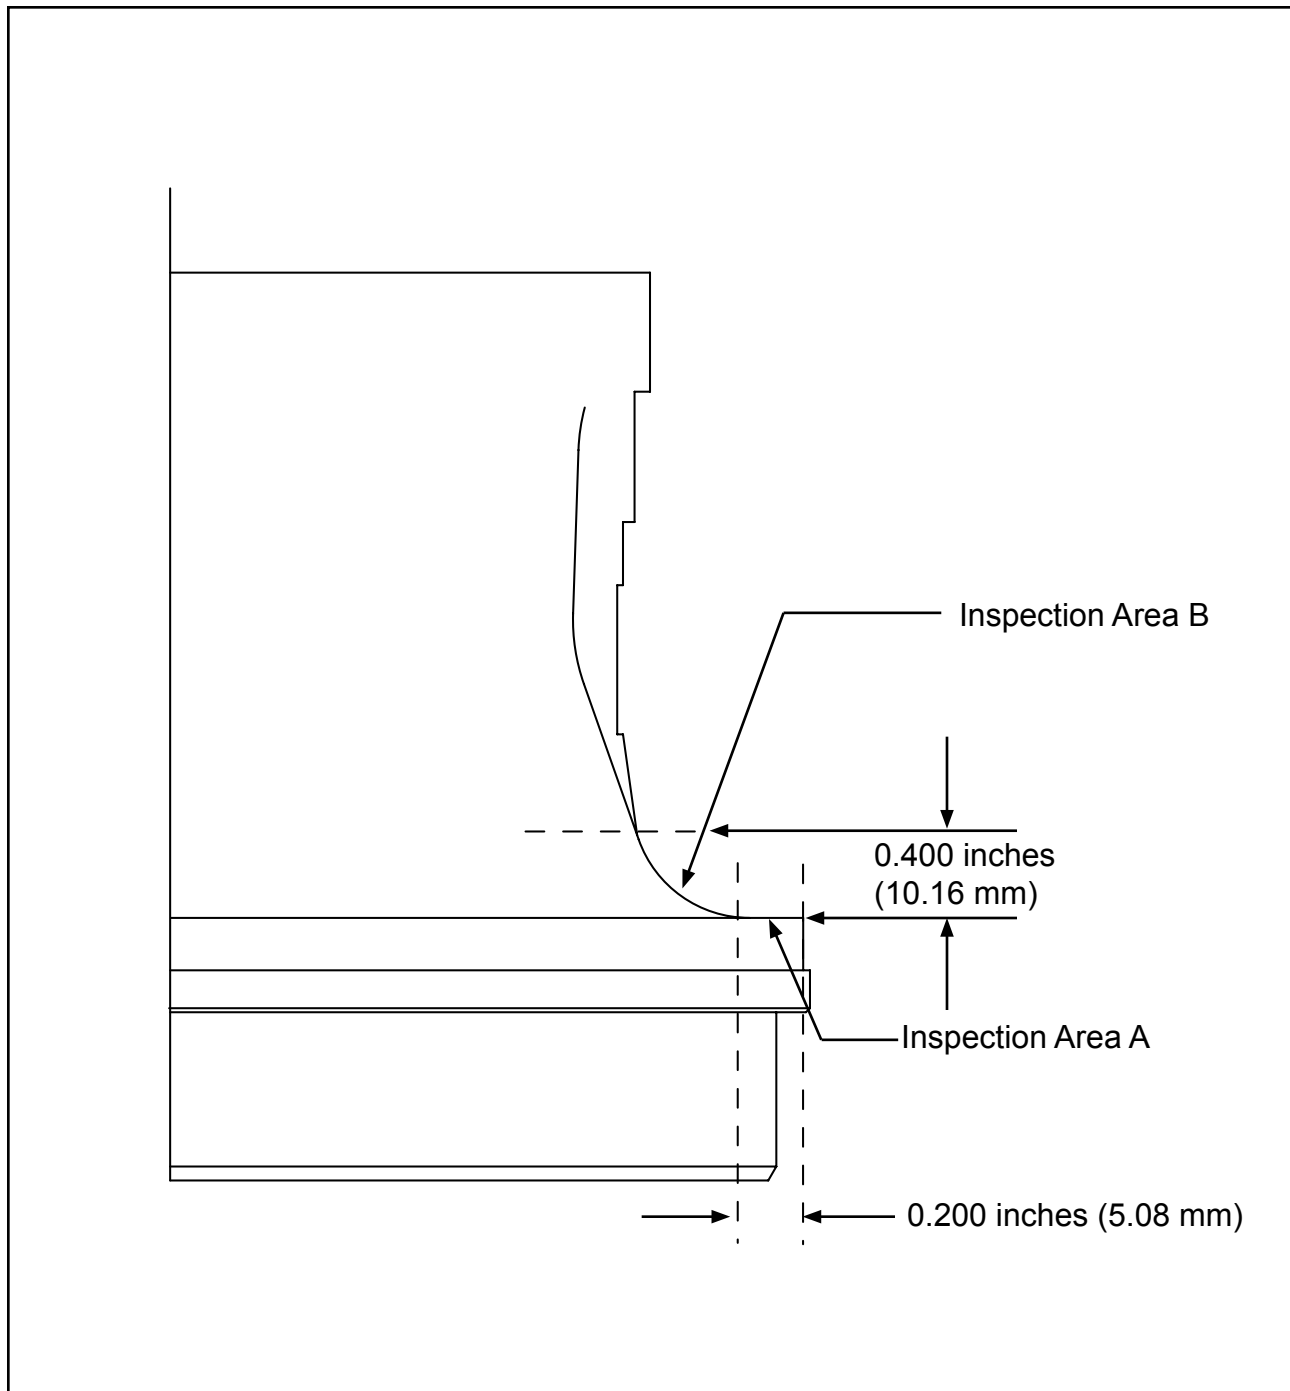
**Inspection of the Blade Retention Shoulder and Retention Radius  
Figure 2**

- (b) Inspect the blade shoulder, Area A, for damage. Refer to Figure 2.
  - 1 If the damage is visible and reaches or extends into the base metal of the blade shank, return the blade to Hartzell Propeller Inc. for evaluation.

- 2 If damage is visible, measure the shoulder height at the bottom of the damage. If the shoulder height measures less than 0.949 inches (24.10 mm), return the blade to Hartzell Propeller Inc. for evaluation.

- b If any area of damage is greater than 0.250 inches (6.35 mm) in length, return the blade to Hartzell Propeller Inc. for evaluation.
- (c) Inspect the blade retention radius, Area B, for damage. Refer to Figure 2.

- 1 A gouge or loss of composite material less than 0.250 inches (6.35 mm) in length, 0.250 inches (6.35 mm) in width, and 0.020 inches (0.508 mm) in depth anywhere on the retention radius Area B is permitted.

- 2 If any gouge or loss of composite material is more than 0.250 inches (6.35 mm) in length, 0.250 inches (6.35 mm) in width or 0.020 inches (0.508 mm) in depth anywhere on the retention radius Area B, return the blade to Hartzell Propeller Inc. for evaluation.

- 3 If no area measures less than 0.949 inches (24.10 mm) in height:
    - a If each area of damage is less than 0.250 inches (6.35 mm) in length, rework the blade retention radius in accordance with Paragraph 3.D. of this Service Bulletin.

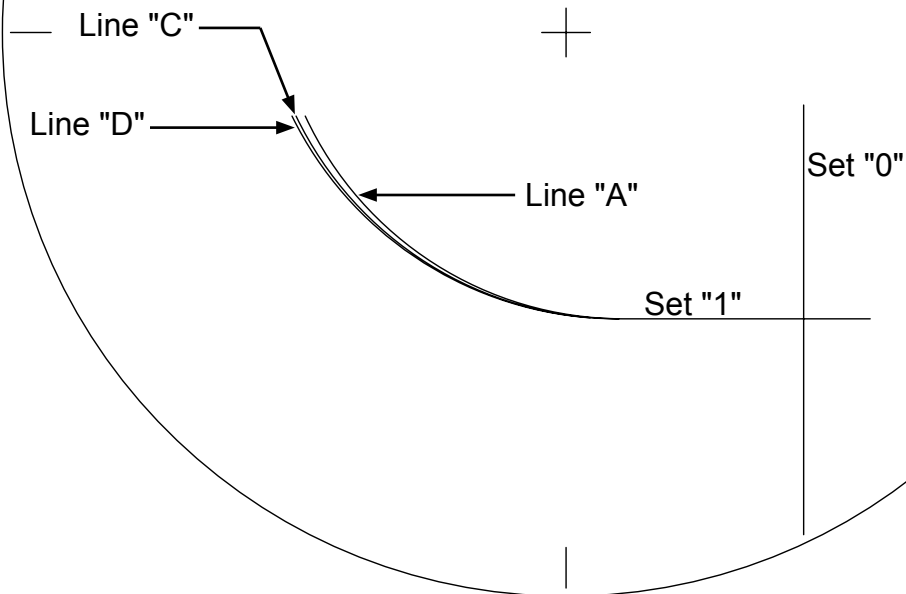
**Optical Comparator Overlay GT-3669, Rev. A  
Figure 3**

1. Set aluminum retention O.D. to Set 0
2. Set retention shoulder to Set 1
3. If radius falls between  
Outside "A" - rework of the retention radius is required  
"A" and "C" - retention radius is acceptable  
"C" and "D" - rework of the retention radius is required  
Inside "D" - return blade to Hartzell Propeller Inc. for evaluation

- (a) Determine serviceability/repairability by comparing the projected image with the overlay. Make sure that the projected image is within the "A" and "D" lines. See Figure 3.

- 2 If projection is between lines "A" and "C" retention radius is acceptable.

- 4 If projection is inside line "D", retention radius laminate repair is required. Return the blade to Hartzell Propeller Inc. for evaluation.

- 1 If projection is outside line "A", rework the retention radius in accordance with Paragraph 3.D. of this Service Bulletin.

- 3 If projection is between lines "C" and "D", rework retention radius in accordance with Paragraph 3.D. of this Service Bulletin.
