HARTZELL PROPELLER INC.
SERVICE BULLETIN
TRANSMITTAL SHEET
HC-SB-61-304

Propeller - Introduction of an Improved Blade

August 1, 2012

HARTZELL PROPELLER INC.
SERVICE BULLETIN
HC-SB-61-304

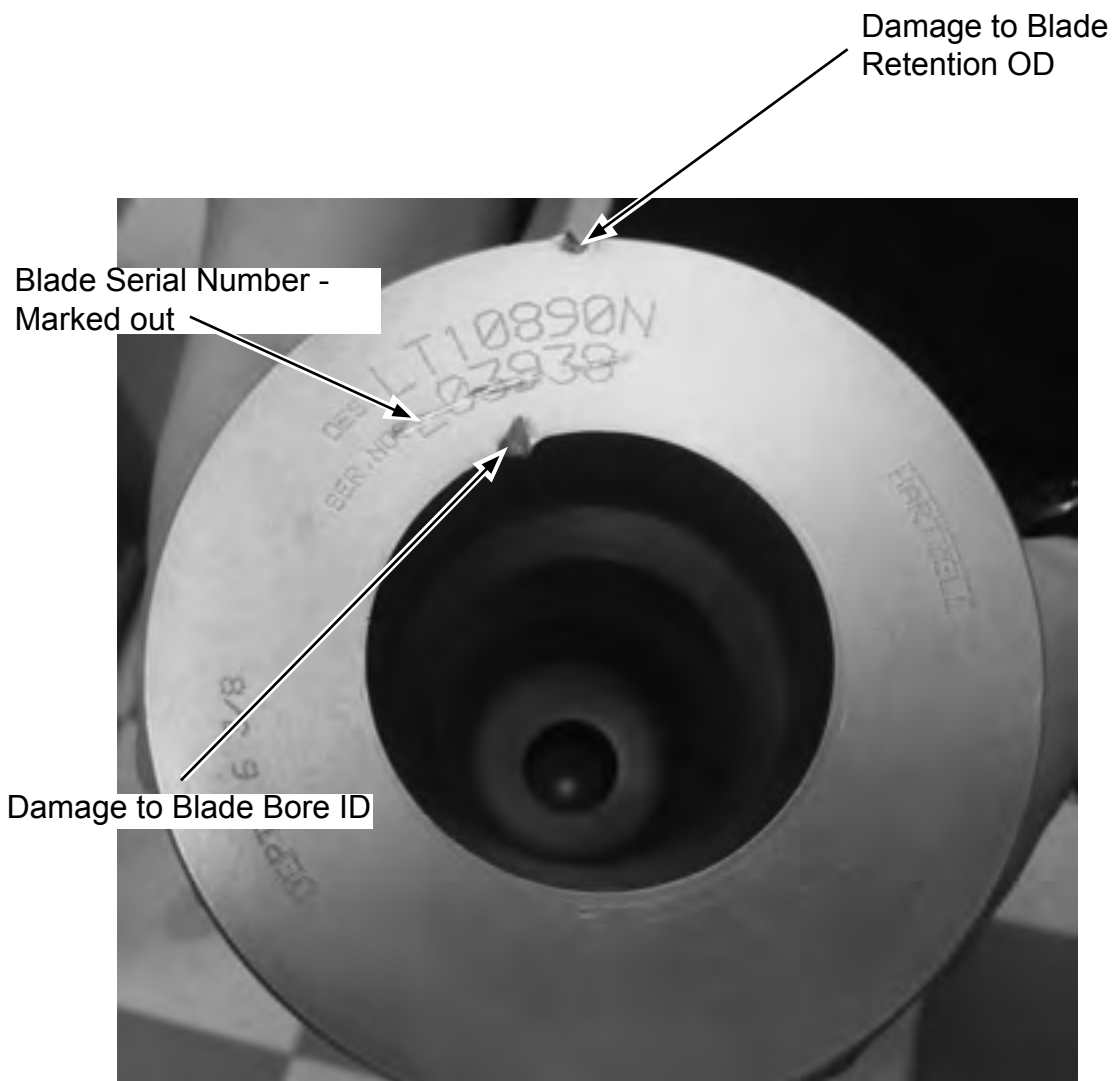
Blade Butt Showing Damage to Prevent Further Use of the Blade
Figure 2

Note: The blade shown is not an affected blade. This blade is shown as an example only of the damage that should be made to retire the blade.

- 1 The retired blades cannot be modified or returned to service for use in any application, including experimental applications.
- 2 Each blade must be damaged in such a way that prevents further use of the blade.
 - 1 Using a tool, damage the ID of the blade bore and the OD of the blade retention surface. Damage must be sufficient to prevent installation of the blade bearing and the blade clamp. Refer to Figure 2.
 - 2 Mark out the blade serial number, so that the number is still legible.
 - 3 Take a photograph of the blade butt to show the damage, the blade model number, and the blade serial number. Refer to Figure 2.
 - 4 Send the photo via email to techsupport@hartzellprop.com in accordance with the Appendix to this Service Bulletin. **DO NOT RETURN THE BLADE.**
