[Docket No. 83-ANE-14-AD; Amendment 39-14043; AD 83-08-01R2]

Airworthiness Directives; Hartzell Propeller Inc. (Formerly TRW Hartzell Propeller) Models HC-B3TN-2, HC-B3TN-3, HC-B3TN-5, HC-B4TN-3, HC-B4TN-5, HC-B4MN-5, and HC-B5MP-3 Turbopropellers

ACTION: Final rule.

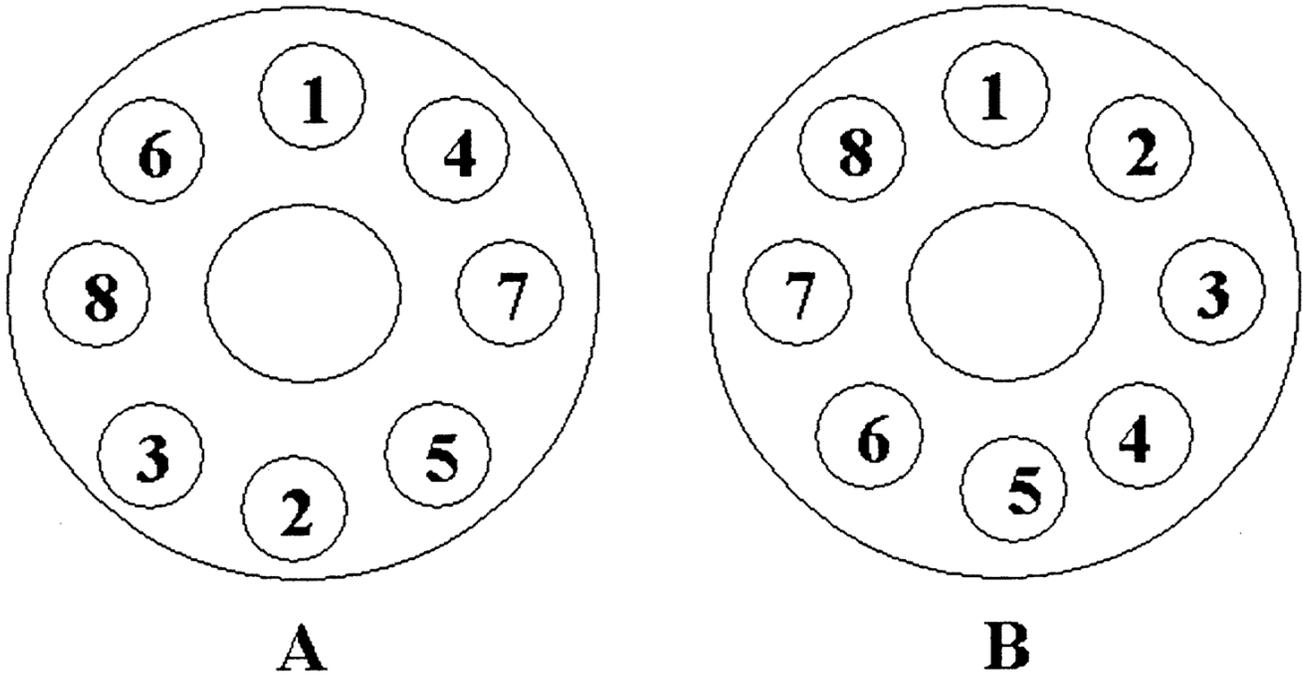
(5) Torque all attaching bolts with a torque wrench and an appropriate adapter, to 40 ft.-lbs., and then to 80 ft.-lbs., following sequence "A" (shown below). Final torque all attaching bolts using sequence "B" (shown below) to 100 ft.-lbs. to 105 ft.-lbs. Safety wire all attaching bolts in an FAA-approved manner.
