AD 94-11-04 Hub Arm Assembly

Effective Date: June 10, 1994

94-11-04 MITSUBISHI HEAVY INDUSTRIES, LTD.: Amendment 39-8920; Docket No. 94-CE-09-AD.

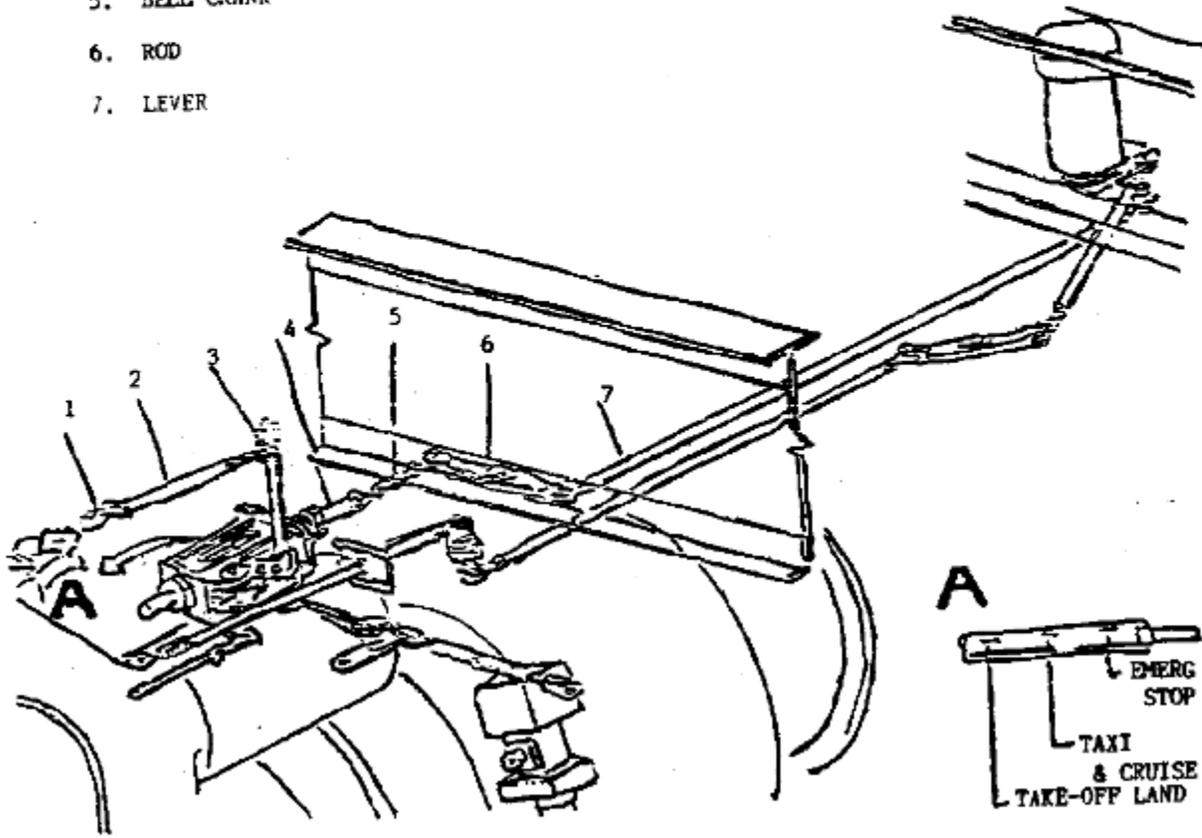
To prevent propeller hub arm assembly failure because of high vibration frequencies during ground idle speed and possible separation of the propeller from the airplane, which could result in loss of control of the airplane, accomplish the following:

1. ROD
2. LEVER
3. CYLINDER ASSEMBLY
4. ROD (Reference dimension 3.39 inches \pm by 0.02 inches)
5. BELL CRANK
6. ROD
7. LEVER

(b) Modify the airframe condition control linkage by adjusting Rod 1 and Levers 2 and 7 as specified in Figure 1 of this AD in accordance with Chapter 6, Section 9.2, of the applicable Mitsubishi MU-2 maintenance manual.
