HARTZELL PROPELLER LLC
ALERT SERVICE BULLETIN
HM-ASB-003
Beta Rod Nut/Safety Wire Inspection

- (1) Hartzell Propeller HM-(D,E)4N-3() Wing-In-Ground Effect lightweight turbine propellers are affected by this Alert Service Bulletin.

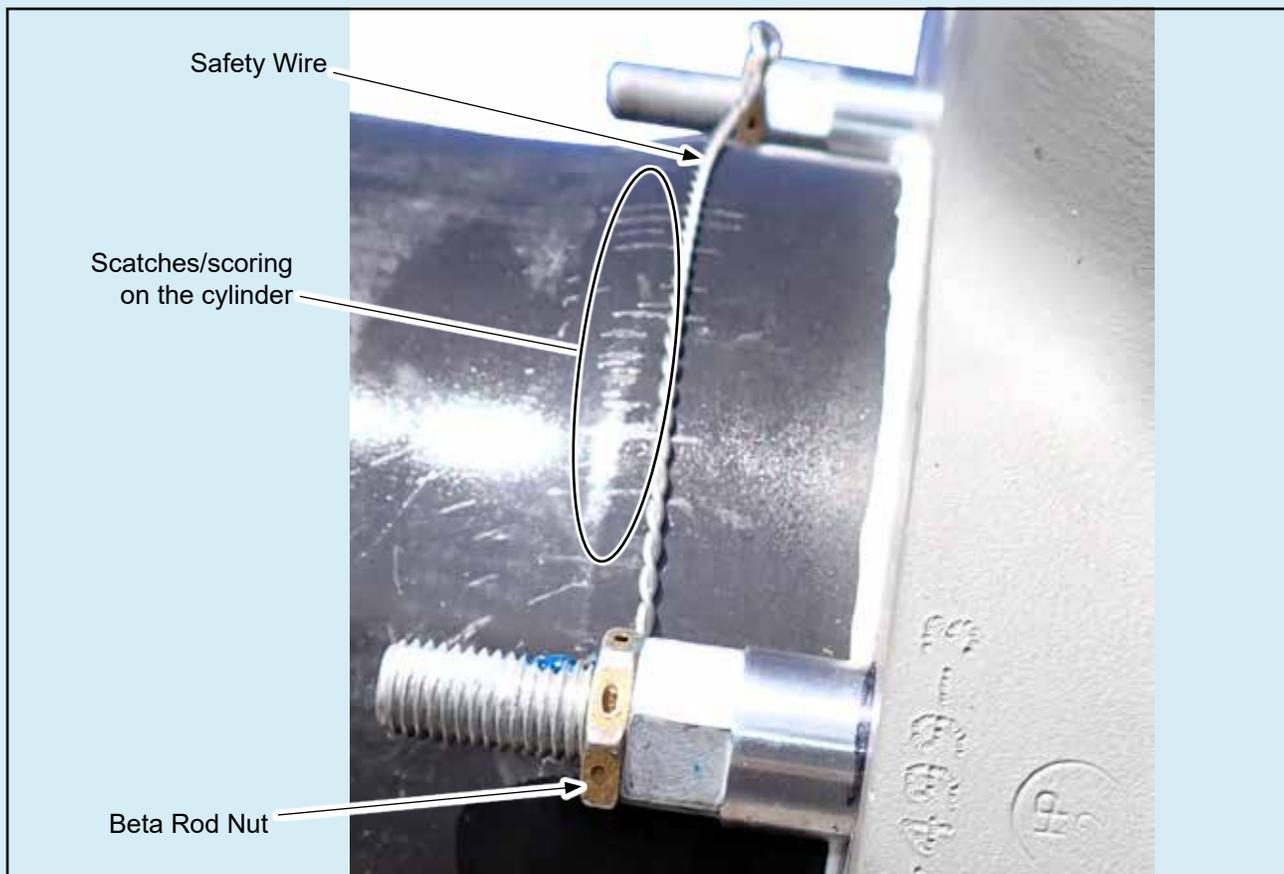
Safety Wire Interference
Figure 1

- (1) Hartzell Propeller LLC received information about an accident involving a propeller that went into uncommanded reverse during flight.
- (a) The accident investigation found safety wire securing the beta rod nuts and evidence of interference between the safety wire and the cylinder on the affected propeller. Refer to Figure 1.
- 1 Safety wire is **not** authorized for the beta rod nuts on affected propellers.

- (1) This Alert Service Bulletin provides Instructions for Continued Operation (ICO).
- (2) This Alert Service Bulletin provides instructions for a pre-operation inspection of the beta rod nuts on affected propellers.
- (3) This Alert Service Bulletin provides instructions for removing safety wire from the beta rod nuts on affected propellers (if present).
