HARTZELL PROPELLER INC.
SERVICE LETTER

HM-SL-002

Propeller - Hub Clamping Bolt Inspection

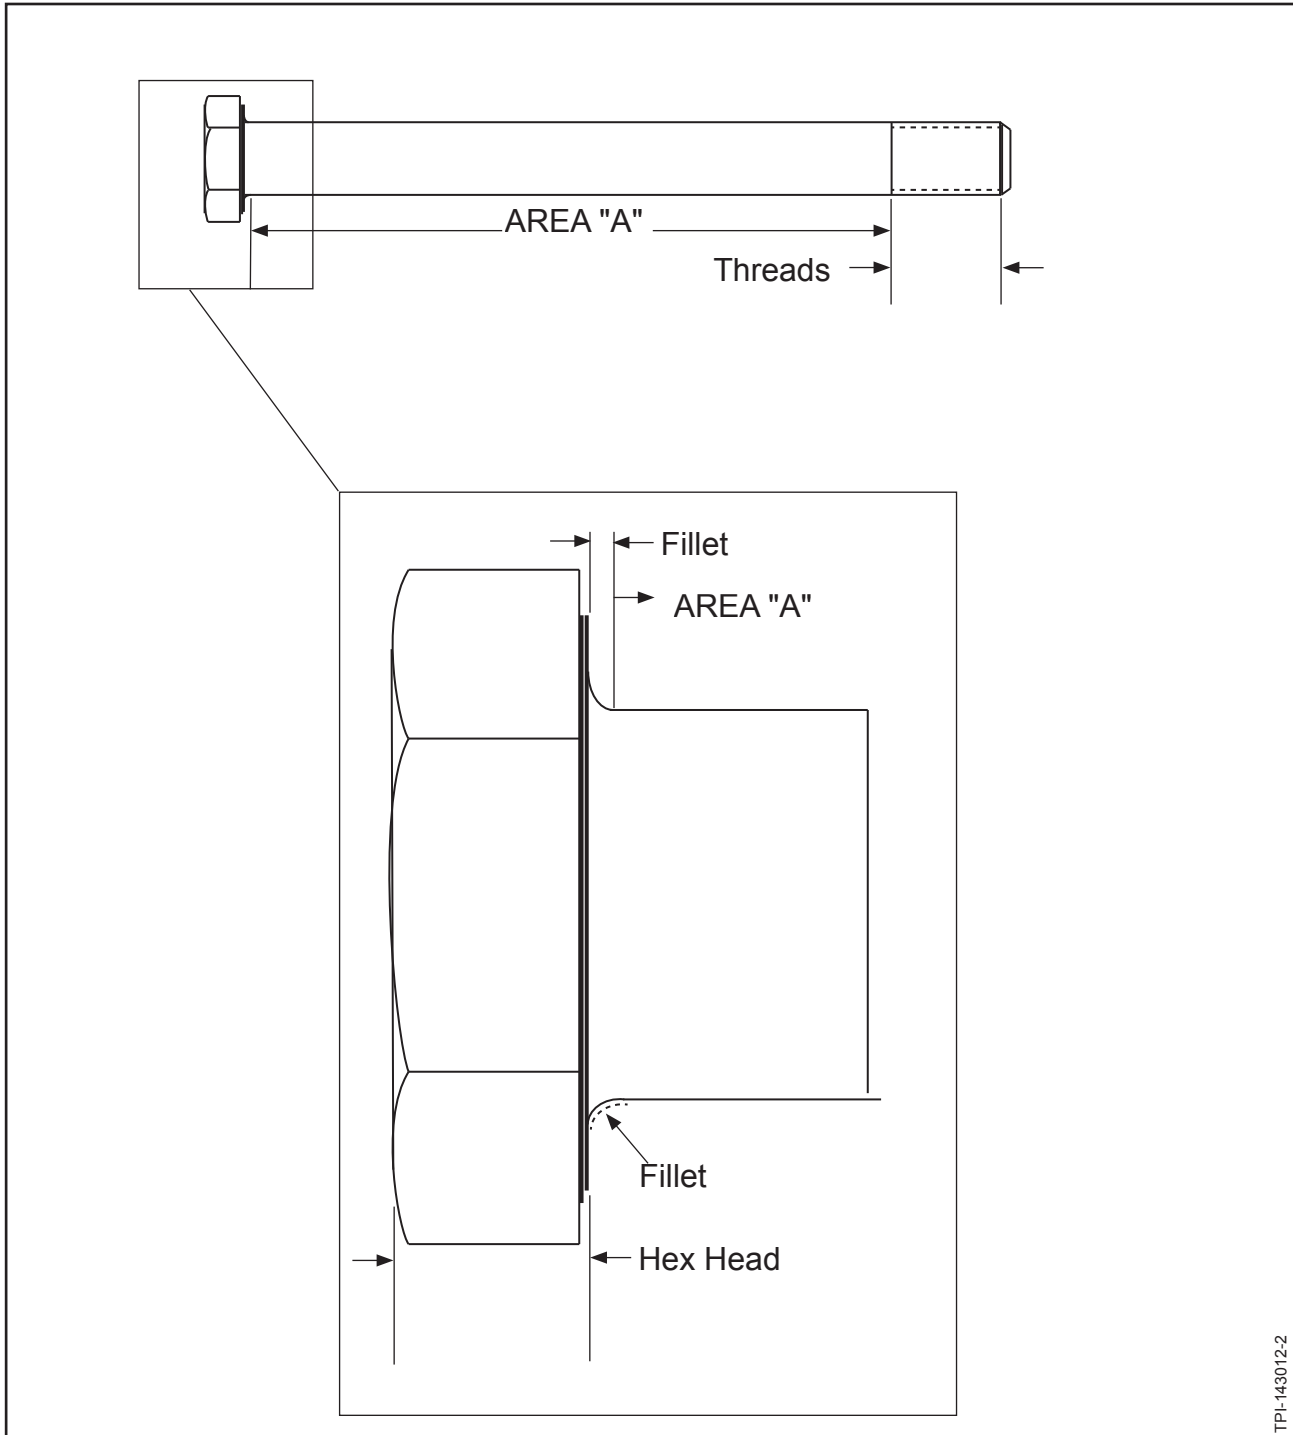
**Hex Head Bolt
Figure 1**

Inspect	Serviceable Limits	Corrective Action
<u>HEX HEAD BOLT</u>		
Refer to Figure 1.		
(1) Visually examine the hex head bolt for corrosion and pitting.	Corrosion is not permitted. The maximum permitted depth of pitting is 0.002 inch (0.05 mm). No more than 5% of the total unthreaded surface may be pitted. The maximum permitted diameter of an individual pit is 0.032 inch (0.81 mm). Pitting is not permitted in the fillet between the hex head and the grip, area "A". Pitting must not affect the fit or function of the hex head bolt.	Corrosion may be removed using glass bead cleaning. Refer to the Cleaning chapter of Hartzell Propeller Inc. Standard Practices Manual 202A (61-01-02). If the pitting is greater than the permitted serviceable limits, replace the hex head bolt.

(2) Except for the threads, visually examine the hex head bolt for damage or scratches.	The maximum permitted depth of damage or a scratch is 0.002 inch (0.05 mm). Scratches or damage must not affect the fit or function of the hex head bolt. Pushed-up material is not permitted.	Pushed up material may be removed. If the depth of a scratch or damage is greater than the permitted serviceable limits or affects the fit or function of the bolt, replace the hex head bolt.

(3) Visually examine the hex head bolt for circumferential scoring caused by installation and removal.	Circumferential scoring that reduces the diameter of the hex head bolt is not permitted. The minimum permitted OD in Area A is 0.370 inch (9.40 mm).	If the scoring is greater than the permitted serviceable limits or the OD in Area A is less than the serviceable limits, replace the hex head bolt.

(4) Visually examine the wrenching surfaces of the head of the hex head bolt for metal movement caused by wrenching.	Limited damage from wrenching is permitted, but the hex head bolt must be able to be torqued and metal movement must not interfere with the installation of the hex head bolt or cause damage to the hub.	Remove metal movement with a file or equivalent. Only corners may be repaired. Refacing a complete surface is not permitted. If metal movement is greater than the permitted serviceable limits, replace the hex head bolt.

Inspect	Serviceable Limits	Corrective Action
<u>HEX HEAD BOLT, CONTINUED</u>		
Refer to Figure 1.		
(5) Visually examine the threads of the hex head bolt for damage and pitting.	A maximum total accumulation of damage and pitting of 3/4 thread is permitted. Thread damage must not cause damage to the mating part. An A-2043-1 nut with the plastic locking element removed should be able to freely rotate by hand on the bolt threads. For the modification of the nut, refer to Figure 2.	Limited thread file repair is permitted, but must be considered as thread damage. If the damage and pitting is greater than the permitted serviceable limits, replace the hex head bolt.

(6) Magnetic particle inspect each bolt in accordance with the Magnetic Particle Inspection chapter of Hartzell Propeller Inc. Standard Practices Manual 202A (61-01-02). <u>NOTE:</u> It is not necessary to strip the cadmium plating from the hex head bolt before magnetic particle inspection.	A relevant indication is not permitted.	If there is a relevant indication, replace the hex head bolt.

(7) Visually examine the hex head bolt for cadmium plating coverage.	Cadmium plating must completely cover the bolt with the following exceptions: A few scratches and corners with cadmium plating missing, minor abrading of cadmium plating on the threads, or minor abrading of the cadmium plating on the hex head because of wrenching.	Cadmium replate and bake for a minimum of 23 hours within four hours after plating the hex head bolt in accordance with the Cadmium Replating chapter of Hartzell Propeller Inc. Standard Practices Manual 202A (61-01-02).
