# ALERT SERVICE BULLETIN

HC-ASB-61-292

## Propeller - Blade Clamp Inspection

- (1) Aero Commander 500 series aircraft equipped with HC-A2MV(K,R)-2 or HC-A3MV(K,R)-2(A,B) Propellers.

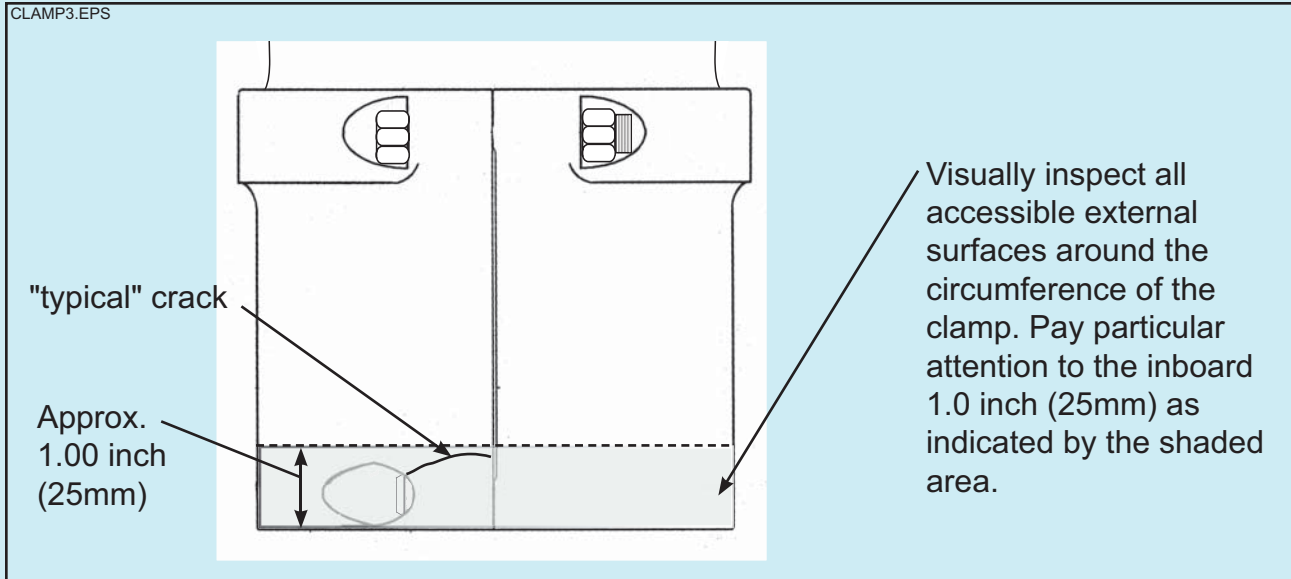
**Blade Clamp Inspection**  
**Figure 1**

- (1) There have been several instances of cracked clamps. Cracks originate from the inboard clamp radius and progress to the clamping screw.
- (2) The cracked clamps have been found only on the affected application. All have been identified by sudden grease leakage, during visual inspection in accordance with Alert Service Bulletin HC-ASB-61-255, or during overhaul. No blade separations have occurred.

- (4) Visually inspect the outer surfaces of each blade clamp for cracks. Refer to Figure 1.
- (5) If a crack is not found during visual inspection of the blade clamp:
  - (a) Reinstall the spinner in accordance with Hartzell Propeller Owner's Manual 168 (61-00-68).
  - (b) Make an entry in the propeller logbook indicating compliance with this Service Bulletin and note when the next clamp inspection is due.

- (6) If a crack is found during visual inspection of the blade clamp, remove the propeller from the aircraft in accordance with Hartzell Propeller Owner's Manual 168 (61-00-68).
  - (a) Send the propeller to an appropriately licensed propeller repair facility.
  - (b) Contact Hartzell Product Support to document the inspection results.
