HARTZELL PROPELLER INC.
ALERT SERVICE BULLETIN
TRANSMITTAL SHEET
HC-ASB-61-297
Propeller - Hub Inspection

February 12, 2016

HARTZELL PROPELLER INC.
ALERT SERVICE BULLETIN
HC-ASB-61-297
Propeller - Hub Inspection

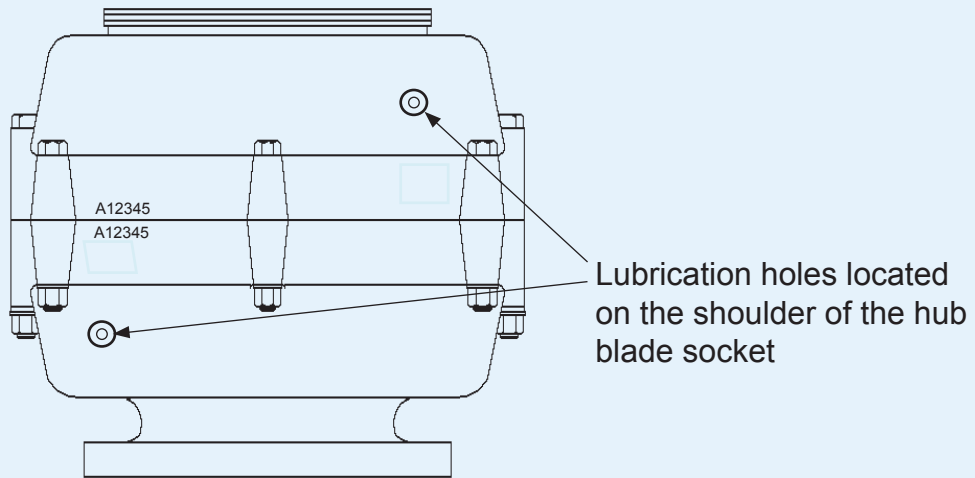
- (1) Hartzell Propeller Inc. left-hand rotating, aluminum hub compact propellers ()HC-() (2,3)Y(K,R)-2 that have the propeller lubrication holes located on the shoulder of the hub blade socket as shown in View A of Figure 1 are affected by this Alert Service Bulletin.
- (a) The affected propellers are installed on Piper Seneca PA-34-200, Piper Seminole PA-44-180, PA-44-180T, or Beech 76 Duchess aircraft with Lycoming 360 series engines.

View A: Location of the lubrication holes before 1983
(This propeller is affected by this Alert Service Bulletin)

- (1) There was a blade separation event originating in the lubrication hole located on the shoulder of the hub blade socket installed in a left-hand rotating propeller.

- (2) There have been numerous occurrences of hub cracks starting from the lubrication holes on the shoulder of the hub blade socket on left-hand rotating propellers, including incidents of in-flight blade separation on some affected propellers.

- (3) Hub cracks have been discovered during inspections related to abnormal vibration or grease leakage. Cracks typically start in the area around the lubrication holes and increase in size. If the crack reaches the blade socket, the growth of the crack accelerates and may result in separation of one blade from the propeller and may further progress to separation of the propeller or engine from the aircraft.

- (4) This Alert Service Bulletin requires an initial and repetitive eddy current inspection of the area around the lubrication holes on the affected propellers.

- (a) Replacement of the hub in an affected propeller with a new or serviceable hub that has an "A" or "B" serial number suffix is an optional terminating action for this Alert Service Bulletin when the hub replacement is performed in accordance with the Accomplishment Instructions in this Alert Service Bulletin.

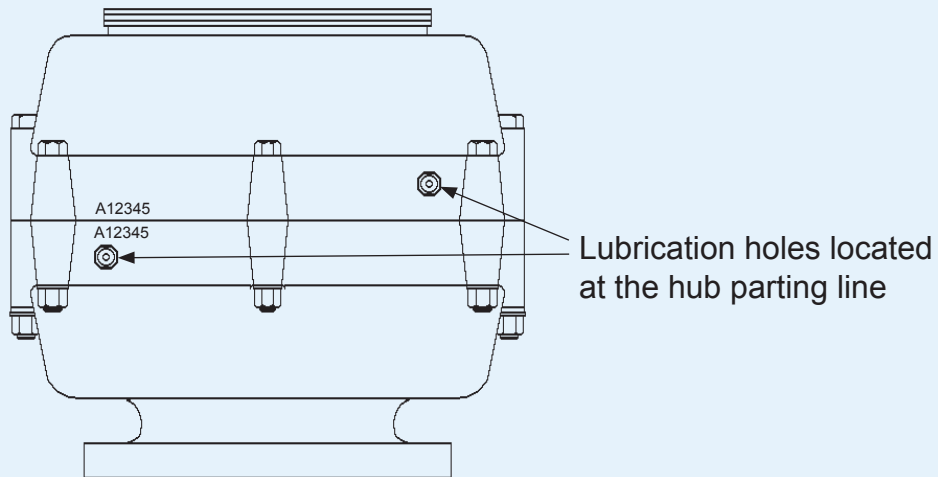
- (b) During 1983, the propeller lubrication holes were relocated to the hub parting line. Propellers with the lubrication holes located at the hub parting line as shown in View B of Figure 1 are not affected by this Alert Service Bulletin.

- 1 Propellers with a suffix letter "A" or "B" at the end of the hub and propeller serial number were manufactured with the lubrication holes located at the hub parting line. These propellers are not affected by this Alert Service Bulletin.
- 2 Propellers that have the lubrication holes located at the hub parting line, but no suffix letter after the serial number are not affected by this Alert Service Bulletin.

View B: Location of the lubrication holes after 1983
(This propeller is not affected by this Alert Service Bulletin)

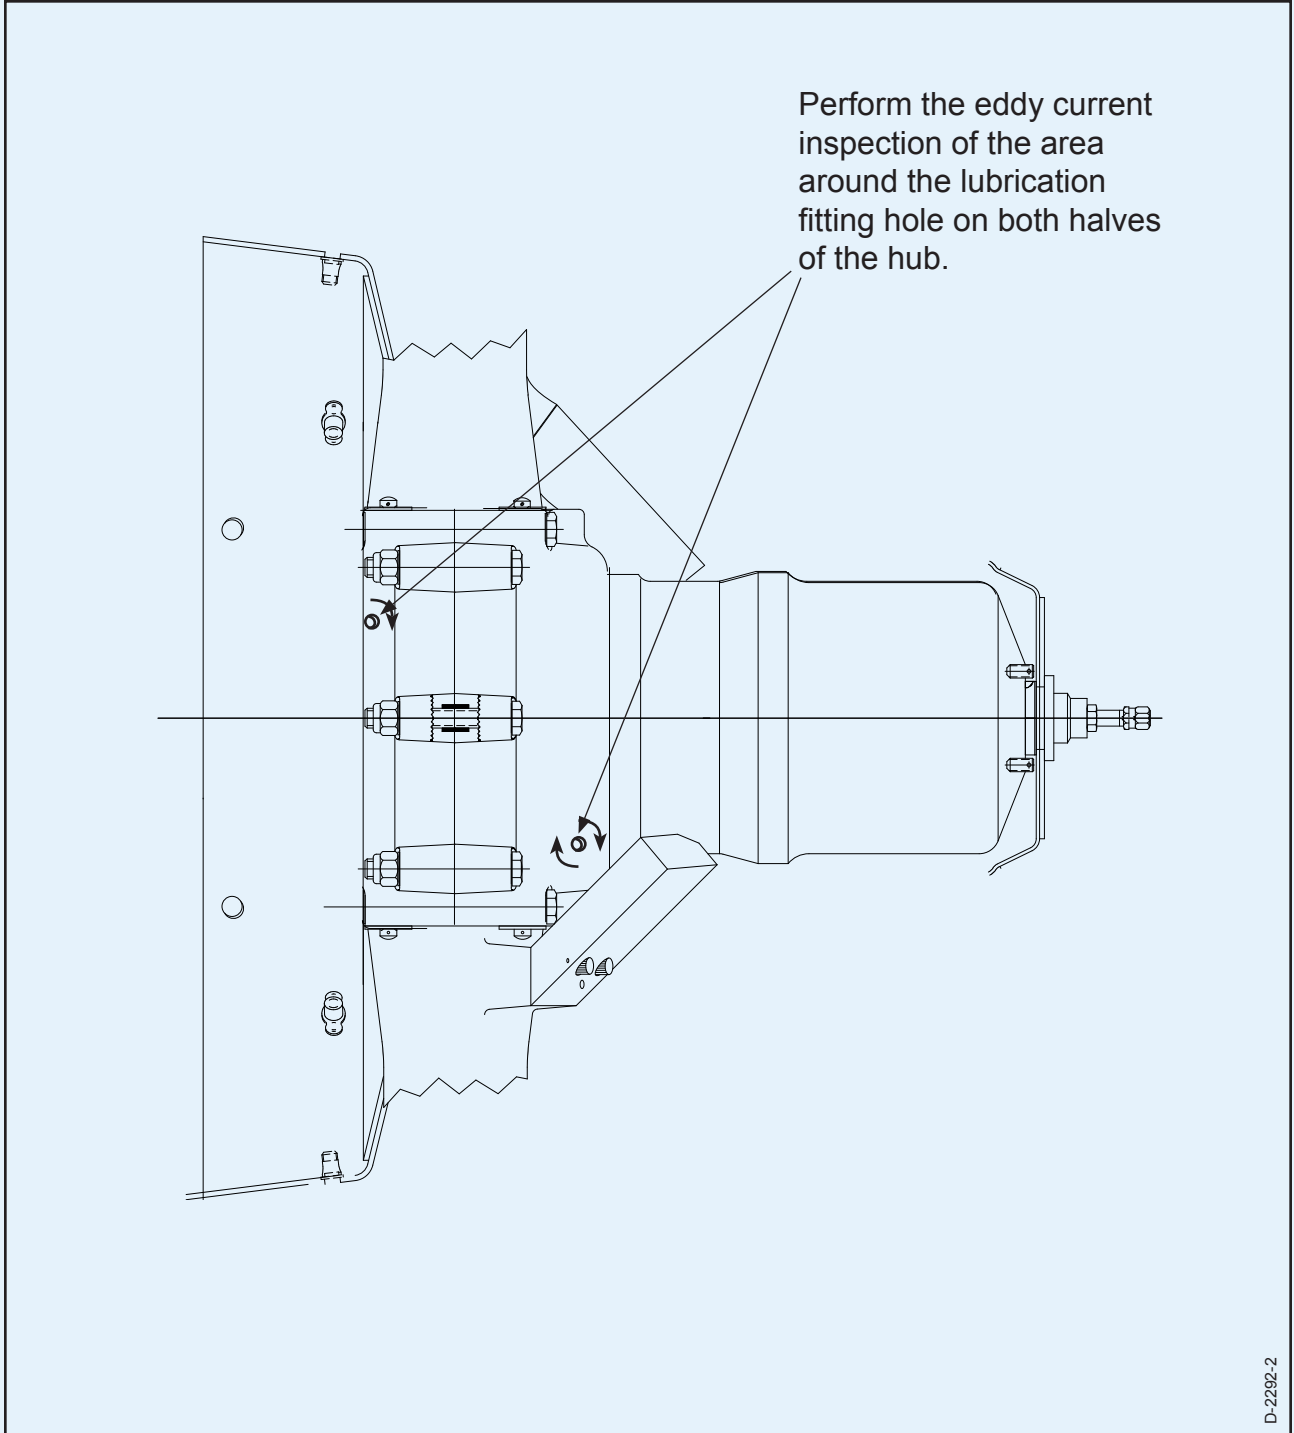
Figure 3

Lubrication Hole Inspection

- (4) Before any cleaning, visually examine the hub for cracks in the area around the lubrication holes. Refer to Figure 3.
 - (a) A cracked hub may have traces of grease visible at the location of the crack.
- (5) Clean the surface of the hub in accordance with the Cleaning chapter of Hartzell Propeller Inc. Standard Practices Manual 202A (61-01-02), Volume 1 to remove oil, grease, or other contaminants that may interfere with the efficiency of the eddy current inspection.

- (6) Perform the Aluminum Hub Lubrication Fitting Hole Inspection in accordance with the Eddy Current Inspection chapter of Hartzell Propeller Inc. Standard Practices Manual 202A (61-01-02), Volume 2.
- (7) If a crack indication is found, hub replacement is required before further flight. Report any findings of a cracked hub to the Hartzell Propeller Inc. Propeller Product Support Department.
 - (a) A hub that is removed from an affected propeller because of a crack indication must be retired from service in accordance with the Part Retirement Procedures chapter in Hartzell Propeller Inc. Standard Practices Manual 202A (61-01-02), Volume 6.
