**HARTZELL PROPELLER INC.**

# **Alert Service Bulletin**

**TRANSMITTAL SHEET**  
**HC-ASB-61-316**  
**Propeller - Hub Inspection**

June 26, 2009

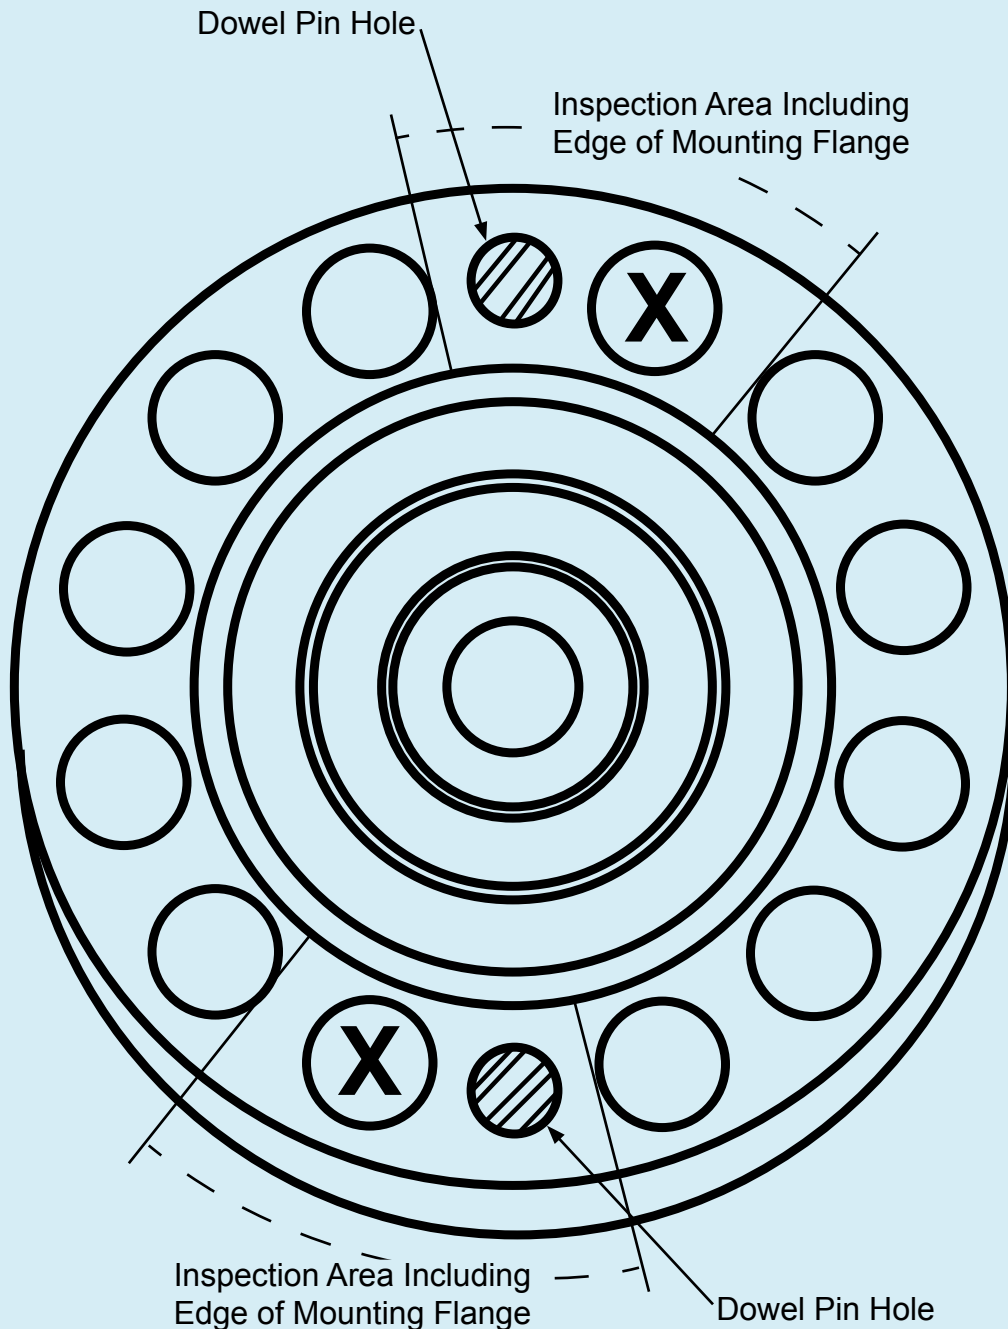
**Eddy Current Mounting Flange Inspection Area**  
**Figure 1**

- (1) Hartzell has discovered two propeller hubs with fractures on the mounting flange side of the hub.
  - (a) The fractures may have initiated near the dowel pin holes and extended to propeller mounting bolt holes.
  - (b) The fractures are located on the side of the dowel pin hole near a mounting bolt hole with an oversize threaded insert installed.
- (2) The fractures were discovered when the propellers were removed from the aircraft for overhaul. At the time of removal, the fractures were visible during penetrant inspection on the mounting flange side of the hub and on the side of the mounting flange nearest the dowel pin holes.
- (3) Hub damage of this type can lead to catastrophic hub failure and propeller blade separation.
- (4) The cause of the fractures is being investigated.

- (2) **Overhaul Compliance** for any propeller hub installed in an HC-E4A-3( )/E10950( ) propeller assembly - **Refer to Figure 1 for the inspection area:**

- (3) **Repetitive Interval** for any propeller hub installed in an HC-E4A-3( )/E10950( ) propeller assembly and with a B-1243-1 oversize insert installed in one or both of the mounting holes specified in Figure 1 or a letter "K" stamped below the propeller serial number on the cylinder side of the hub - **Refer to Figure 1 for the inspection area:**

- (a) If an oversize threaded insert is installed in one or both of the mounting bolt holes identified with an "X" in Figure 1:
    - 1     Proceed to Paragraph 3.B., Eddy Current Inspection.

- (b) Maintain a scanning rate that is equivalent to that used for calibration.
- (4) Scan the probe slowly on the mounting flange surface around the mounting bolt hole identified with the letter "X" in Figure 1.

- (5) Scan the probe slowly on the edge of the propeller mounting flange near each dowel pin hole as shown in Figure 1.
- (6) Verify the calibration in accordance with Paragraph 3.G., Verification of the Instrument's Calibration.

- (1) Calibrate the pencil probe in accordance with the Paragraph 3.C., Eddy Current Equipment Initial Set Up.
- (2) Using a pencil probe, position the probe on the propeller mounting flange surface in the inspection area as defined in Figure 1.

- (3) While holding the probe steady and perpendicular to the propeller mounting flange surface, inspect the areas identified in Figure 1.
  - (a) To make sure of complete coverage of the inspection area, each scan must overlap the previous scan.

- (7) If any hub is identified as having an indication greater than or equal to the reference notch, contact Hartzell Product Support before further flight.
