**HARTZELL PROPELLER INC.**  
**ALERT SERVICE BULLETIN**  
**TRANSMITTAL SHEET**  
**HC-ASB-61-333**  
**Propeller - Blade Replacement -**  
**Aero Twin STC SA02291AK**

March 6, 2013

**Propeller - Blade Replacement -  
Aero Twin STC SA02291AK**

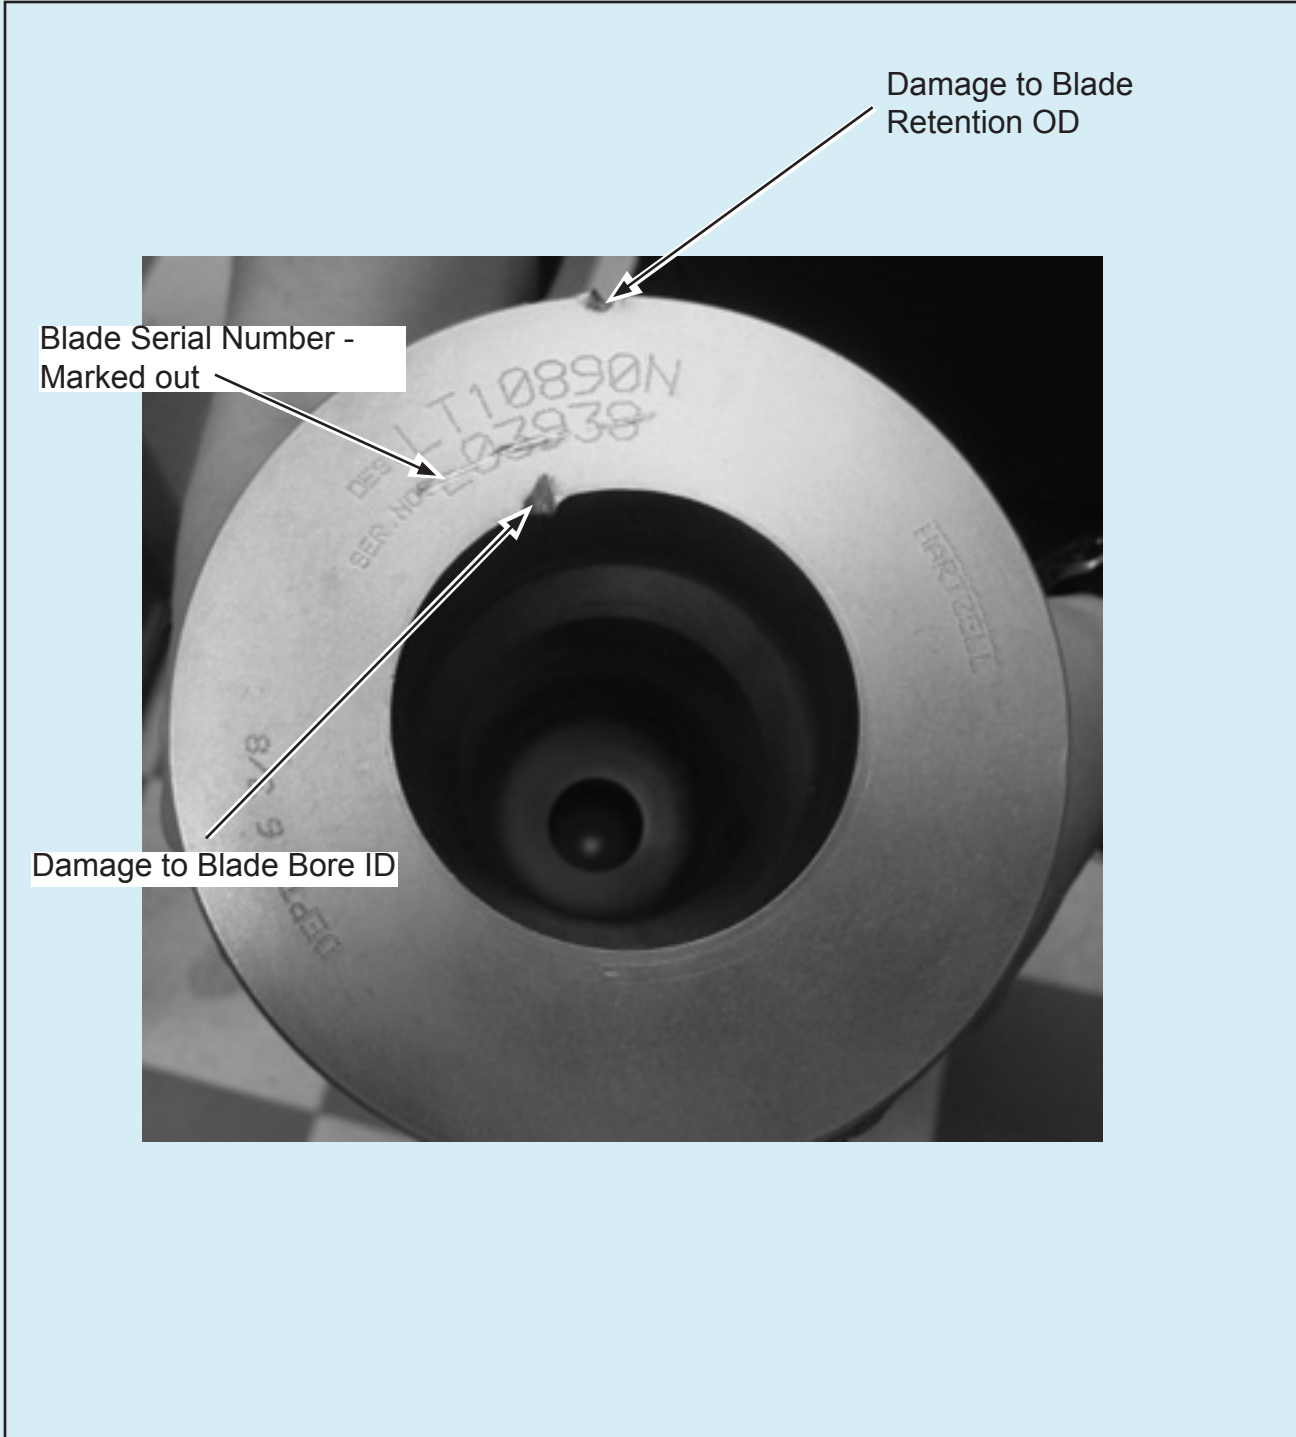
**Blade Butt Showing Damage to Prevent Further Use of the Blade**  
**Figure 1**

- 1 Using a tool, damage the ID of the blade bore and the OD of the blade retention surface. Damage must be sufficient to prevent installation of the blade bearing or the blade clamp. Refer to Figure 1.

- 2 Mark out the blade serial number, so that the number is still legible.
  - 3 Take a photograph of the blade butt to show the damage, the blade model number, and the blade serial number.
