HARTZELL PROPELLER INC.

ALERT SERVICE BULLETIN

HC-ASB-61-338

Propeller - Replacement of B-119-2 Diaphragm

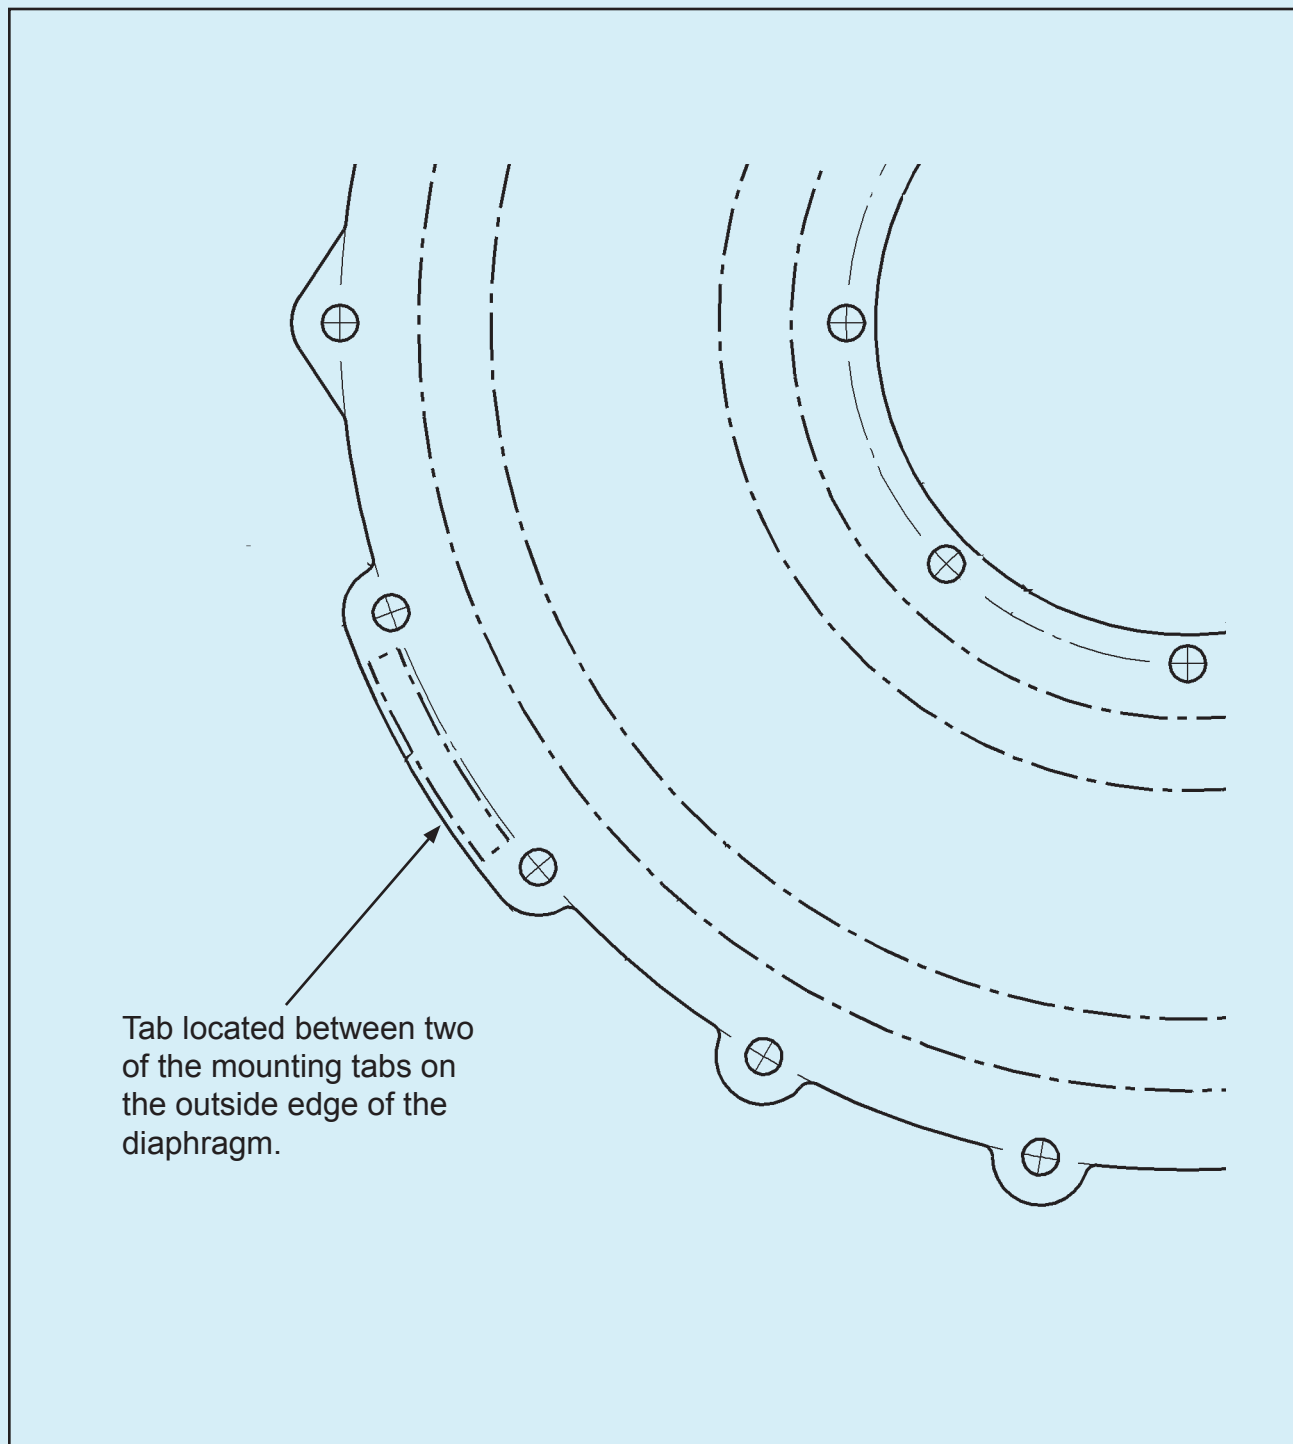
**B-119-2 Redesigned Diaphragm
Figure 1**

- (1) This document provides Instructions for Continued Airworthiness (ICA).
- (2) The original issue of this Alert Service Bulletin required an initial and repetitive inspection of the B-119-2 diaphragm.
- (3) The original design B-119-2 diaphragm did not include a tab for identification.
- (4) Revision 1 to this Alert Service Bulletin required replacement of the original design B-119-2 diaphragm.
 - (a) The redesigned B-119-2 diaphragm was designed with a tab located between two of the mounting tabs on the outside edge of the diaphragm. Refer to Figure 1.

NOTE: This tab will be marked with a batch/lot number.
