ALERT SERVICE BULLETIN

HC-ASB-61-357

Propeller - Mounting Torque and Spacer Inspection

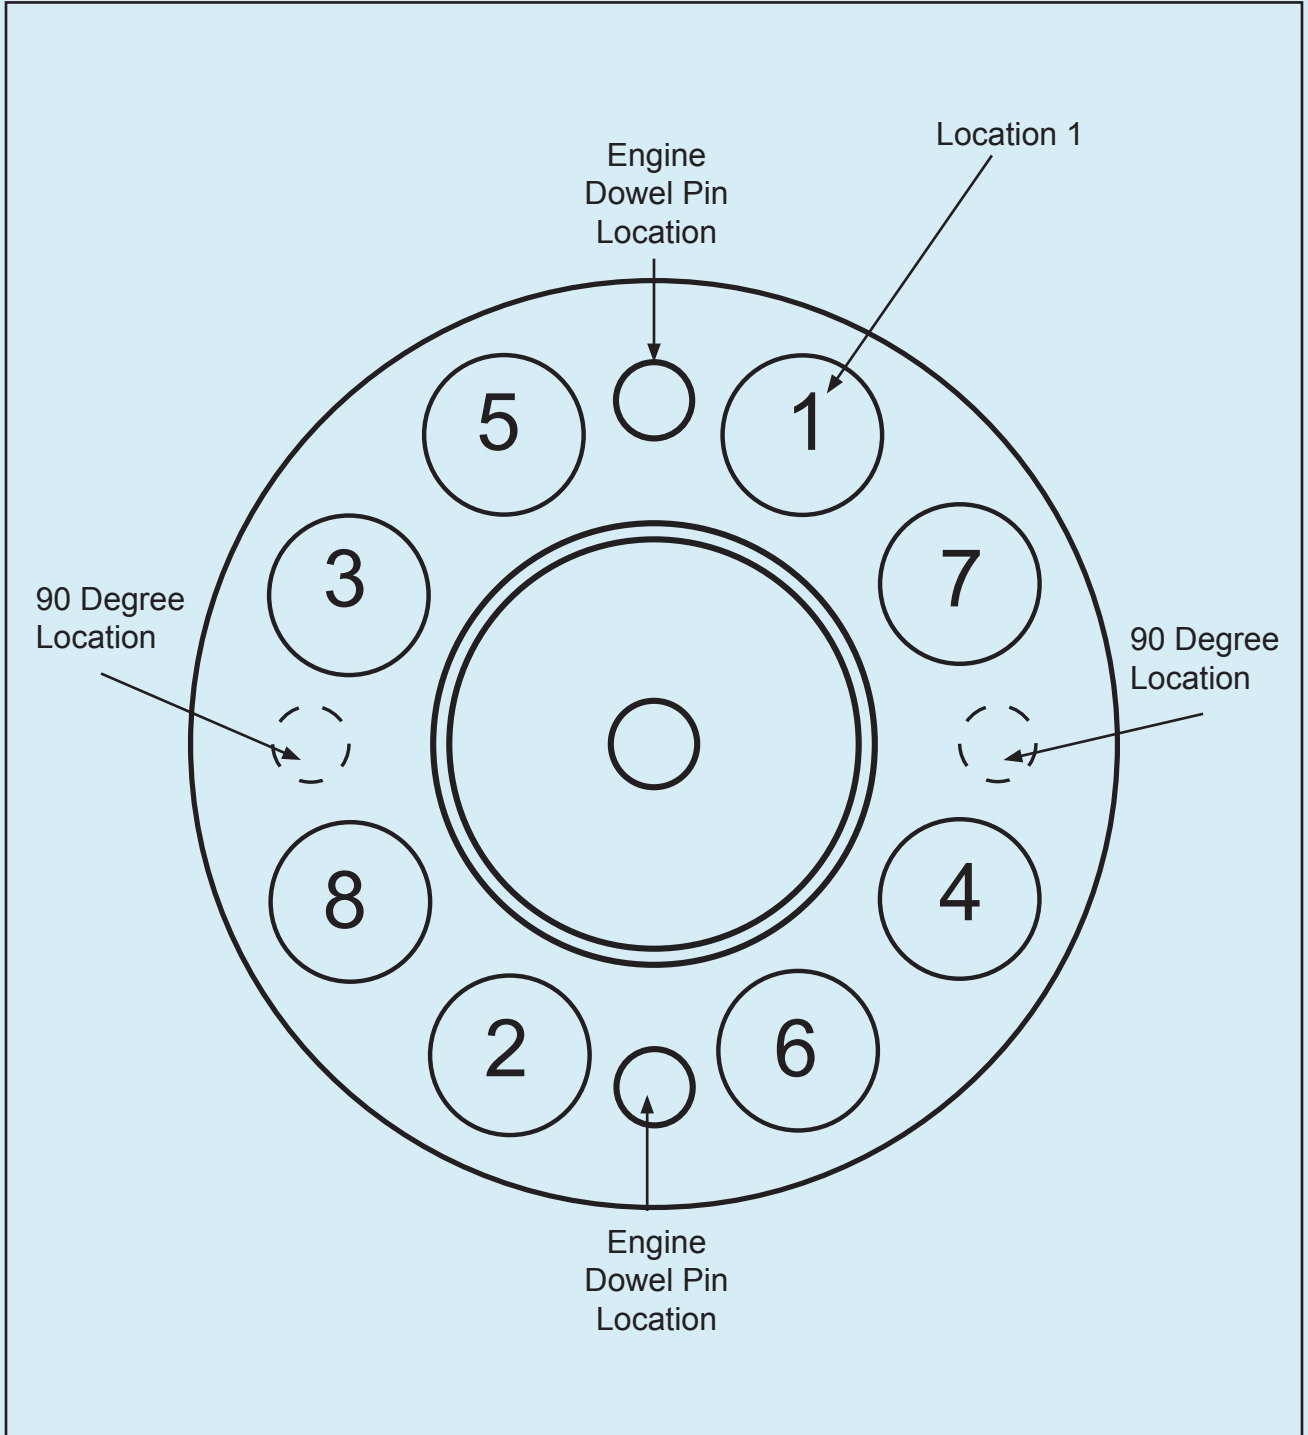
**Alternating Sequence for Inspections and Locations of Mounting Nuts
Figure 1**

B. Feeler Gauge Inspection - Refer to Figure 1.

- (1) At the location of the two engine dowels, use a 0.001 inch (0.025 mm) metallic feeler gauge or shim stock to inspect for a gap between the mounting spacer and the engine/propeller shaft mounting flange.
 - (a) If the metallic feeler gauge or shim stock can fit between the spacer and the engine flange to a depth that would indicate a gap:
 - 1 Before further flight, contact Hartzell Propeller Inc. Product Support.
 - (b) If the metallic feeler gauge or shim check does not indicate a gap:
 - 1 Perform the Mounting Nut Torque Inspection, Paragraph 3.C.

- (1) Remove the mounting nut and washer from the stud at location 1, identified in Figure 1.
- (2) Retain the mounting nut and washer.

- (1) Install the cleaned washer on the stud.
 - (a) The side of the washer with the OD chamfer must be installed against the engine flange.
- (2) After each mounting nut has been installed and dry torqued to an initial 40 Ft-Lbs (54 N•m), repeat the torquing sequence in Figure 1 and torque all mounting nuts to 80 Ft-Lbs (108 N•m).
