**HARTZELL PROPELLER INC.**  
**ALERT SERVICE BULLETIN**  
**TRANSMITTAL SHEET**  
**HC-ASB-61-376**  
**Blade - Counterweight Inspection**

September 05, 2018

- (1) Hartzell Propeller Inc. has received multiple reports of corrosion on the blade counterweights installed on the affected propellers.
- (2) Regulatory action is not expected.

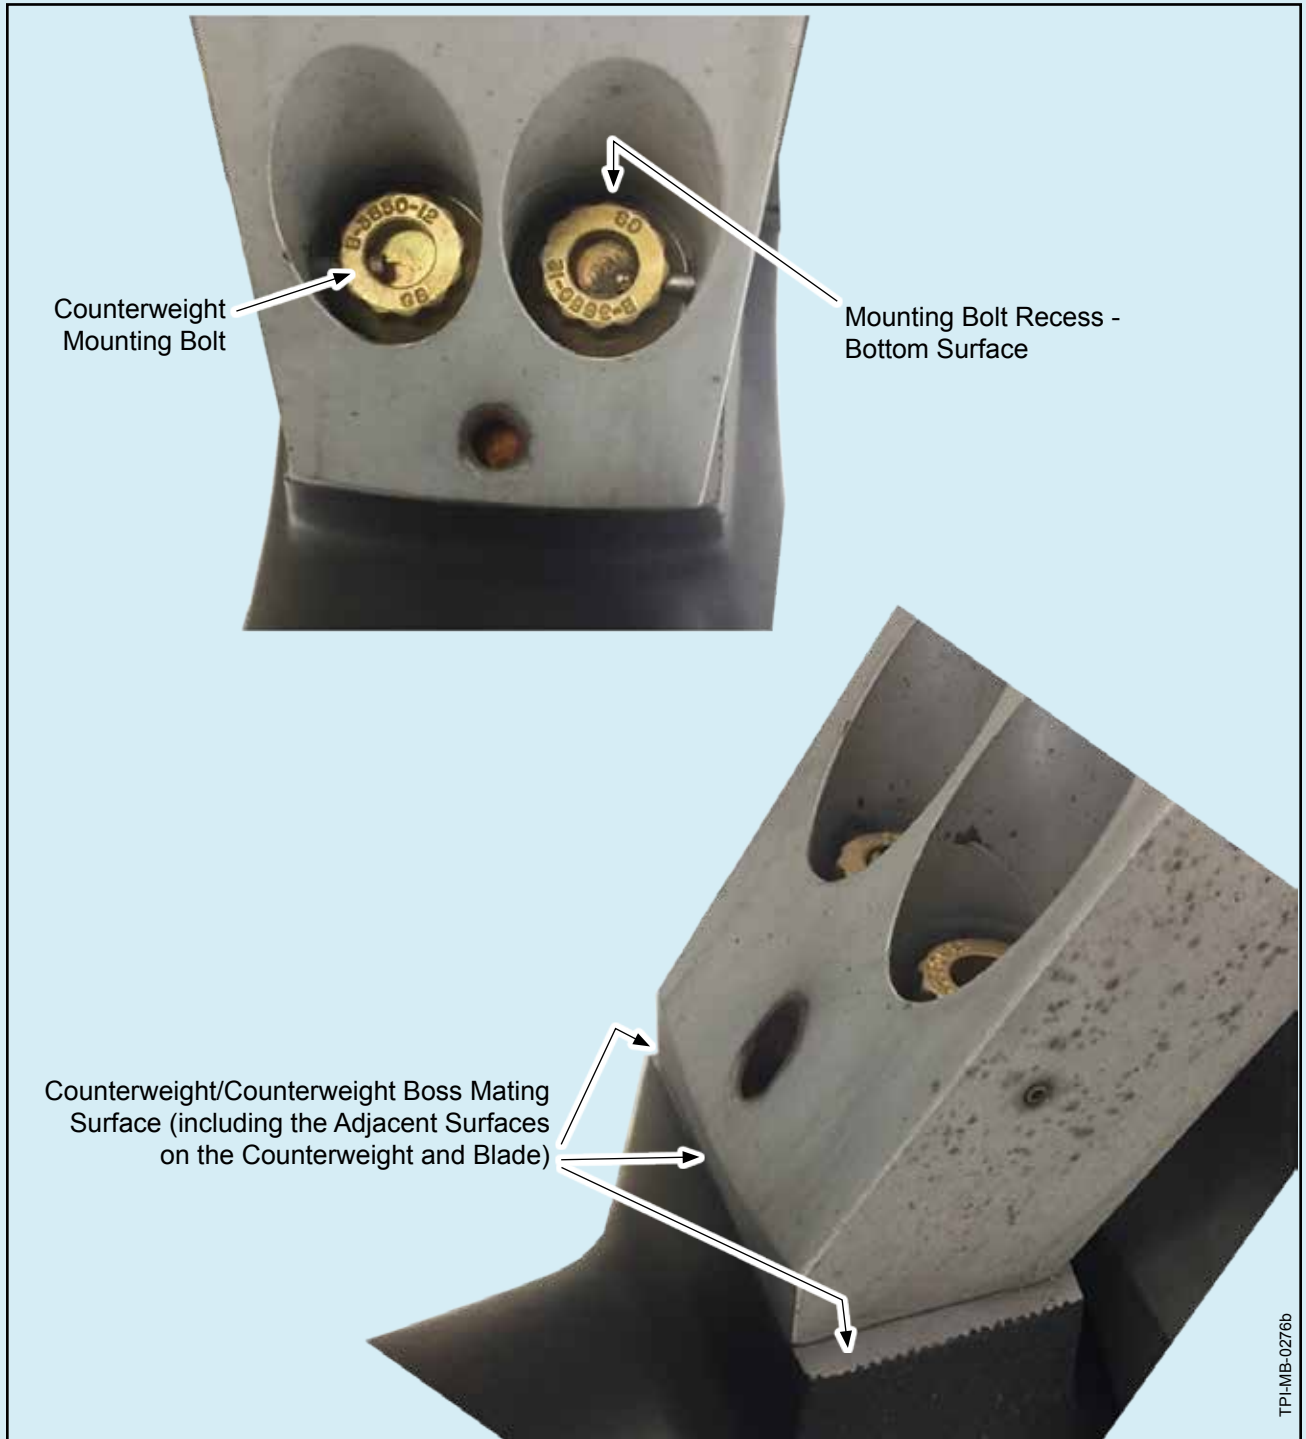
**Figure 1**

**Visual Inspection** (*Corrosion is not permitted on these surfaces*)

- (2) Visually examine the following surfaces for corrosion (refer to Figure 1):
  - Counterweight Mounting Bolts
  - Mounting Bolt Recesses - Bottom Surface  
(If there is sealant on this surface, do not remove it for visual inspection).

- Counterweight/Counterweight Boss Mating Surface and the Adjacent Surfaces on the Counterweight and the Blade
  - (a) If corrosion is found on any of these surfaces:

- 1 Before further flight, remove the propeller from the aircraft in accordance with Hartzell Propeller Inc. Propeller Owner's Manual 149 (61-00-49), then perform the Counterweight/Blade Inspection and Repair procedure in accordance with the instructions in this Alert Service Bulletin.

- a The Counterweight/Blade Inspection and Repair procedure must be performed by a certified propeller repair station with the appropriate rating.

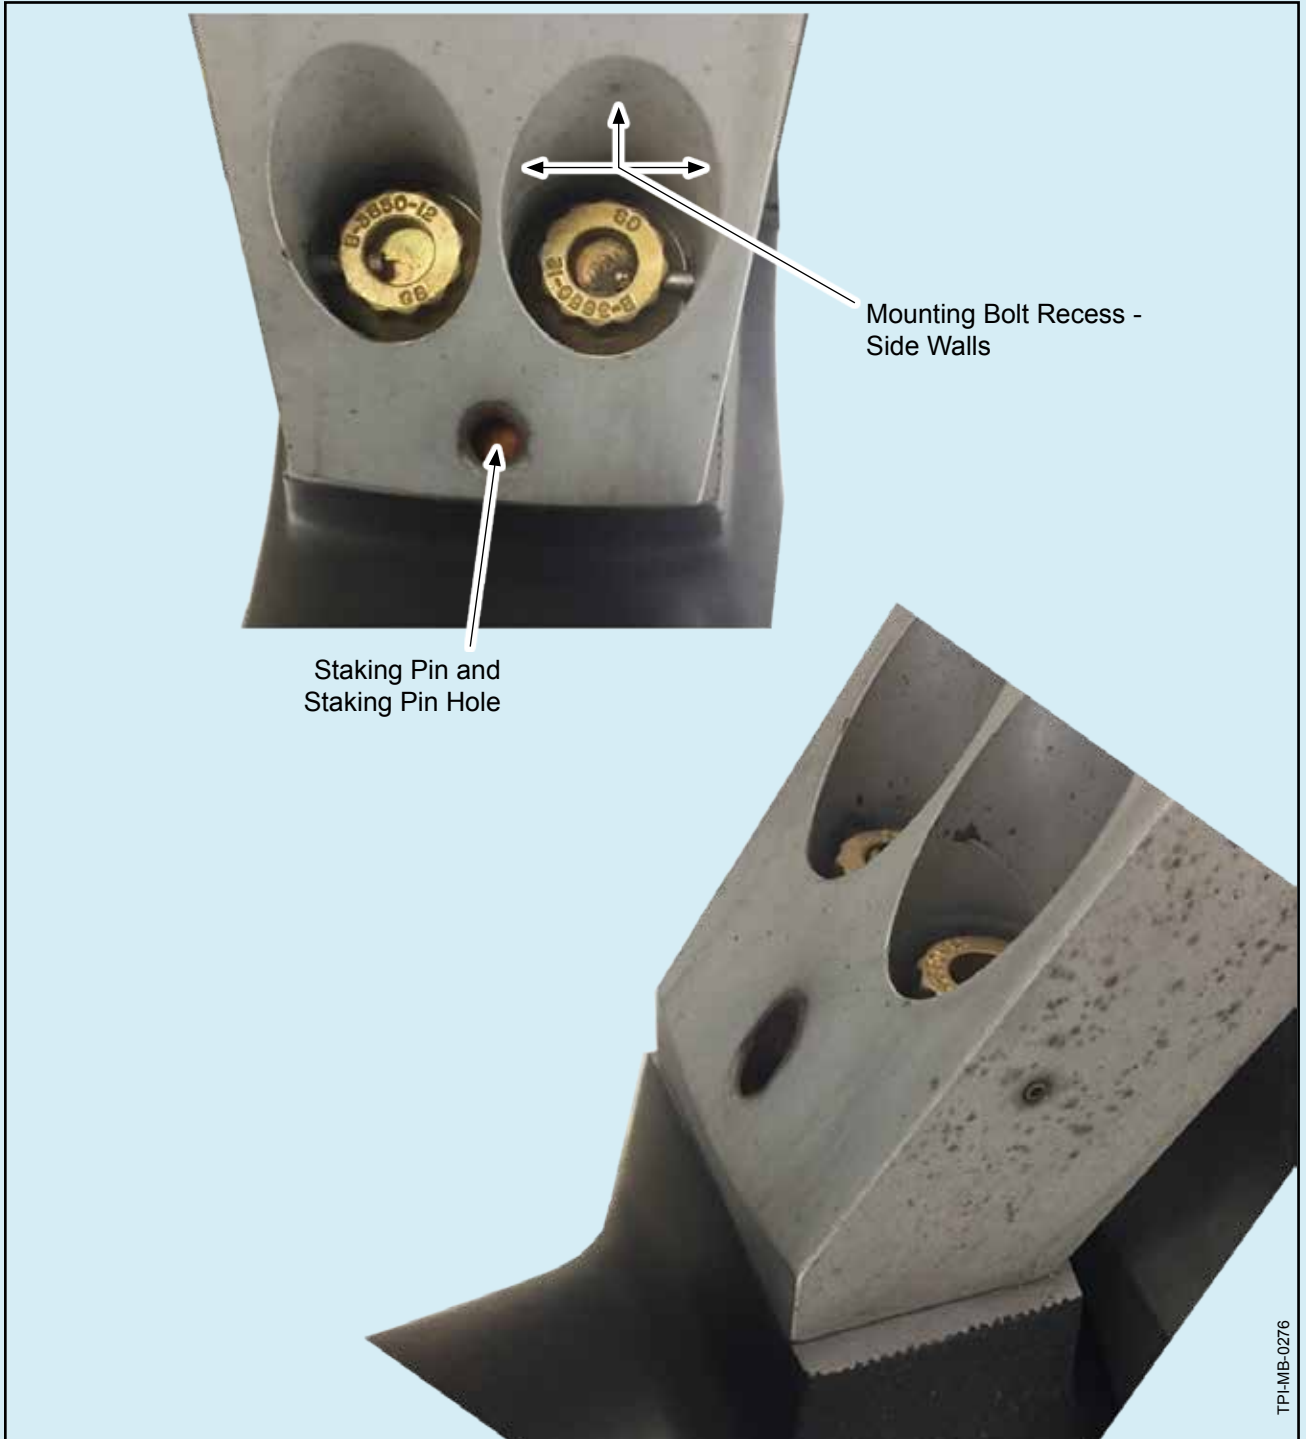
**Figure 2**

**Visual Inspection** (*Corrosion on these surfaces can be removed*)

(3) Visually examine the following surfaces for corrosion (refer to Figure 2):

- Staking Pin and Staking Pin Hole
- Mounting Bolt Recesses - Side Walls
- All other Counterweight surfaces not specified in step 3.A.(2)

(a) If corrosion is found on any of these surfaces:

- 1 Using Stoddard solvent CM23 and an abrasive pad CM47 or equivalent, clean these surfaces, then apply corrosion inhibitor CM352 or equivalent.
