HARTZELL PROPELLER INC.
ALERT SERVICE BULLETIN
TRANSMITTAL SHEET
HC-ASB-61-378
Propeller - Counterweight Clamp Inspection

February 09, 2018

Revision 2 is issued to change the following in this Alert Service Bulletin:

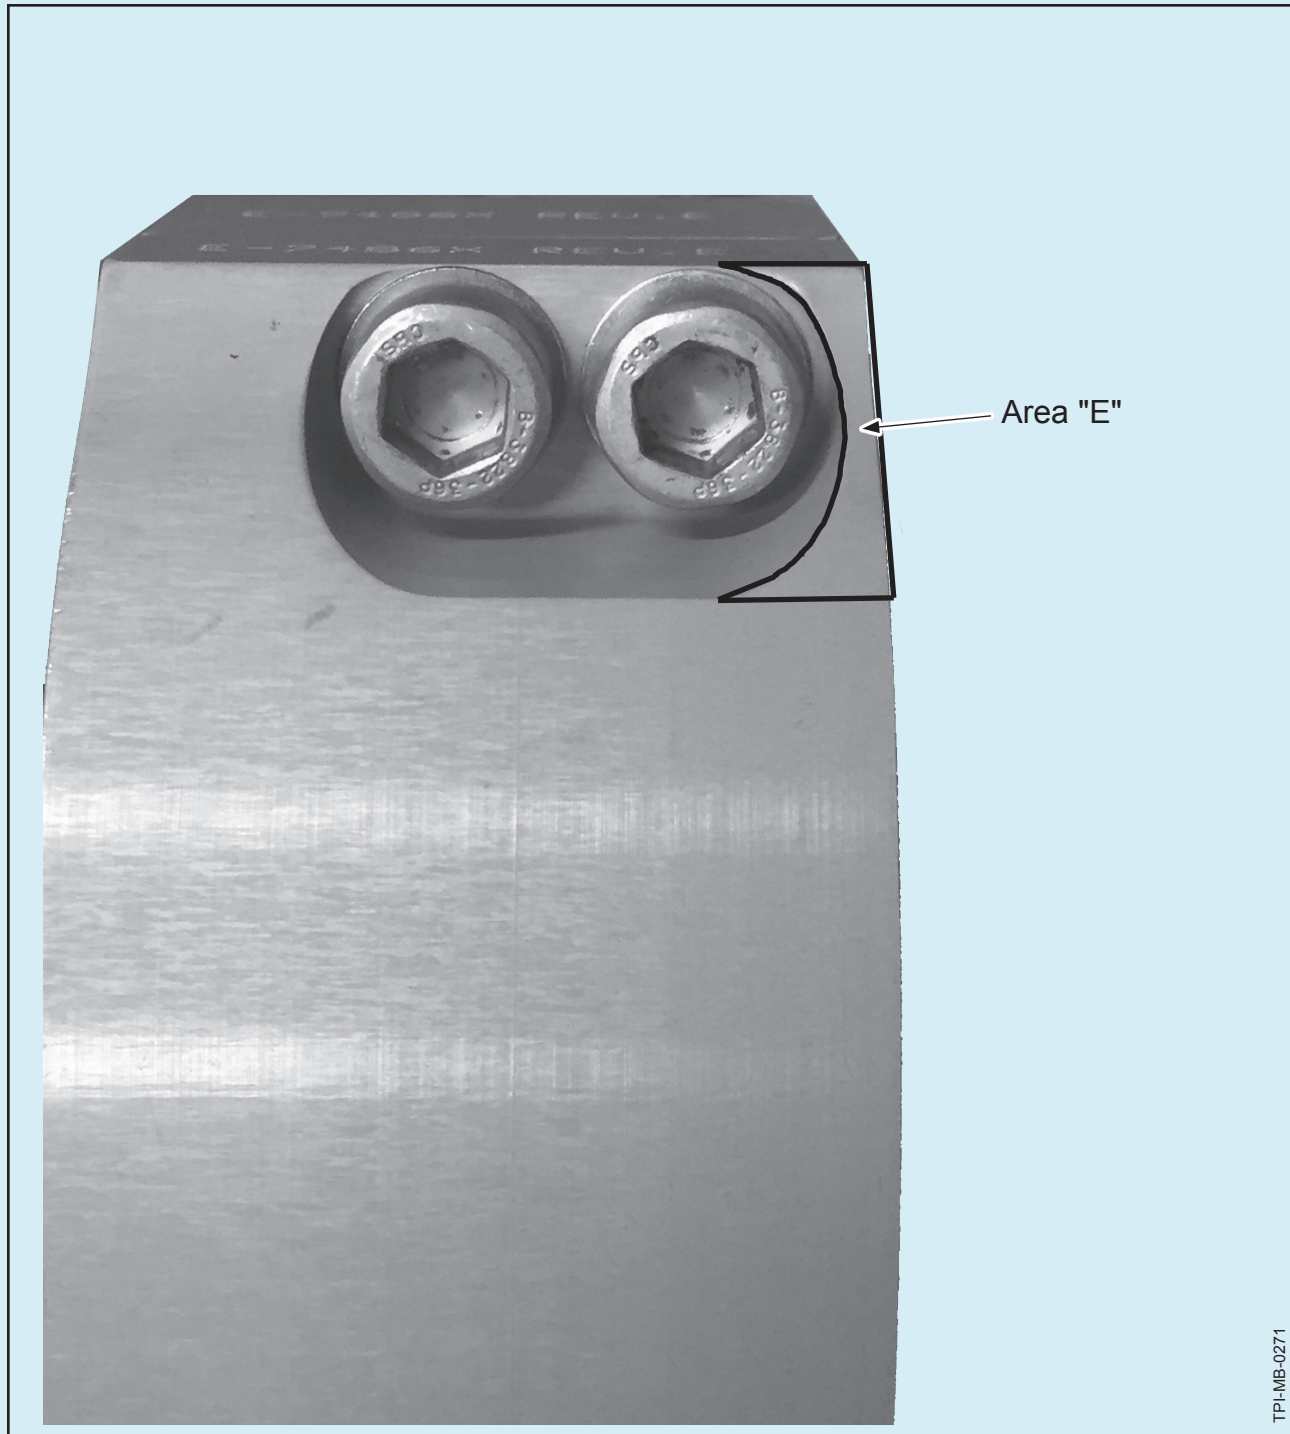
Eddy Current Inspection: Area E Only
Figure 1

- (c) Hold the probe firmly on the test specimen TE121 or equivalent with the coil perpendicular to the surface.
 - 1 Slide the probe across the 0.008 inch (0.20 mm) reference notch and make a record of the meter deflection.
 - (d) Obtain a 50% amplitude signal.
 - (e) A signal readout that is equal to, or greater than 3 times the readout from surface noise is desired.
- (5) Using the appropriate probe, perform an eddy current inspection of Area E of the counterweight clamp (refer to Figure 1) in accordance with the Eddy Current Inspection chapter of Hartzell Propeller Inc. Standard Practices Manual 202A (61-01-02).
- (a) If there is any indication exceeding a ratio of 3:1 signal amplitude to noise amplitude in these areas, replace all five counterweight clamps in accordance with the Accomplishment Instructions in this Alert Service Bulletin before further flight.

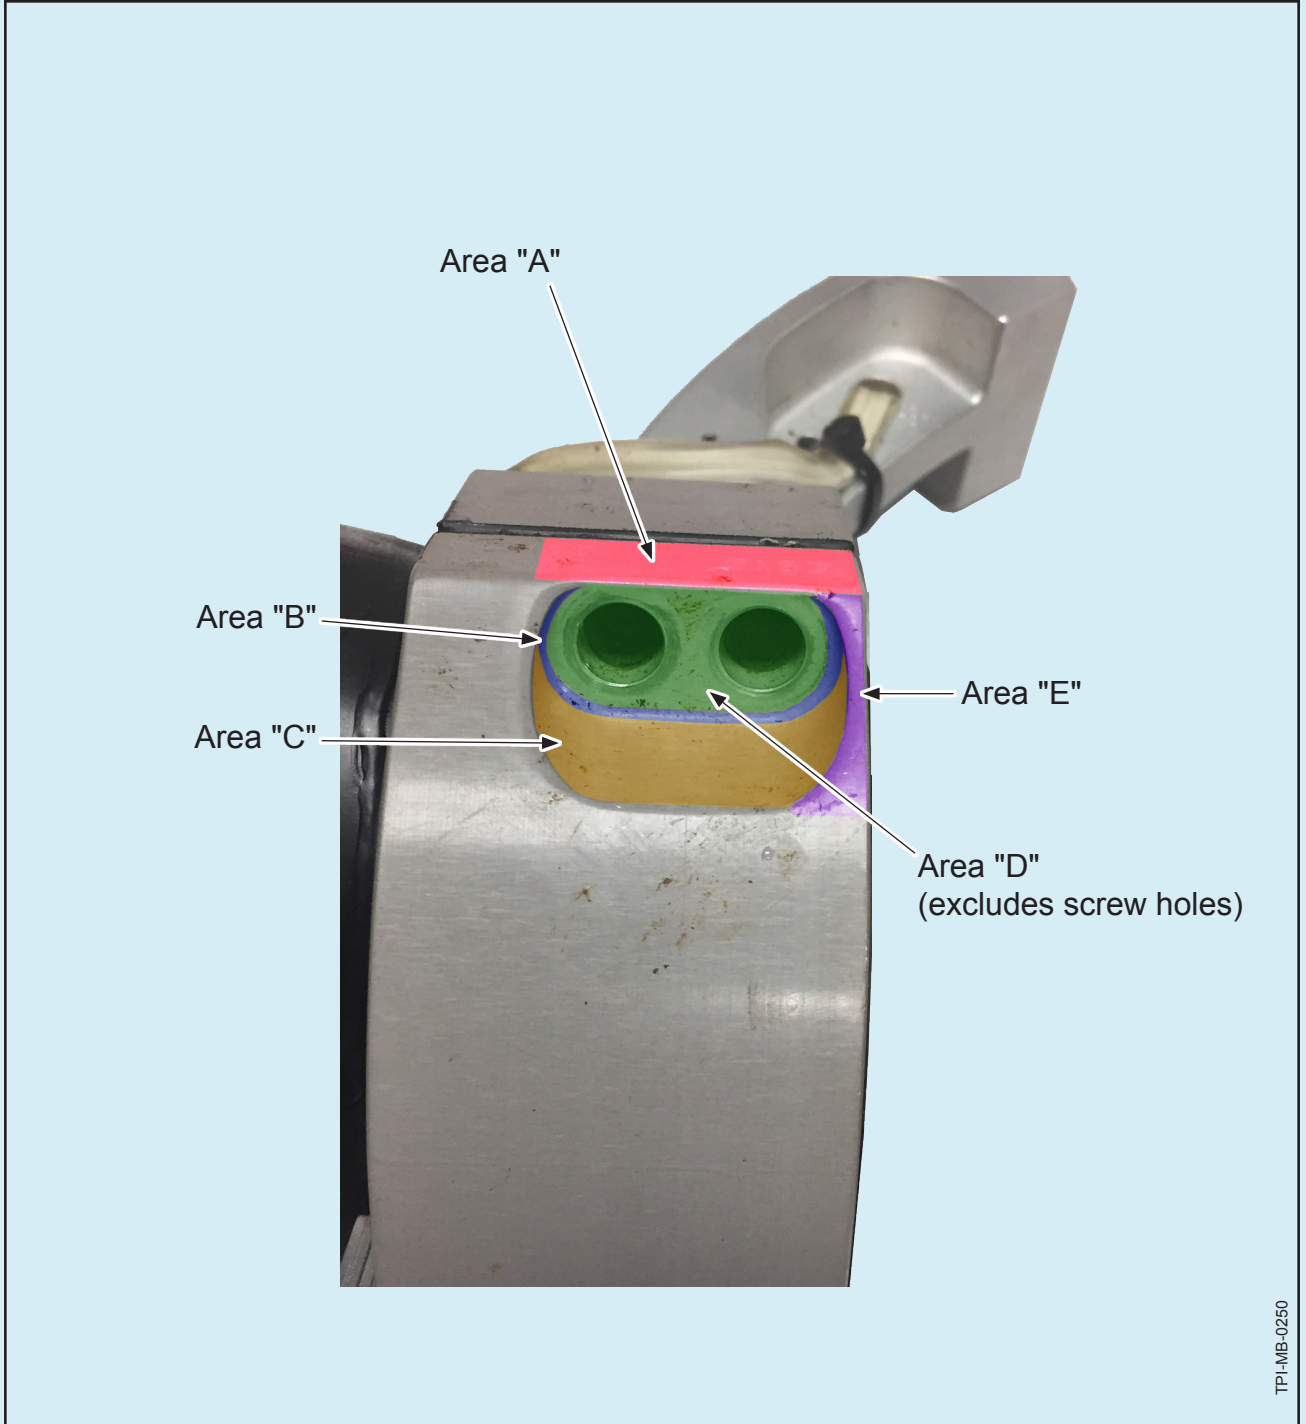
Eddy Current Inspection: Areas A, B, C, D
Figure 3

- (6) Using the appropriate probe, perform an eddy current inspection of Areas A, B, C, and D of the counterweight clamp (refer to Figure 3) in accordance with the Eddy Current Inspection chapter of Hartzell Propeller Inc. Standard Practices Manual 202A (61-01-02).
- (a) If there is any indication exceeding a ratio of 3:1 signal amplitude to noise amplitude in these areas, replace all five counterweight clamps in accordance with the Accomplishment Instructions in this Alert Service Bulletin before further flight.

- (10) Visually examine Area "C" and Area "E" of the counterweight clamp (refer to Figure 3) for damage that may have occurred during hardware installation.
 - (a) If there is damage that has compromised the anodize coating, clean the damaged area using Stoddard solvent CM23 or equivalent, then apply Ardrex AV 30 to the damaged area in accordance with the manufacturer's instructions.
