HARTZELL PROPELLER INC.
ALERT SERVICE BULLETIN
TRANSMITTAL SHEET
HC-ASB-61-381
Propeller - Blade Bearing Races

August 16, 2018

Propeller - Blade Bearing Races

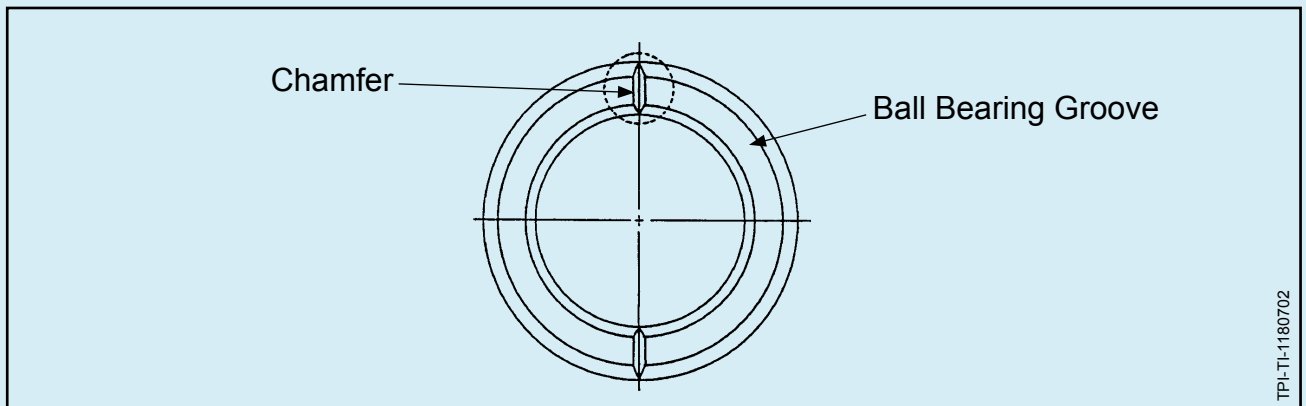
Figure 1

- (2) Bearings races without a "T" in the item number can be identified by a chamfer in the ball bearing groove located at the mating surface of the race halves. Refer to Figure 1.

A-1851 Blade Retention Bearing Identification

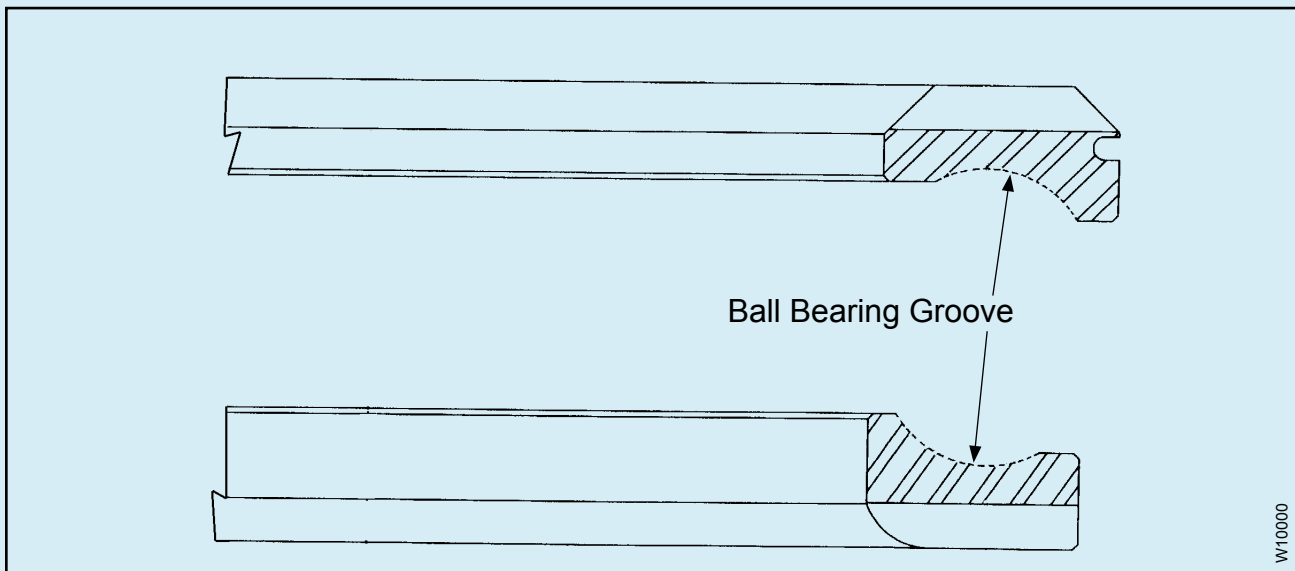
A-1851-() Blade Retention Bearing
Figure 2

<u>A-1851-() BLADE RETENTION BEARING</u> Refer to Figure 2			
	Inspect	Serviceable Limits	Corrective Action
(1)	Visually examine the ball bearing groove for wear.	If the ball bearing groove shows wear, measure it. The maximum permitted depth of wear is 0.005 inch (0.12 mm).	If the wear is greater than the permitted serviceable limits, replace the blade retention bearing with a new A-1851 blade retention bearing.

(2)	Visually examine the ball bearing groove for cracks and chipping.	Cracks and/or chipping are not permitted in the ball bearing groove.	If there are cracks and/or chipping in the ball bearing groove, replace the blade retention bearing with a new A-1851 blade retention bearing.

(3)	Visually examine the blade retention bearing for corrosion and pitting.	Corrosion is not permitted. If corrosion is present, remove it in accordance with the corrective action repair limits. The maximum permitted depth of pitting, excluding the ball bearing groove, is 0.005 inch (0.12 mm).	Light corrosion can be removed with an abrasive pad CM47 or equivalent. If corrosion cannot be removed, replace the blade retention bearing. If pitting is deeper than the serviceable limits, replace the blade retention bearing with a new A-1851 blade retention bearing.
		Pitting is not permitted in the ball bearing groove.	If there is pitting in the ball bearing groove, replace the blade retention bearing with a new A-1851 blade retention bearing.
