**HARTZELL PROPELLER INC.**  
**ALERT SERVICE BULLETIN**  
**TRANSMITTAL SHEET**  
**HC-ASB-61-396**  
**Raptor Hub Units - Shot Peening**

March 09, 2022

**HARTZELL PROPELLER INC.**  
**ALERT SERVICE BULLETIN**  
**HC-ASB-61-396**  
**Raptor Hub Units - Shot Peening**

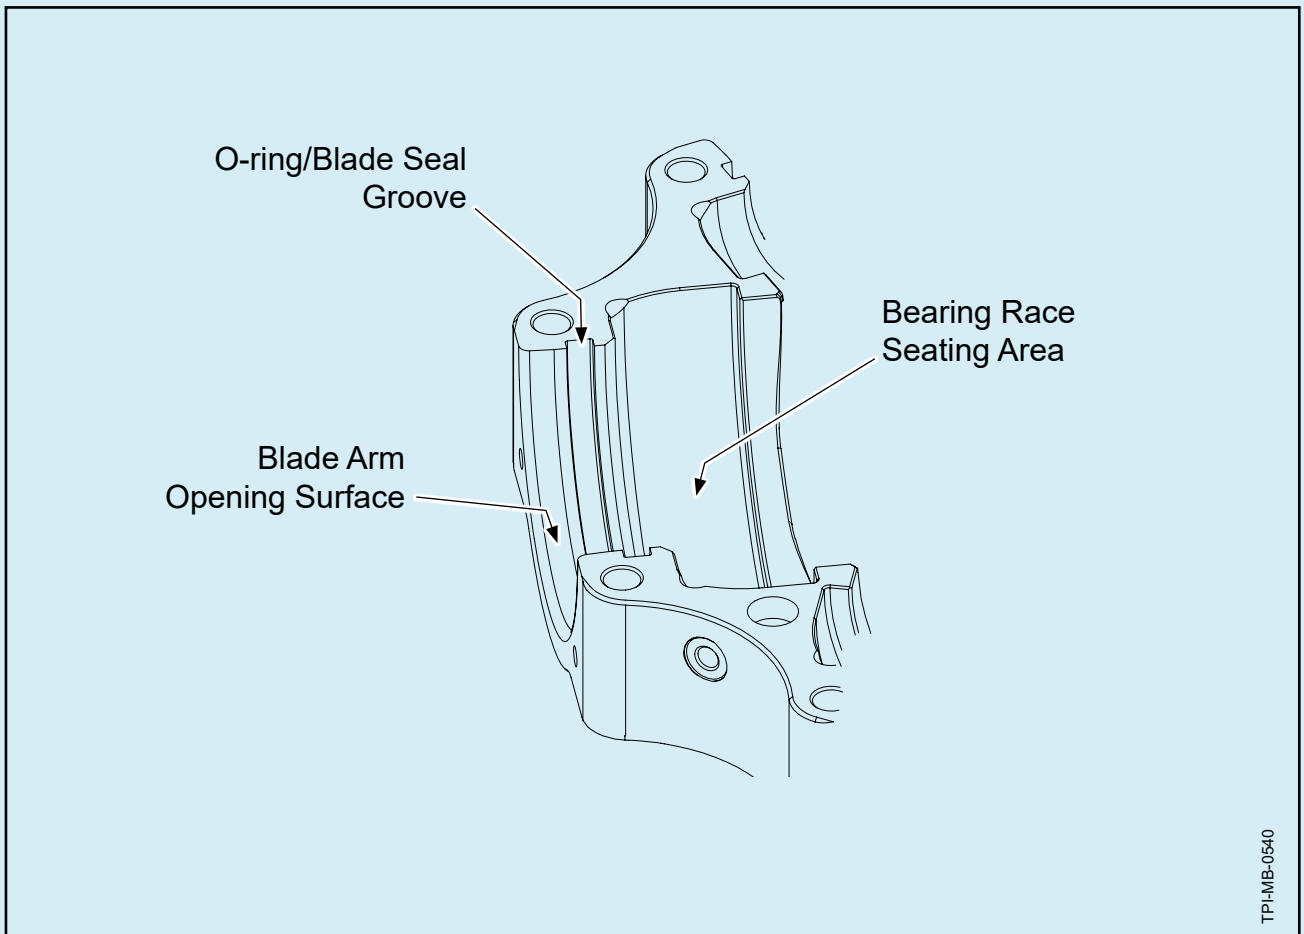
**Bearing Arm Opening Surface**  
**Figure 2**

- (1) Hartzell Propeller Inc. has received reports of insufficient shot peen coverage in the bearing race seating area of the hub unit on affected propellers. Refer to Figure 2.

- (1) Mask the internal surfaces of the hub in accordance with the Aluminum Hub Overhaul chapter of Hartzell Propeller Inc. Standard Practices Manual 202A (61-01-02).
  - (a) Additionally, mask the blade arm opening surface outboard of the O-ring/blade seal groove. Refer to Figure 2.
