1. Planning Information

- A. Effectivity
 - (1) Hartzell Propeller Inc. 5D31-NK366B1() Raptor turbine propellers with serial numbers listed in Table 1 are affected by this Alert Service Bulletin.

C. Reason

Document No. HC-ASB-61-405 Date of Issue: Oct 13/23

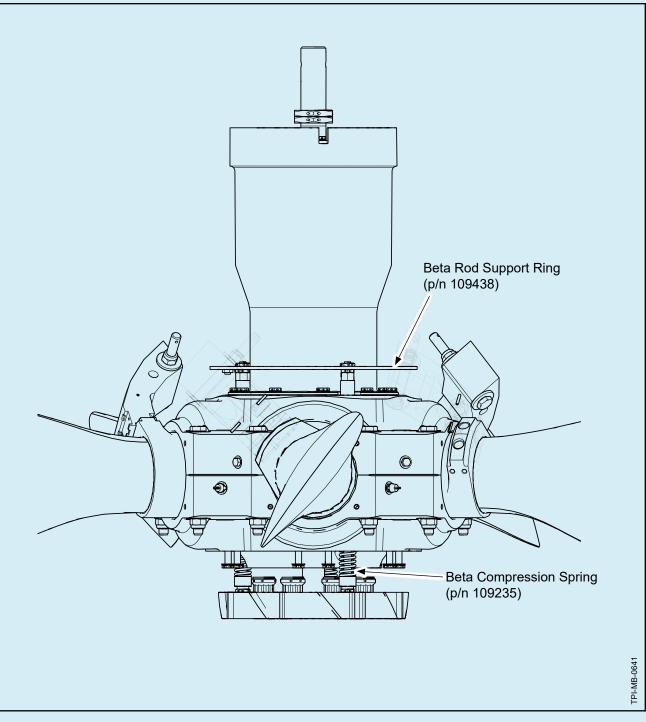
109438 Beta Rod Support Ring and 109235 Beta Compression Spring Figure 2

- (1) During operation, centrifugal force on the 107372 beta rods can create friction that affects the response of the electronic beta system used on the affected propellers.
 - (a) Centrifugal force causes the top (cylinder-end) of the 107372 beta rods to move outward, creating friction against the B-457 beta sleeves as the beta rods move. Refer to Figure 1.
- (2) Hartzell Propeller Inc. is introducing a design change to reduce friction and increase the return spring force of the electronic beta system used on the affected propellers. Refer to Figure 2.
 - (a) The new design incorporates a beta rod support ring (p/n 109438) to prevent outward movement of the beta rods at the cylinder-end, stronger compression springs (p/n 109235) for increased return force, and a redesigned spring guide sleeve (p/n A-466-1, Rev. I) with a smaller OD to reduce friction.

- (5) This Alert Service Bulletin provides instructions to install the 109438 beta rod support ring and the 109235 beta compression spring on affected propellers.
