HARTZELL PROPELLER LLC
ALERT SERVICE BULLETIN
HC-ASB-61-407
Beta Rod Nut/Safety Wire Inspection

- (1) Hartzell Propeller (4,6)D3-NK()() and 5D3-()() Raptor-series turbine propellers are affected by this Alert Service Bulletin.
- (2) Hartzell Propeller HC-D4N-3() and HC-E4(N,P,W)-3() lightweight turbine propellers are affected by this Alert Service Bulletin.

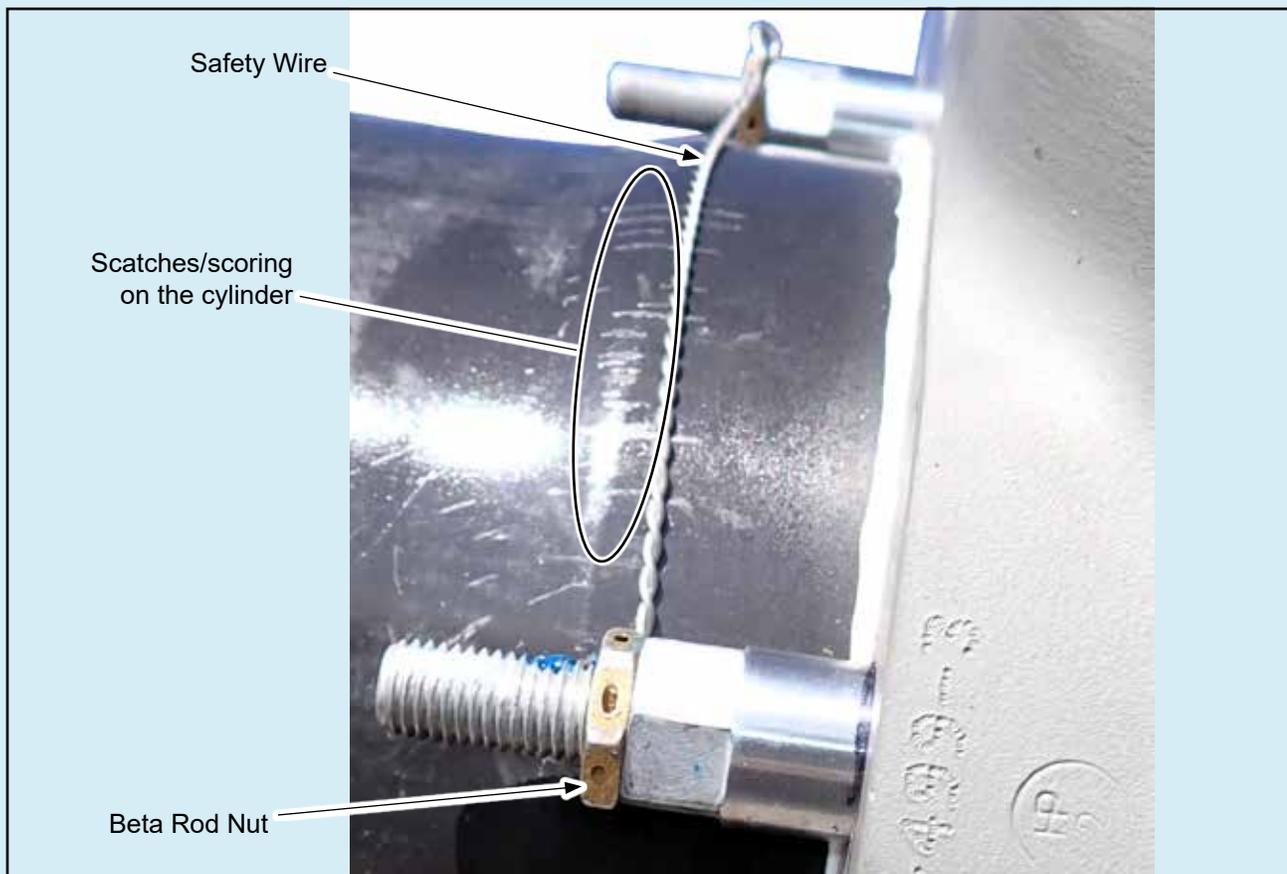
**Safety Wire Interference
Figure 1**

- (1) Hartzell Propeller LLC received information about an accident involving an affected propeller that went into uncommanded reverse during flight.
 - (a) The accident investigation found safety wire securing the beta rod nuts and evidence of interference between the safety wire and the cylinder on the affected propeller. Refer to Figure 1.
 - 1 Safety wire is **not** authorized for the beta rod nuts on affected propellers.

- (1) This Alert Service Bulletin provides Instructions for Continued Airworthiness (ICA).
- (2) This Alert Service Bulletin provides instructions for a pre-flight inspection of the beta rod nuts on affected propellers.
- (3) This Alert Service Bulletin provides instructions for removing safety wire from the beta rod nuts on affected propellers (if present).
