**HARTZELL PROPELLER LLC**  
**ALERT SERVICE BULLETIN**  
**TRANSMITTAL SHEET**  
**HC-ASB-61-409**  
**A-1373 Self-Locking Hex Nut, 7/16-20**

April 15, 2026

**HARTZELL PROPELLER LLC**  
**ALERT SERVICE BULLETIN**  
**HC-ASB-61-409**  
**A-1373 Self-Locking Hex Nut, 7/16-20**

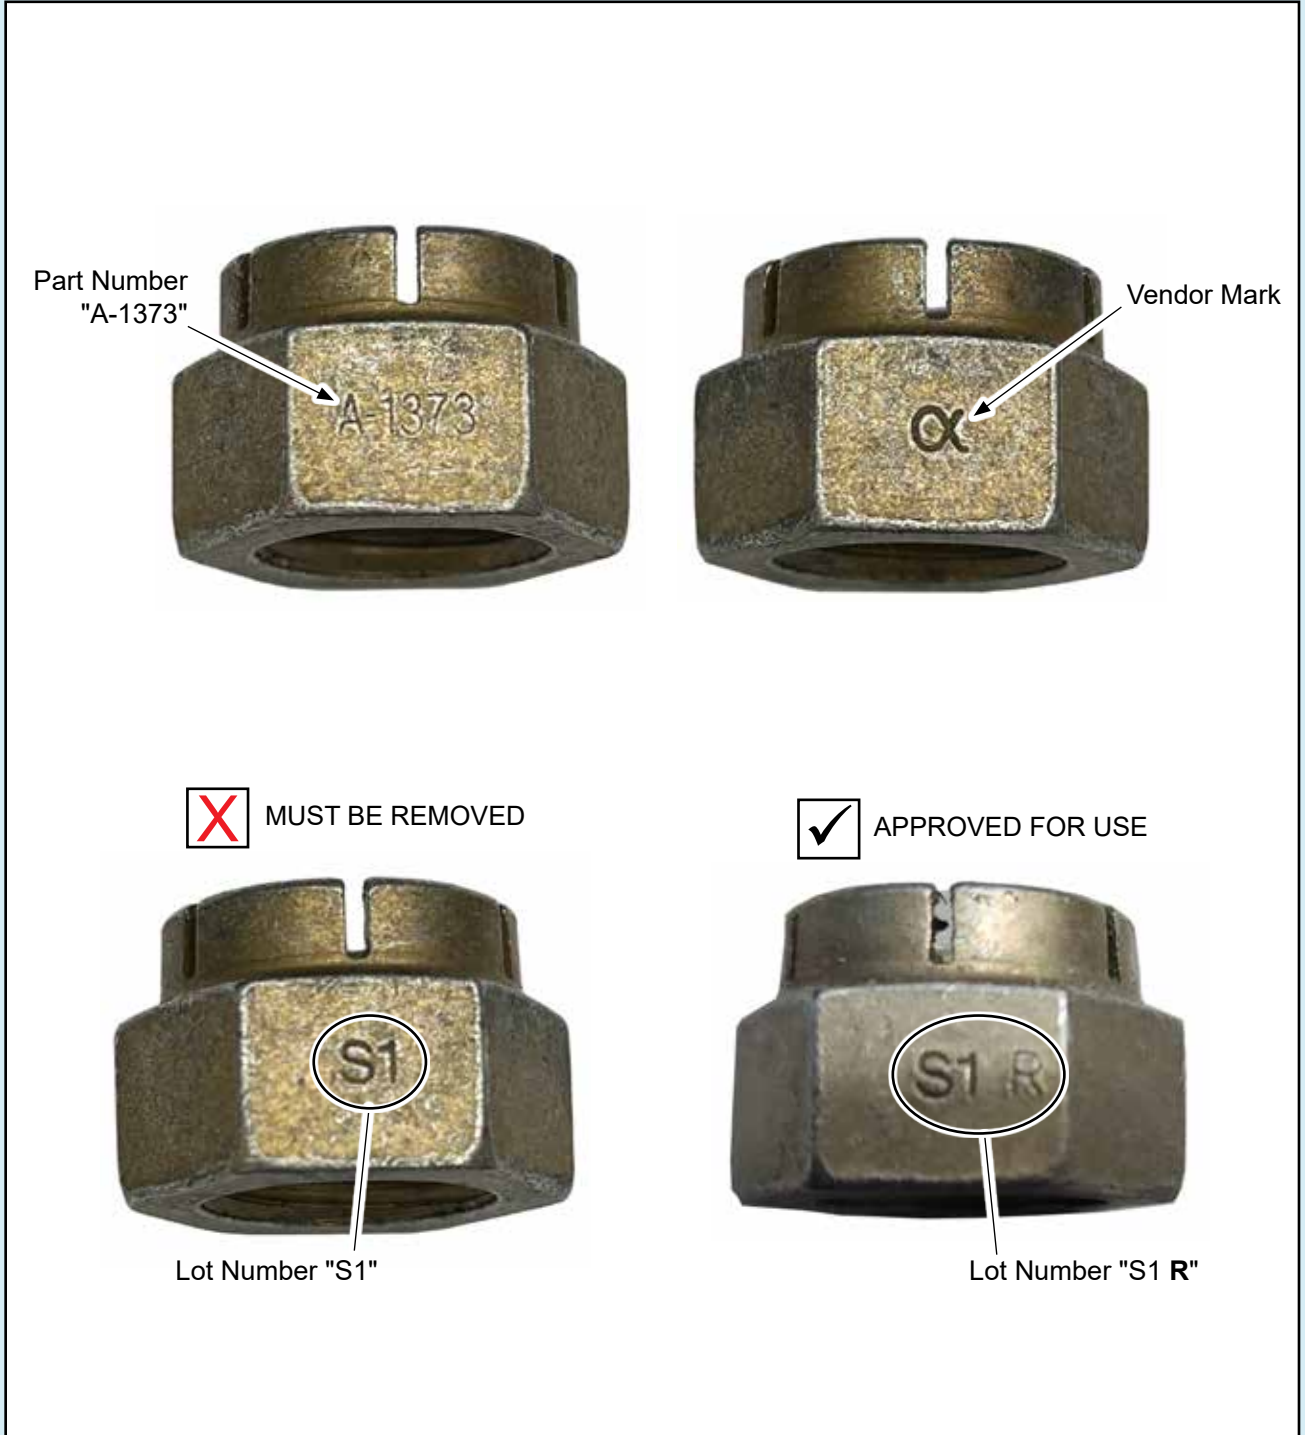
- (a) Affected A-1373 hex nuts will be marked with lot number "S1" and the vendor mark shown in Figure 1.
- (3) Hartzell Propeller overhaul kits listed Table 2 that were shipped from Hartzell between January 15, 2026 and January 27, 2026 are affected by this Alert Service Bulletin.

- (1) Hartzell Propeller received a shipment of A-1373 self-locking hex nuts that were manufactured incorrectly. The locking feature on the nuts in the affected lot is defective and can loosen during flight.
  - (a) The A-1373 hex nuts are used on the blade clamp assemblies of Hartzell steel hub propellers.

Affected A-1373 Hex Nut Identification

**NOTE:** A-1373 hex nuts marked with lot number "S1 R" as shown in Figure 1, are approved for use. These nuts can be returned to inventory/stock.

- (a) A-1373 hex nuts marked with lot number "S1" as shown in Figure 1 must be removed from inventory and returned to Hartzell.
- (b) Complete and sign the Parts Order/Compliance Form in the Appendix section of this Alert Service Bulletin.
  - 1 Send the completed form to Hartzell Propeller to initiate the order for the required parts.

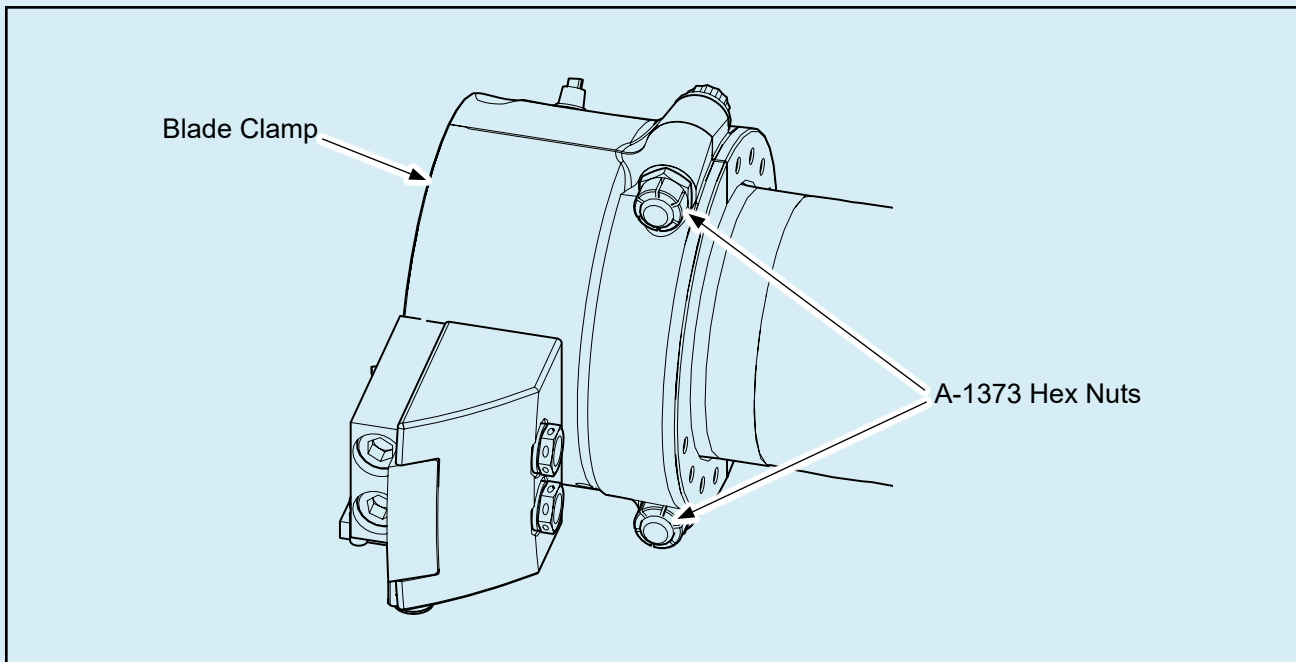
**Blade Clamp/A-1373 Hex Nuts**  
**Figure 2**

- (1) Remove the spinner dome in accordance with the applicable Hartzell Propeller owner's manual.
- (2) Examine the blade clamp nuts (Figure 2) to identify the lot number marked on each A-1373 hex nut (Figure 1).

- (a) A-1373 hex nuts marked with lot number "S1" must be replaced in accordance with the "Blade Clamp Nut Replacement" procedure in this section within 125 flight hours of this inspection.
- (b) A-1373 hex nuts marked with lot numbers other than "S1" are not affected by this Alert Service Bulletin and require no further action.
- (3) Make an entry in the propeller logbook indicating this inspection was performed in accordance with this Alert Service Bulletin.

- (3) Remove the affected A-1373 hex nuts from each blade clamp (refer to Figure 2) in accordance with the applicable Hartzell Propeller overhaul manual.

- (a) Affected A-1373 hex nuts must be returned to Hartzell Propeller in accordance with the Appendix section of this Alert Service Bulletin.
- (4) Install new, non-affected A-1373 hex nuts onto each blade clamp in accordance with the applicable Hartzell Propeller overhaul manual.
