**HARTZELL PROPELLER LLC**  
**ALERT SERVICE BULLETIN**  
**HC-ASB-61-413**  
**Hub Inspection**

- (1) Hartzell Propeller HC-E4N-5KFL lightweight turbine propellers are affected by this Alert Service Bulletin.
  - (a) The affected propellers are installed on Mitsubishi MU-2( ) aircraft under STC# SA09916AC.

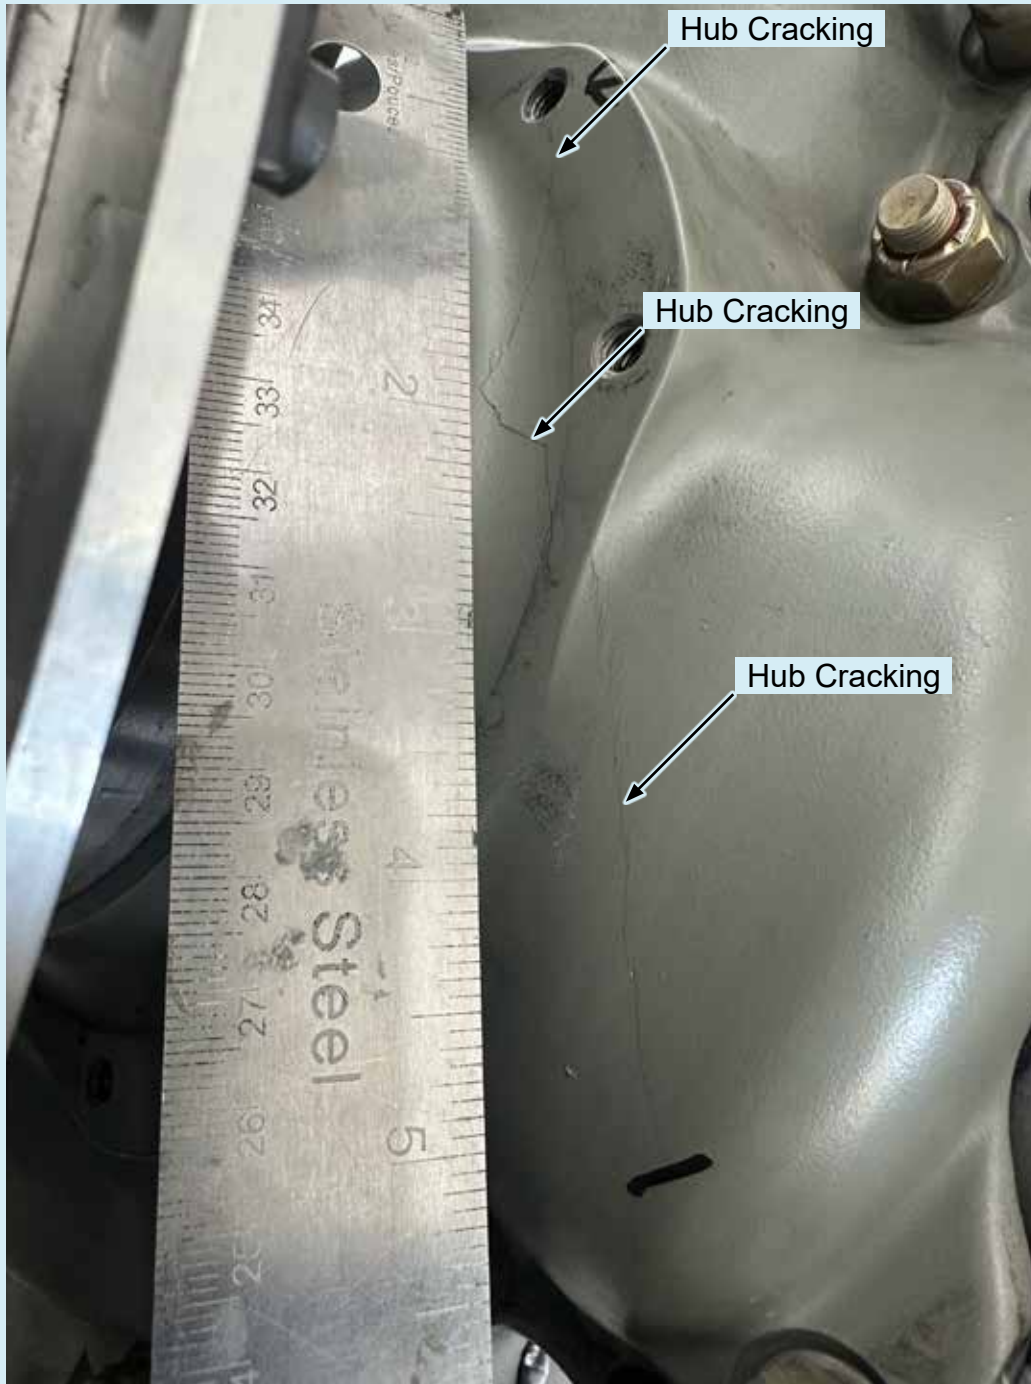
**Hub Cracks**  
**Figure 1, page 1 of 2**

- (1) Hartzell Propeller received a report of hub cracks on an affected propeller. Refer to Figure 1.
  - (a) The propeller reporting the cracked hub had accumulated approximately 3300 flight hours.

- (1) Remove the spinner dome in accordance with the applicable Hartzell Propeller owner's manual.
- (2) Using a mirror and/or borescope, examine all areas of the hub for cracking, focusing on the flange area and hub arms of the engine-side hub half. Refer to Figure 1.

- (a) Report findings to Hartzell Propeller. If cracking is found, discontinue flight and contact Hartzell Propeller immediately.
- (3) Examine the propeller for excessive blade play and/or grease leaks.
  - (a) Report findings to Hartzell Propeller. If excessive blade play or a grease leak is found, discontinue flight and contact Hartzell Propeller immediately.
- (4) Complete the Inspection Compliance Form in the Appendix section of this Alert Service Bulletin.
- (5) Make an entry in the propeller logbook indicating this inspection was performed in accordance with this Alert Service Bulletin.
