HARTZELL PROPELLER INC.
SERVICE BULLETIN
TRANSMITTAL SHEET
HC-SB-30-375
De-ice - Wire Harness Replacement

April 27, 2017

HARTZELL PROPELLER INC.
SERVICE BULLETIN
HC-SB-30-375
De-ice - Wire Harness Replacement

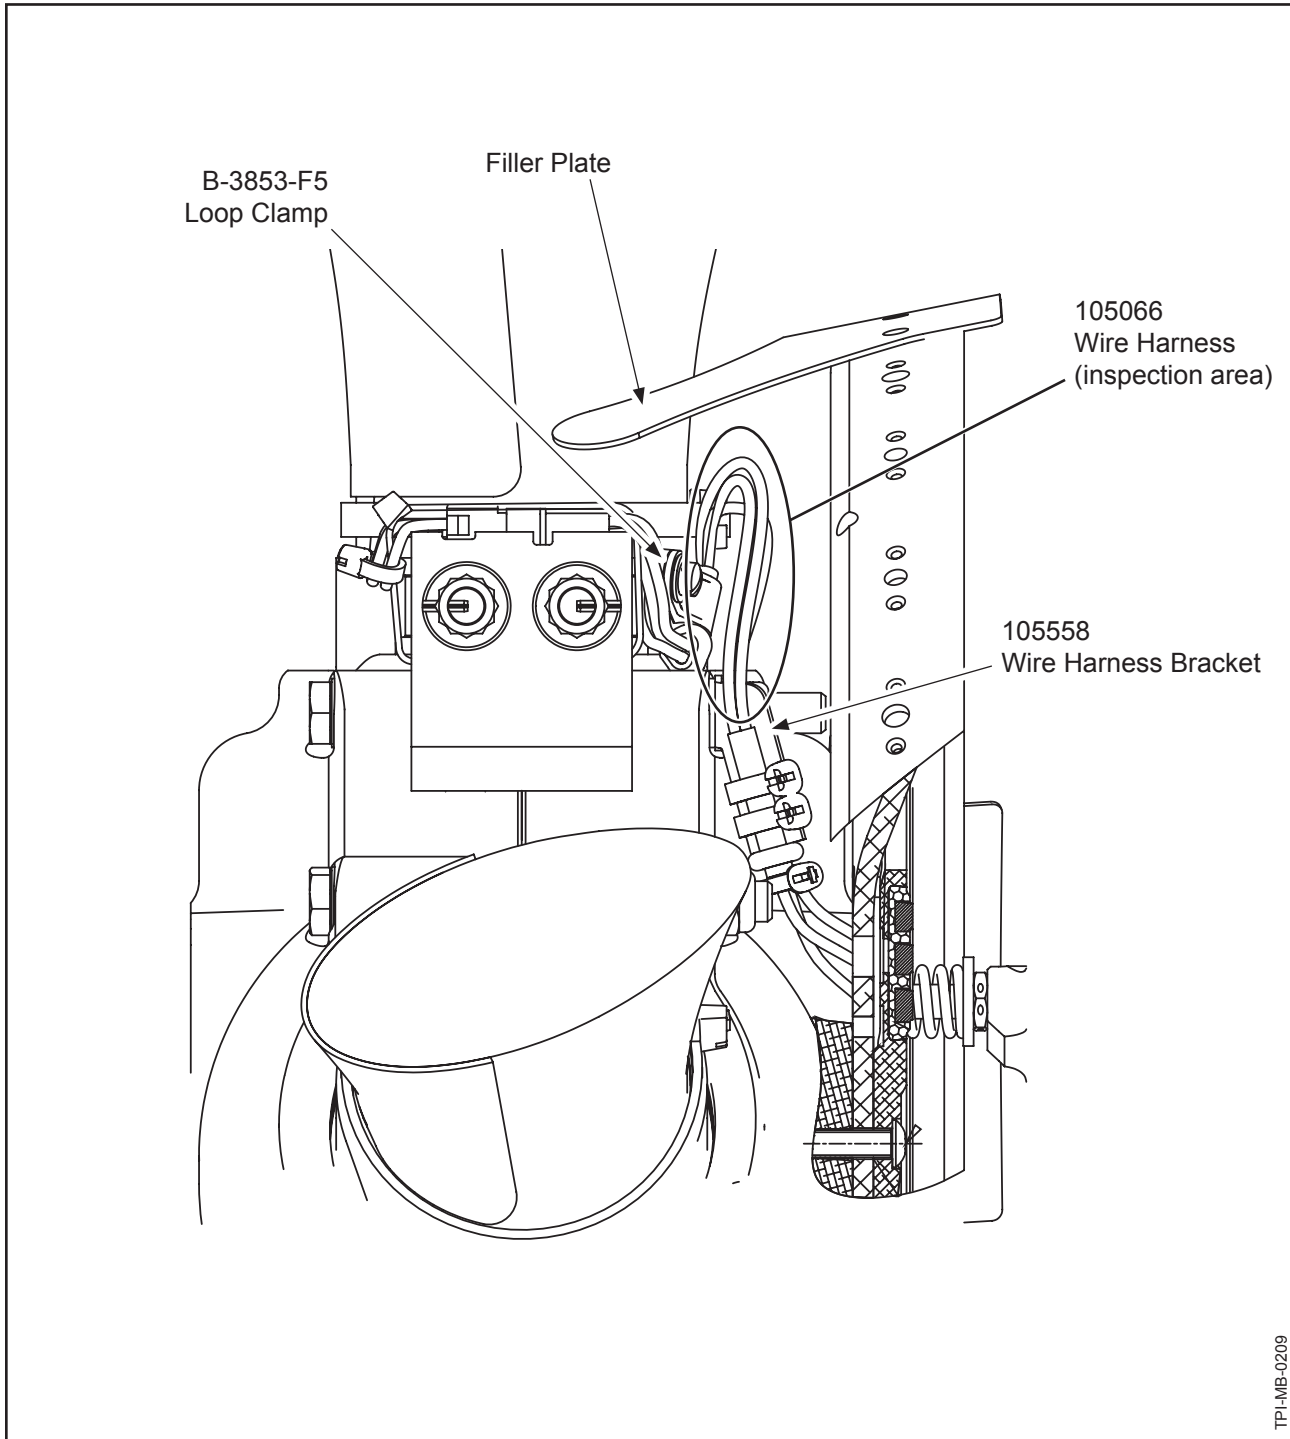
Visual Inspection
Figure 1

- (a) Examine all three wires on each 105066 wire harness for cuts or damage to the insulation between the B-3853-F5 loop clamp and the 105558 wire harness bracket. Refer to Figure 1.

- 1 If there is no damage to any of the 105066 wire harnesses, replace all five 105066 wire harnesses with five 105555 wire harnesses in accordance with the Accomplishment Instructions in this Service Bulletin within 50 flight hours from the visual inspection.

- 2 If the first layer of insulation (black) on any of the 105066 wire harnesses is damaged but the copper wire is not exposed, replace all five 105066 wire harnesses with five 105555 wire harnesses in accordance with the Accomplishment Instructions in this Service Bulletin within 25 flight hours from the visual inspection.

- 3 If the copper wire on any of the 105066 wire harnesses is exposed, replace all five 105066 wire harnesses with five 105555 wire harnesses in accordance with the Accomplishment Instructions in this Service Bulletin before further flight.
