HARTZELL PROPELLER INC.
SERVICE BULLETIN
HC-SB-30-390

Propeller - Spinner/Anti-ice Travel Tube Interference

- (1) Hartzell Propeller Inc. has been informed that there is a possible interference between the anti-ice travel tube and the spinner dome that can result in damage to the spinner dome.

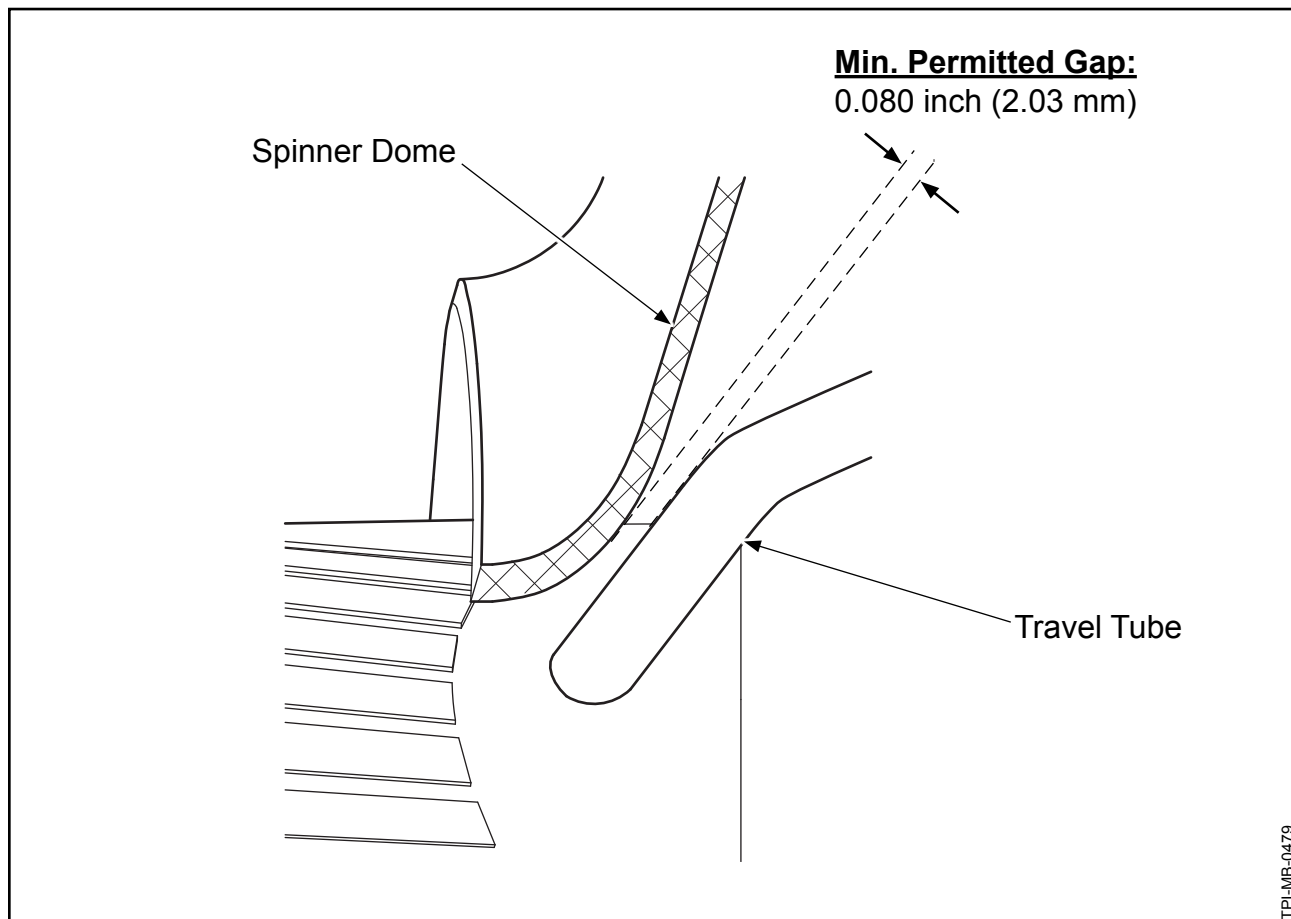
Gap Between the Travel Tube and Spinner Dome
Figure 1

- (b) If there is no interference between the travel tubes and the spinner dome:
- 1 Using a wire or feeler gauge, measure the gap between the travel tube and the spinner dome. Refer to Figure 1.

- a If the gap is less than 0.080 inch (2.03 mm):
 - (1) Match mark and remove the spinner dome in accordance with the applicable Hartzell Propeller Inc. Owner's Manual.

- b If the gap is greater than, or equal to 0.080 inch (2.03 mm):
 - (1) Make an entry in the propeller logbook indicating compliance with the Spinner Dome/Travel Tube Inspection section of this Service Bulletin.

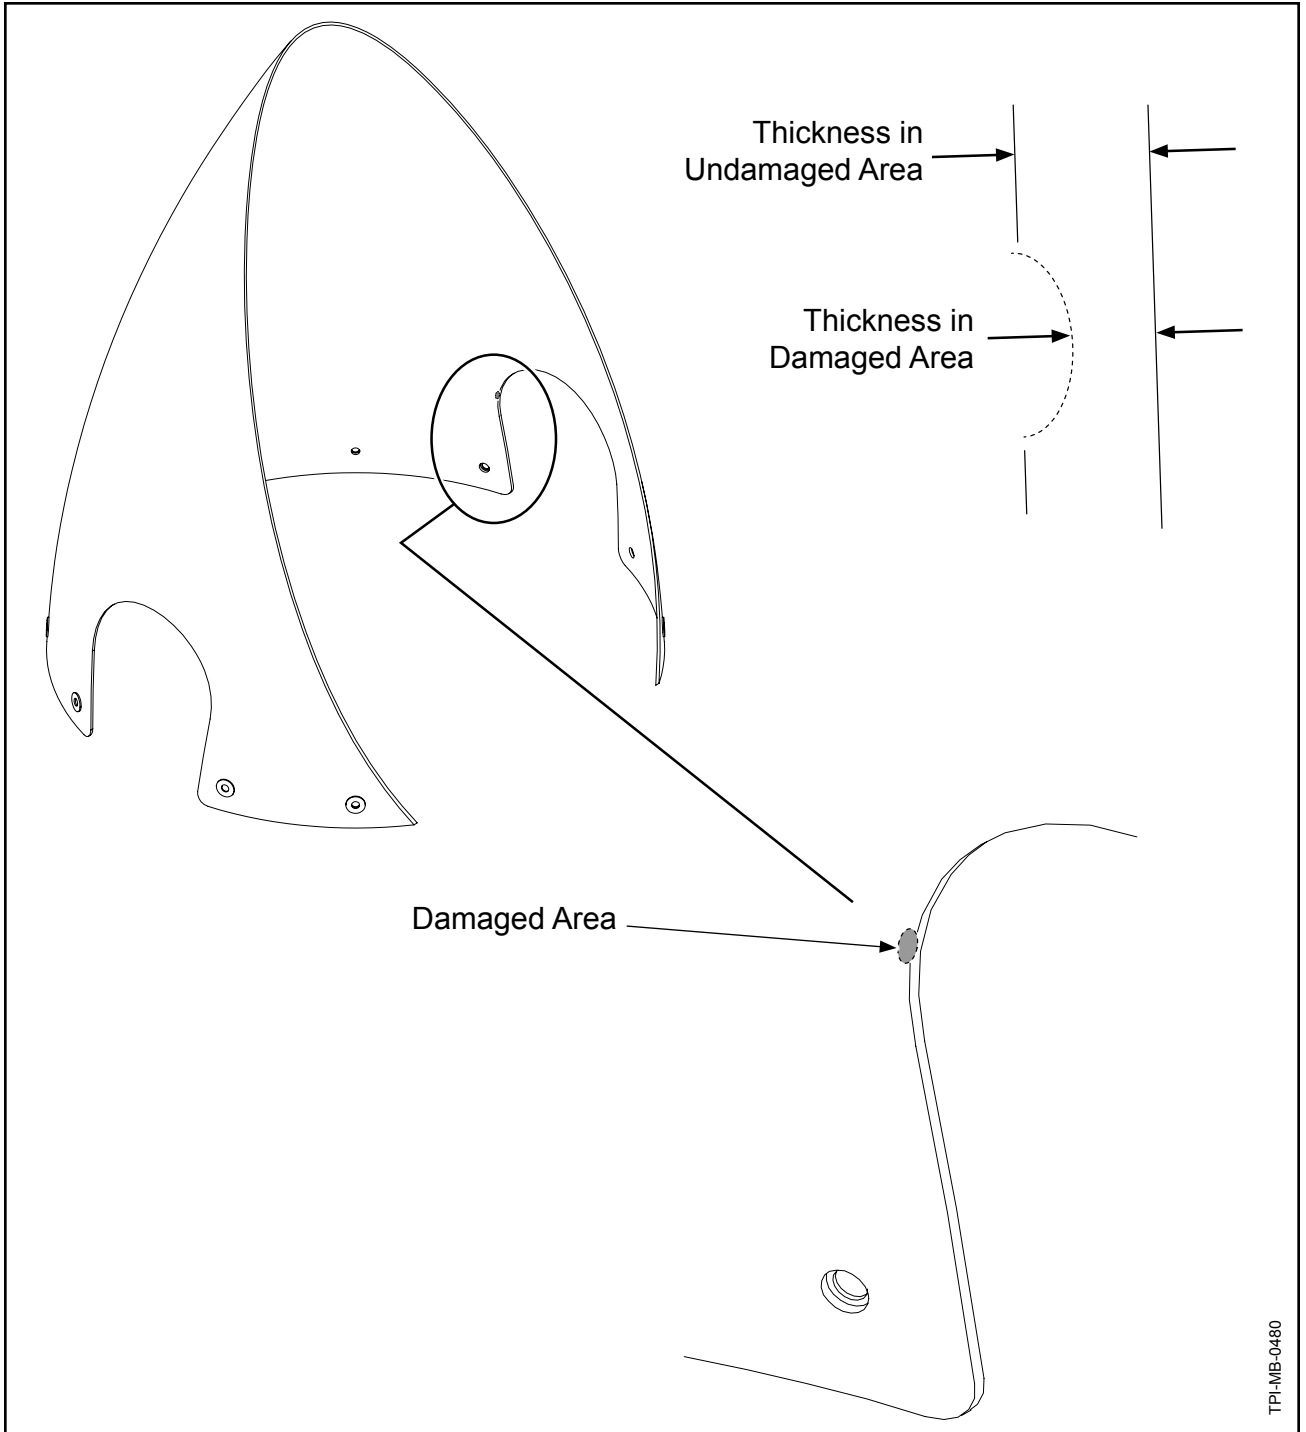
Measuring the Depth of Spinner Dome Damage
Figure 2

Inspect	Damage/Permitted Limits	Required Action
<p><u>Spinner Dome</u> Visually examine the spinner dome for cracks and damage caused by interference with the travel tube(s).</p>	<p>One crack is permitted if it is less than 0.75 inch (19 mm) long.</p>	<p>A crack that is less than 0.75 inch (19 mm) long must be stop drilled before further flight.</p> <p>If the crack is longer than 0.75 inch (19 mm), or if there is more than one crack, replace the spinner dome before further flight.</p>
<p>Measure the thickness in the damaged area. Then measure the local thickness in an undamaged area. Refer to Figure 2.</p>	<p>The thickness in the damaged area must be greater than 1/2 of the local thickness of the undamaged area.</p>	<p>If the thickness in the damaged area is less than 1/2 of the local thickness in an undamaged area, repair the dome in accordance with the "Spinner Dome Repair Procedure" in this Service Bulletin.</p>

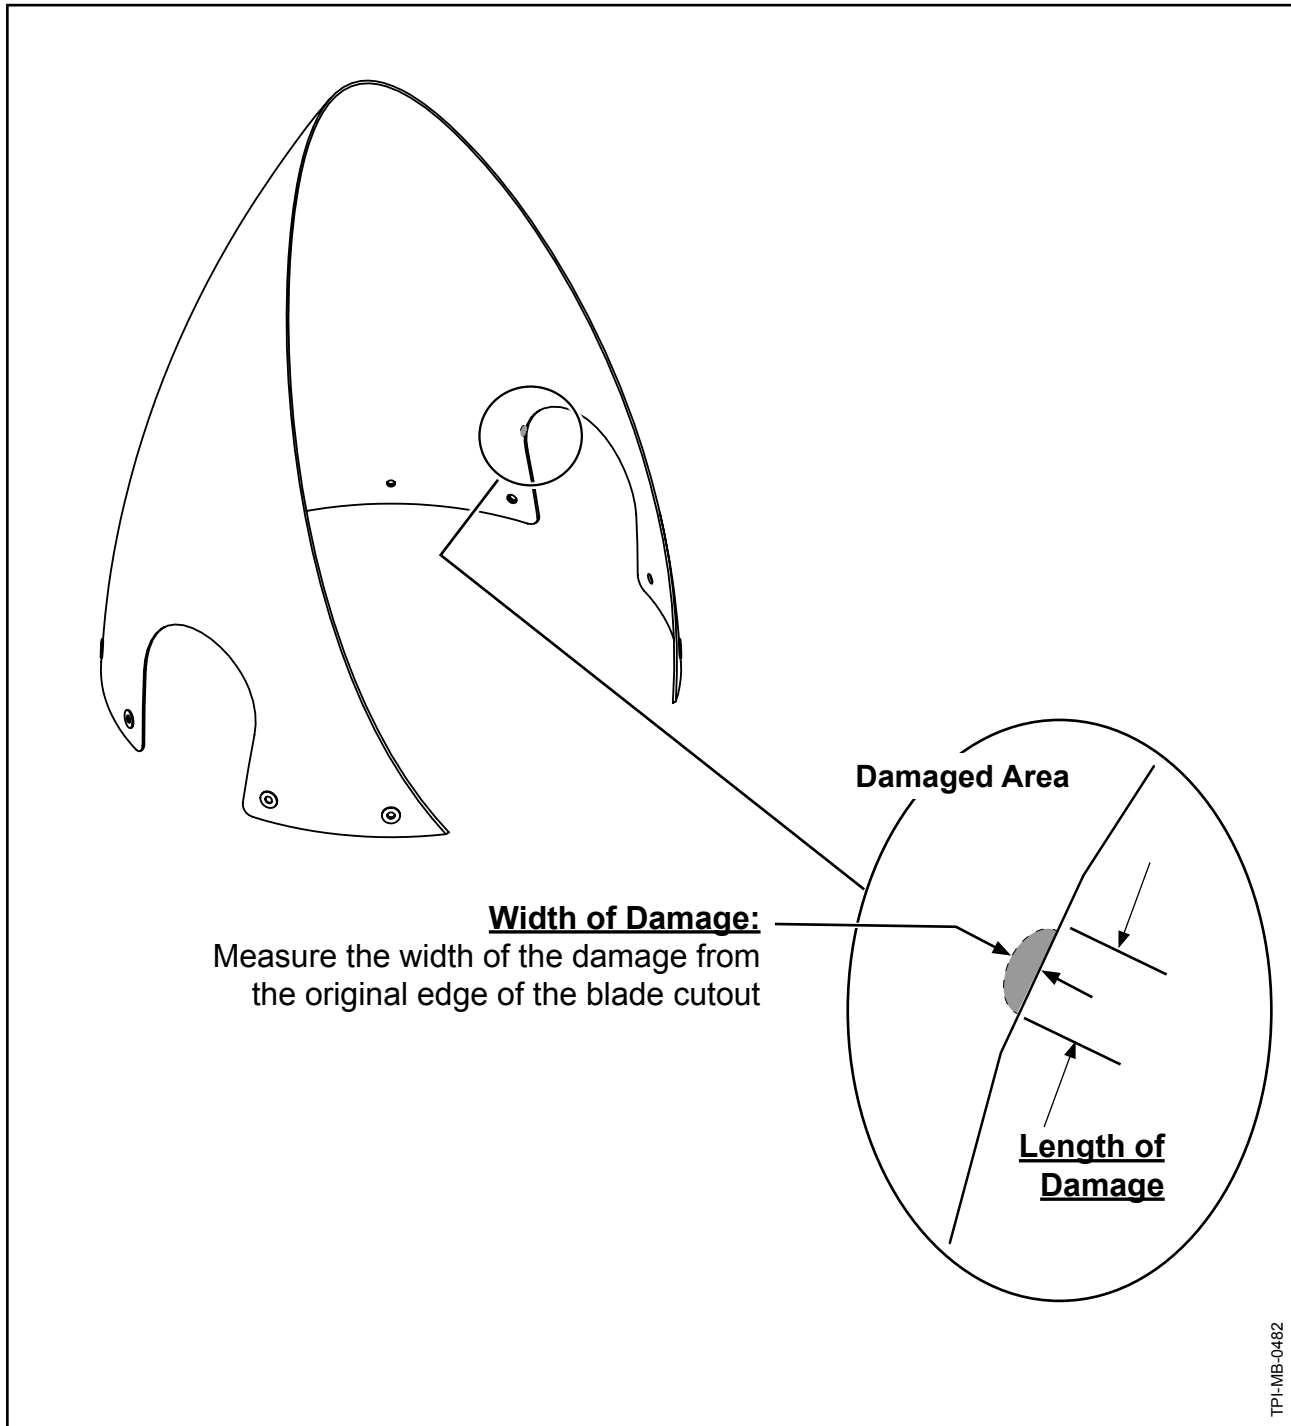
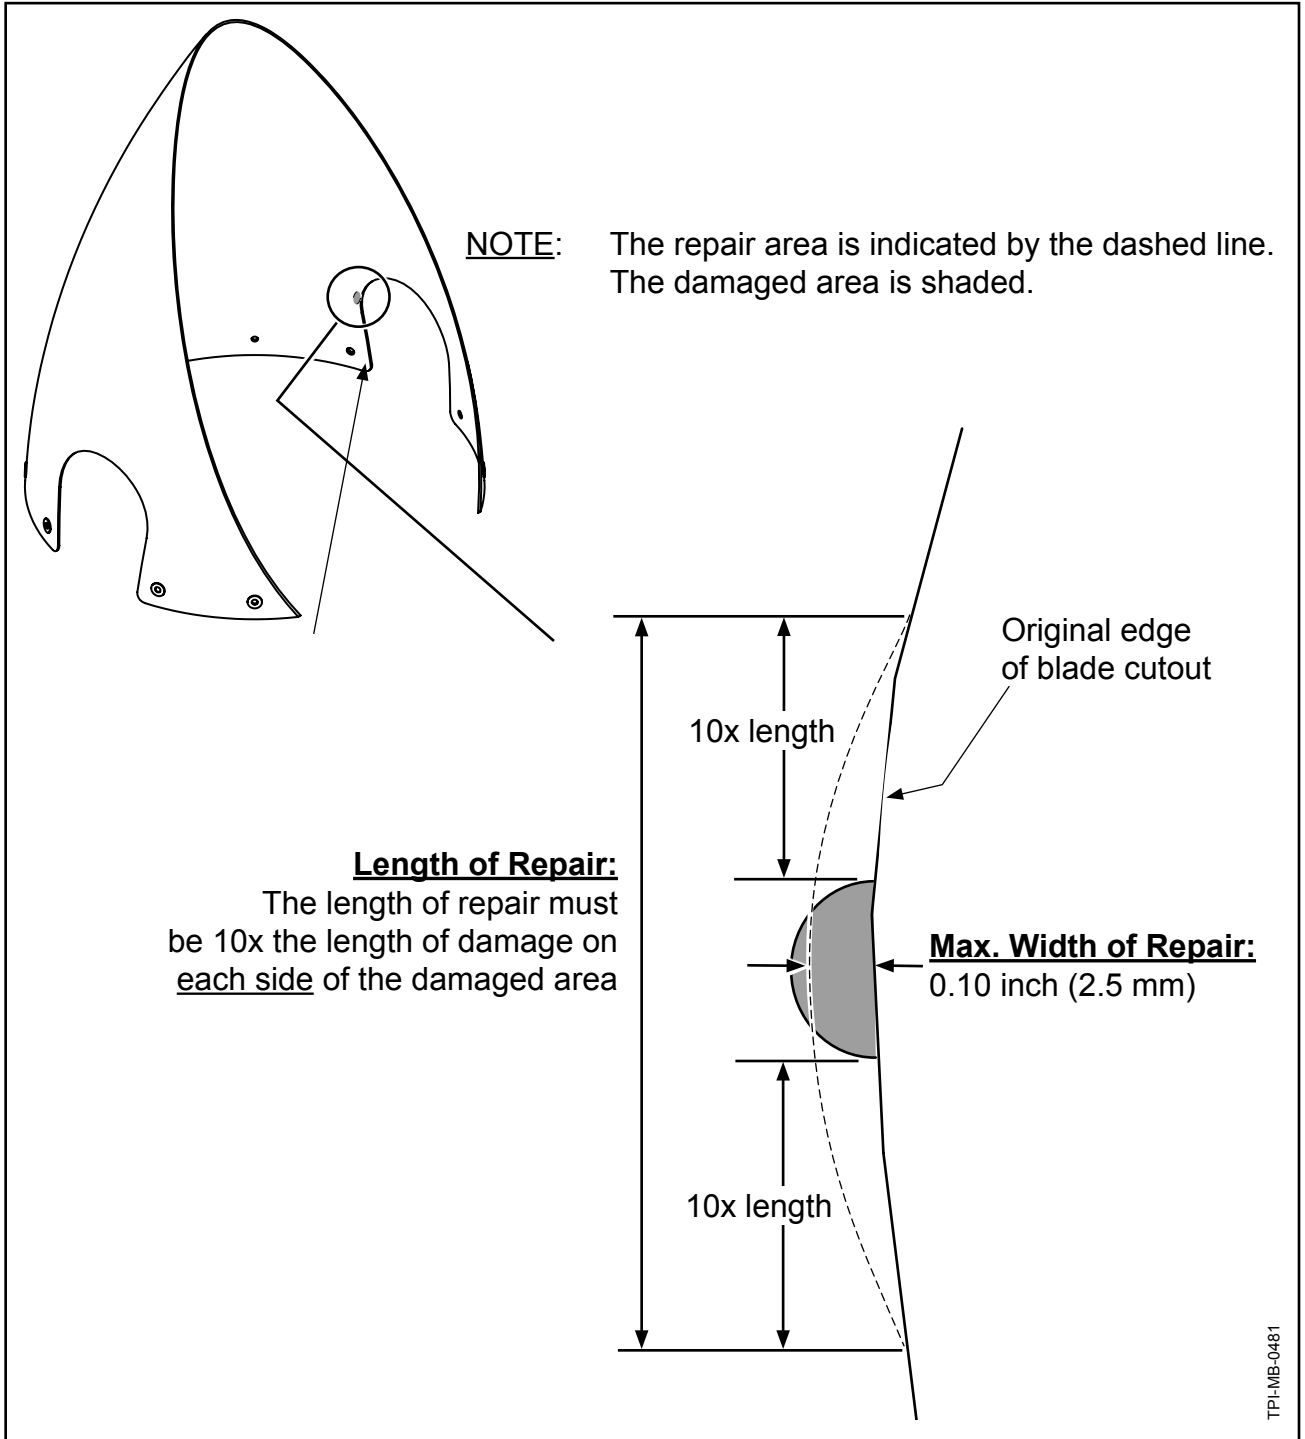
Spinner Dome Repair
Figure 3, page 1 of 2

- 1 Use a grinder or file to remove the damaged area from the side of the blade cutout in accordance with the repair limits in this section and Figure 3.

- a Repair Limits:
 - (1) The length of the repair must be 10x the length of the damage on each side of the damaged area.
 - (2) The maximum width of repair is 0.10 inch (2.5 mm).
