HARTZELL PROPELLER INC.
SERVICE BULLETIN
TRANSMITTAL SHEET
HC-SB-61-165E
Propeller - Hub Inspection

December 22, 2015

HARTZELL PROPELLER INC.
SERVICE BULLETIN
HC-SB-61-165E
Propeller - Hub Inspection

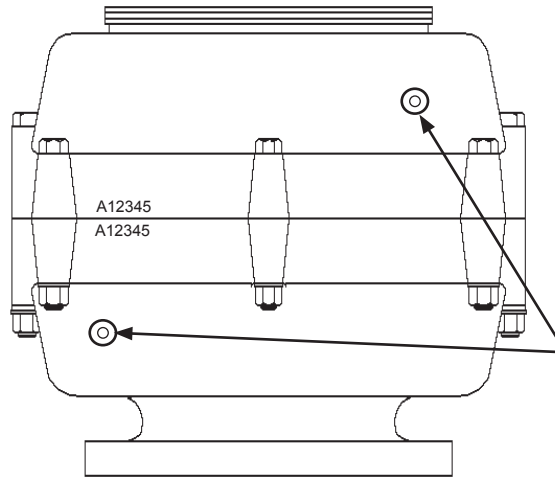
**Location of lubrication
fittings before 1983**

- (c) Any hub with the lubrication fitting holes located on the shoulder of the hub must comply with the Compliance requirements in this Service Bulletin.

Compliance Required
- the lubrication holes
located on the shoulder

- (3) In Hartzell Propeller Inc. three blade "compact" aluminum hub propellers with the lubrication fitting hole located on the hub shoulder, cracks typically originate in the threads of a lubrication fitting hole on the inside of the hub. As the cracks propagate around the blade socket of the hub, the crack progression accelerates and results in failure of one hub half. Several incidents have resulted in blade separation.

- 1 At 400 hours TIS or no later than September 15, 1997, whichever occurs first, replace the propeller hub with a hub that has the lubrication fitting hole at the hub parting line as terminating action for this Service Bulletin.

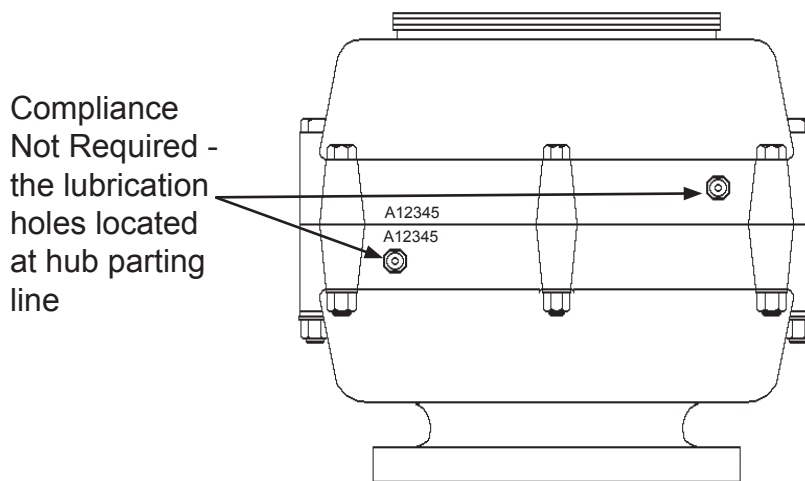
**Location of lubrication
fittings after 1983**

- (a) There may be a few serial numbers listed in Table 1 that were manufactured with the lubrication fitting hole located at the hub parting line.
 - (b) Any hub with the lubrication fitting at the hub parting line is not affected by this Service Bulletin.

Compliance
Not Required -
the lubrication
holes located
at hub parting
line

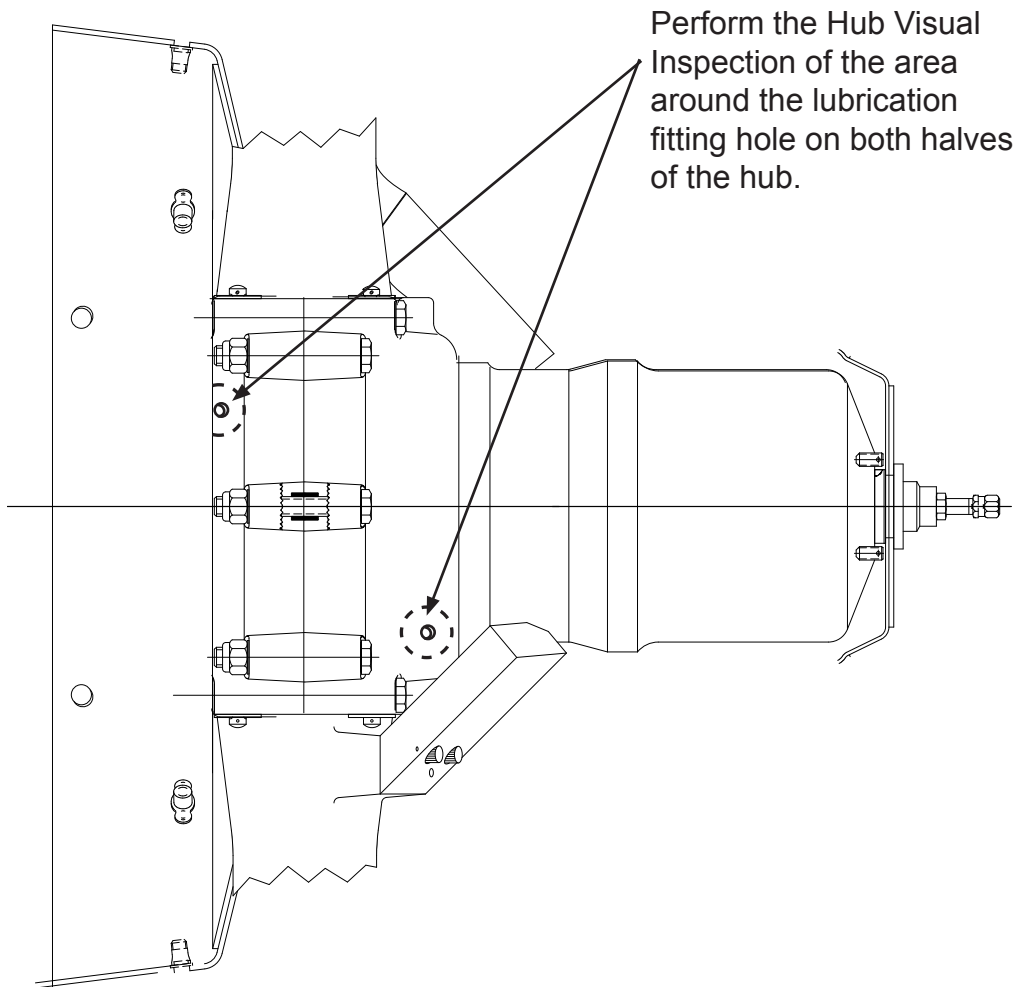
Lubrication Fitting Hole Inspection
Figure 3

- (6) Using solvent acetone CM173, MEK CM106, or MPK CM219 and an abrasive pad CM47 or equivalent, remove any grease or other matter that may interfere with the visual inspection.
- (7) Using a 10X magnifying glass and an appropriate light source, perform a visual inspection of the area around the lubrication fitting hole and the general area of the blade retention bearings. Refer to Figure 3.

- (a) A crack usually initiates at the lubrication fitting hole and propagates perpendicular to the blade around the blade socket.
- (b) A crack may initiate on either hub half from any of the six lubrication fittings holes.
