HARTZELL PROPELLER INC.
SERVICE BULLETIN
TRANSMITTAL SHEET
HC-SB-61-217
Propeller - X and V Shank Propeller Inspection

November 01, 2019

HARTZELL PROPELLER INC.
SERVICE BULLETIN
HC-SB-61-217
Propeller - X and V Shank Propeller Inspection

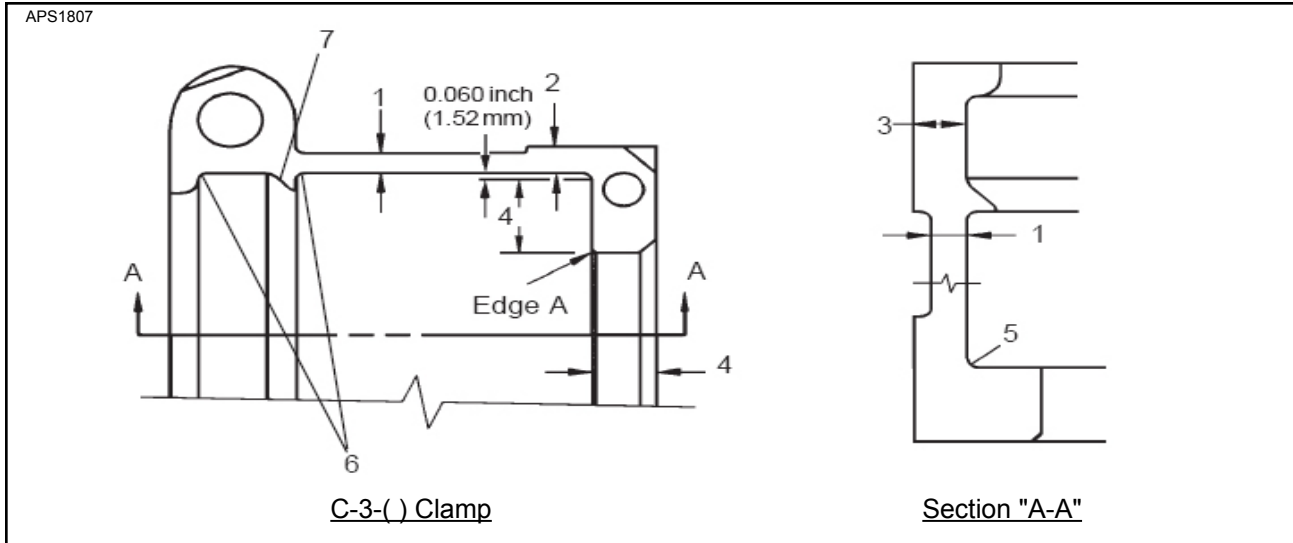
Clamp Inspection Areas and Rework Limits
Figure 1

- (1) Perform visual inspection in accordance with the Blade Clamp Overhaul chapter of Hartzell Standard Practices Manual 202A (61-01-02).
- (2) Perform magnetic particle inspection of the steel blade clamps in accordance with the Magnetic Particle Inspection chapter of Hartzell Standard Practices Manual 202A (61-01-02). For compliance with this inspection, removal of the counterweight from the clamp is required.
- (3) No magnetic particle indications are allowed. Any clamp with a crack indication must be retired from service in accordance with Hartzell Standard Practices Manual 202A (61-01-02). Any relevant indication (visual or magnetic) of damage or corrosion pitting is not permitted, but is repairable within the limits shown in Figure 1.

Area Number (above)	Description	Rework Limits
Area 1	Wall thickness - blade retention area	Rework allowed to 0.007 inches (0.17mm) depth. Minimum wall thickness after rework to be no less than 0.132 inches (3.35 mm).
Area 2	Wall thickness - bearing retention area	Rework allowed to 0.007 inches (0.17mm) depth. Minimum wall thickness after rework to be no less than 0.215 inches (5.46 mm).
Area 3	Wall thickness - double shoulder	Rework allowed to 0.007 inches (0.17mm) depth. Minimum wall thickness after rework to be no less than 0.195 inches (4.95 mm).
Area 4	Inboard wall thickness - bearing retention area	Local spot rework permitted. Maximum material removed is 0.007 inches (0.17mm). Minimum wall thickness after rework to be no less than 0.618 inches (15.69 mm). Wear depth in the area where the link arm rubs is 0.006 inches (1.15mm) maximum. Minimum thickness of clamp inboard wall, in area of link arm only, is 0.612 inches (15.54 mm). Maintain 0.032 inches (0.81mm) x 45 degrees chamfer at "A."

Area 5	Corner - inboard wall	Maintain 0.050 to 0.070 inches (1.27 to 1.77 mm) radius. Rework allowed to 0.007 inches (0.17mm) depth.
Area 6	Corner	Local spot rework is permitted. Maximum material removal is 0.002 inches (0.051 mm). Corner radius of 0.060 inches (1.52 mm) must be maintained.
Area 7	Corner	Local spot rework is permitted. Maximum material removal is 0.005 inches (0.12 mm). Corner radii of 0.060 inches (1.52 mm) and 0.040 inches (1.01 mm) must be maintained.

NOTE 1: Area 4 applies to the point of tangency to the radius, all the way around the entire circumference of the clamp.

NOTE 2: All rework must blend smoothly and have a surface finish of 32 Ra or better when completed.
