# HARTZELL PROPELLER INC.

# SERVICE BULLETIN

## Blade Angle Adjustment

This Service Bulletin applies to HC-C3YR-1RF/F7590 model propellers installed on Piper PA24-260 Comanche 260 aircraft under Supplemental Type Certificate Number SA288CH. The propellers were manufactured between May, 1995 and April 1998 prior to serial number DY3940A.

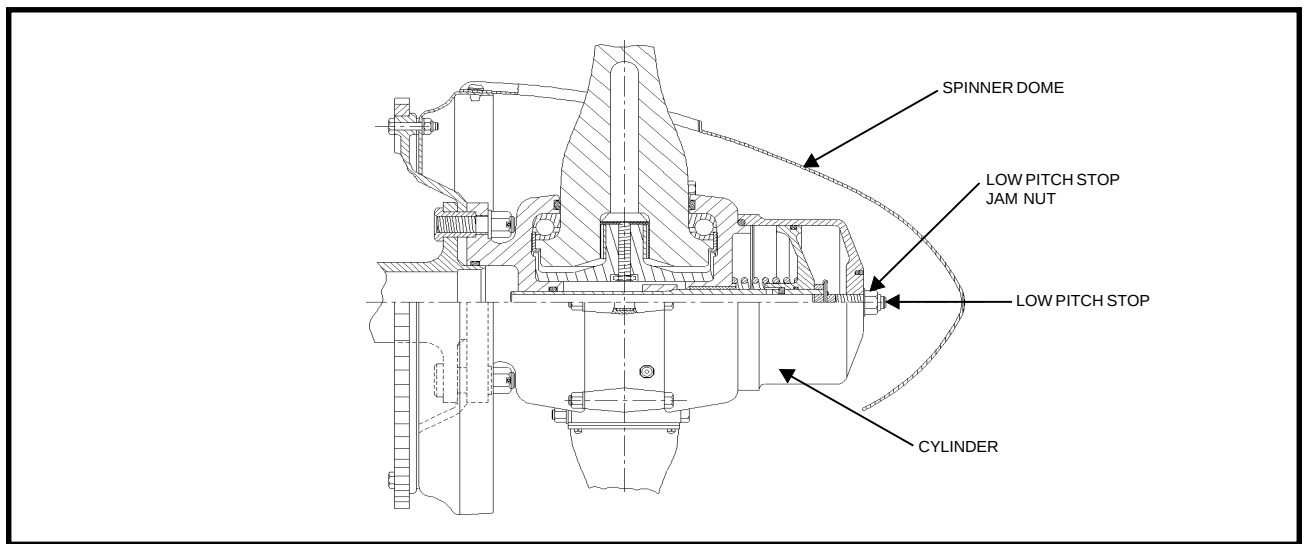
**Figure 1**  
**Low Pitch Stop Location**

- (1) The original STC specified a low pitch blade angle setting of 10.5°. This blade angle has been determined to be lower than desired and could cause engine overspeed in the unlikely case of governor failure or oil pressure loss, during rapid application of power.
- (2) The condition is limited to the propellers listed in the Effectivity section of this document.
- (3) Compliance with this bulletin is required to reduce the chance of engine overspeed.
- (4) Owners of the affected aircraft will receive a new Airplane Flight Manual and Supplement.

- (1) Remove spinner dome.
- (2) Loosen low pitch stop jam nut (see Figure 1)
- (3) Turn the low pitch stop screw in 2-1/3 turns. This will increase the low pitch angle from 10.5° to 13.8°.
- (4) Tighten jam nut and torque to 15 ft/lbs (+/-10%).
