HARTZELL PROPELLER INC.
SERVICE BULLETIN
TRANSMITTAL SHEET
HC-SB-61-287

**Propeller - E10950 Blade Inspection, Rework, and Thrust
Bearing Replacement**

June 5, 2009

- (1) HC-E4A-3()/E10950() propellers installed on Raytheon Beechcraft 1900D aircraft are affected by this Service Bulletin.

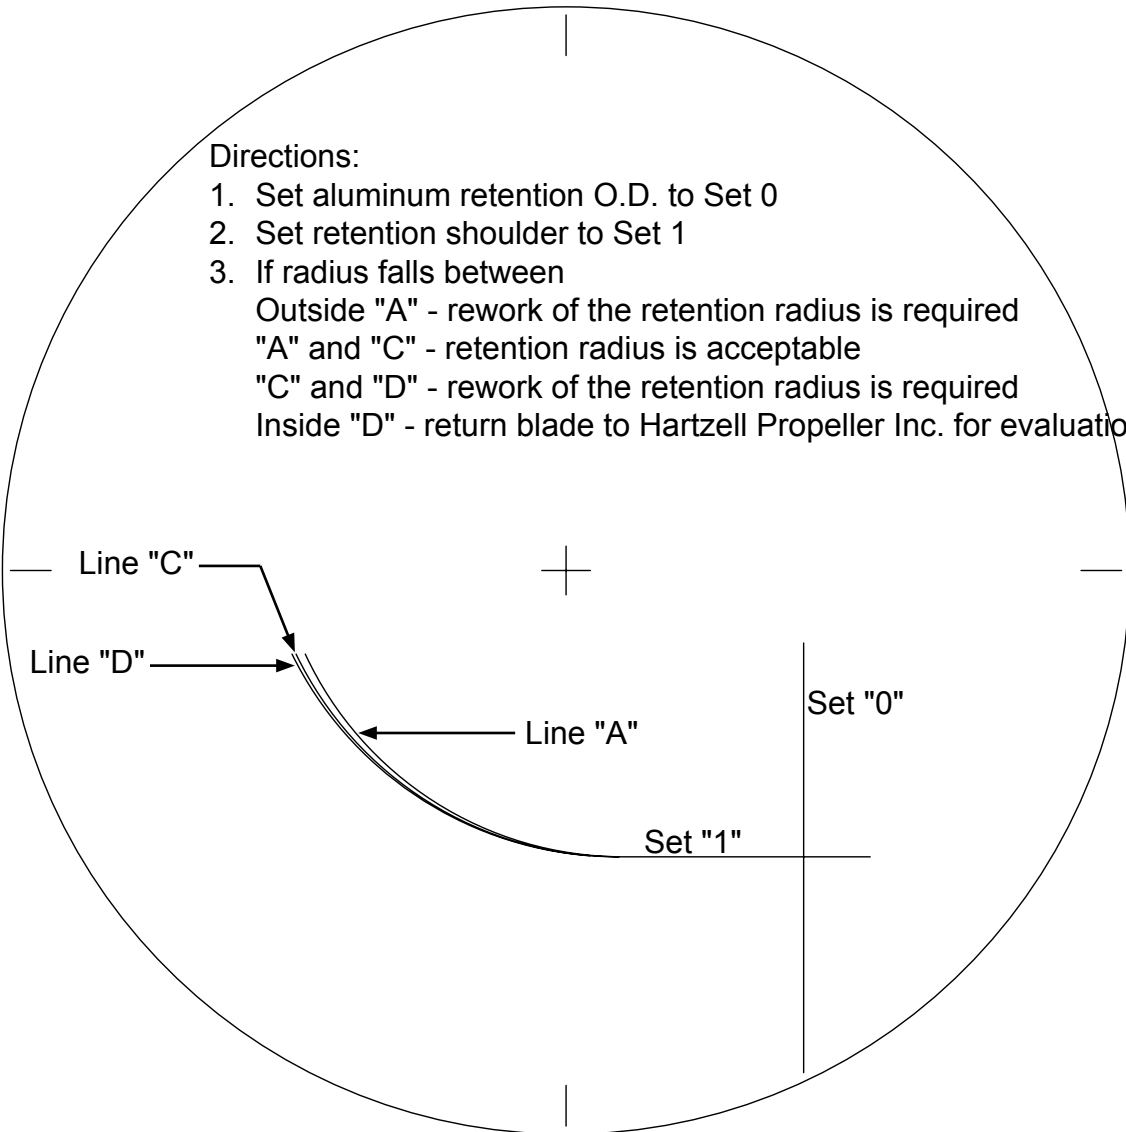
**Optical Comparator Overlay GT-3669, Rev. A
Figure 3**

- (a) Determine serviceability/repairability by comparing the projected image with the overlay. Make sure that the projected image is within the "A" and "D" lines. See Figure 3.

- 2 If projection is between lines "A" and "C" retention radius is acceptable.

- 4 If projection is inside line "D", retention radius laminate repair is required. Return the blade to Hartzell Propeller Inc. for evaluation.

- 1 If projection is outside line "A", rework the retention radius in accordance with Paragraph 3.D. of this Service Bulletin.

- 3 If projection is between lines "C" and "D", rework retention radius in accordance with Paragraph 3.D. of this Service Bulletin.
