HARTZELL PROPELLER INC.
SERVICE BULLETIN
TRANSMITTAL SHEET
HC-SB-61-304

Propeller - Introduction of an Improved Blade

August 1, 2012

HARTZELL PROPELLER INC.
SERVICE BULLETIN
HC-SB-61-304

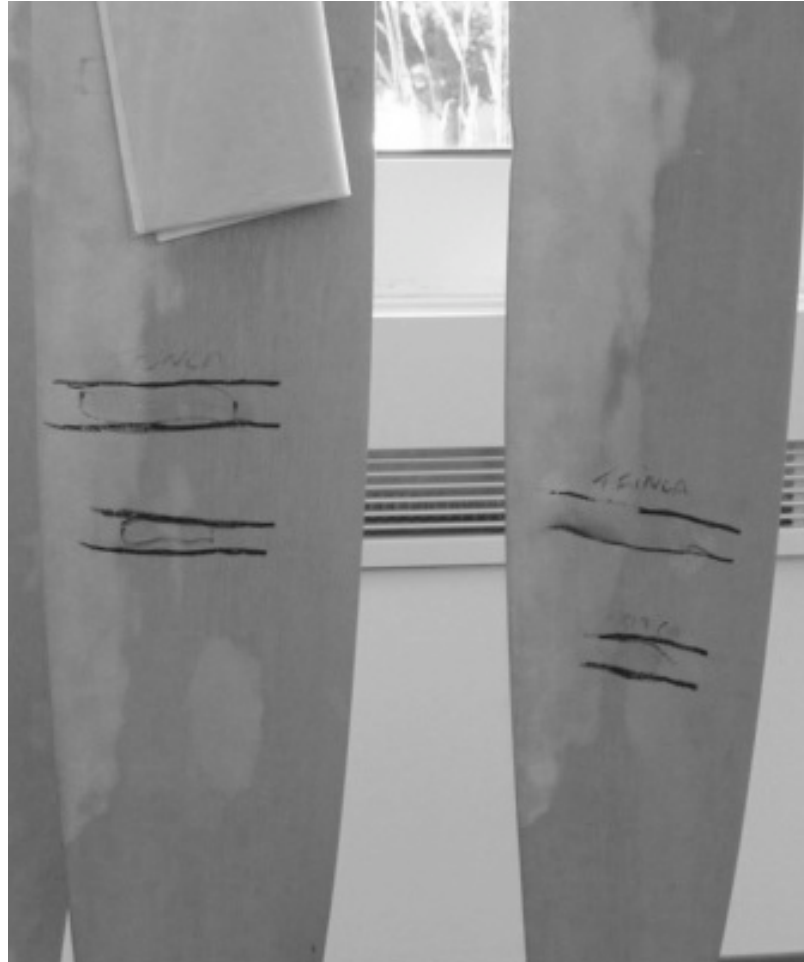
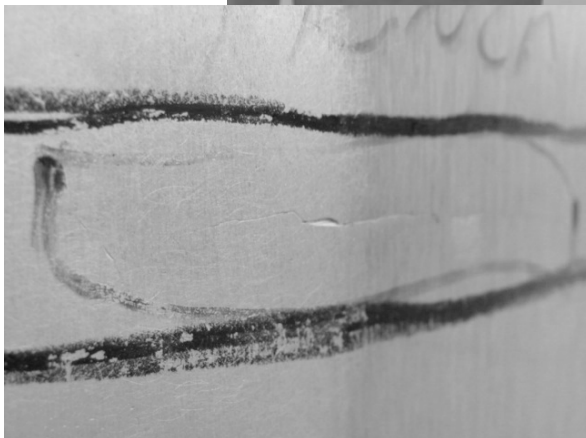
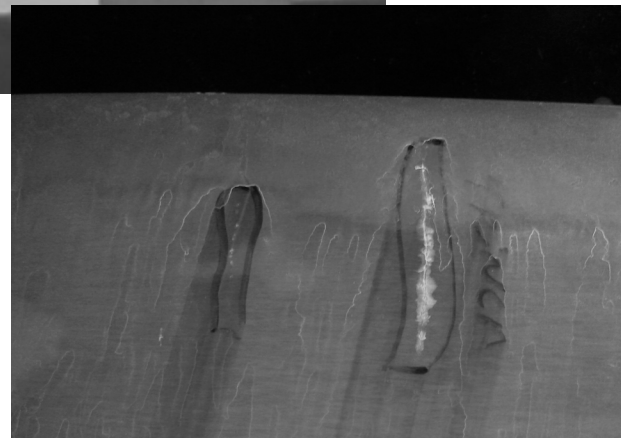
Figure 1

- (1) There have been sporadic reports of blade flutter during landing while using propeller reversing. An investigation identified a greater likelihood for this occurrence with blades nearing dimensional minimums.
 - (a) This same occurrence of blade flutter is also possible with blades near original manufacturing specifications.
 - (b) This condition can cause cracked and/or failed blades. Refer to Figure 1.

Cracks are located between the markings on the blades shown.

Examples of Cracked Blades Caused by this Condition

- (2) Blade Flutter can be identified by a large increase in sound level during application of reverse.
- (3) Blade replacement in accordance with the Compliance section of this Service Bulletin will minimize the tendency for flutter.
- (4) Replacement of all T10173F(N)(B,K)-12.5 blades with improved T10173AN(B,K)-12.5 blades is terminating action for this Service Bulletin.
- (5) Regulatory action is unknown.

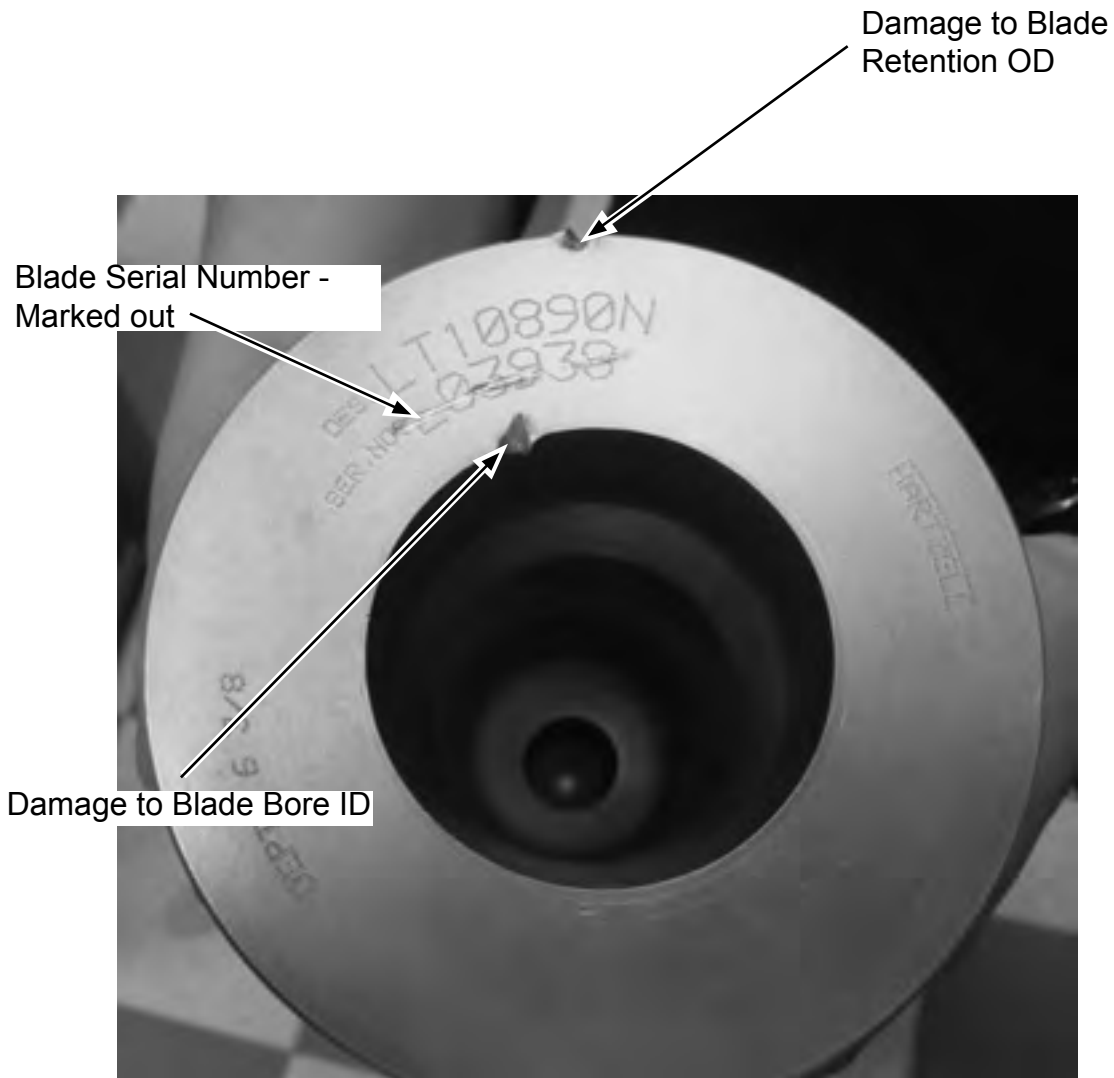
Blade Butt Showing Damage to Prevent Further Use of the Blade
Figure 2

Note: The blade shown is not an affected blade. This blade is shown as an example only of the damage that should be made to retire the blade.

- 1 The retired blades cannot be modified or returned to service for use in any application, including experimental applications.
- 2 Each blade must be damaged in such a way that prevents further use of the blade.
 - 1 Using a tool, damage the ID of the blade bore and the OD of the blade retention surface. Damage must be sufficient to prevent installation of the blade bearing and the blade clamp. Refer to Figure 2.
 - 2 Mark out the blade serial number, so that the number is still legible.
 - 3 Take a photograph of the blade butt to show the damage, the blade model number, and the blade serial number. Refer to Figure 2.
 - 4 Send the photo via email to techsupport@hartzellprop.com in accordance with the Appendix to this Service Bulletin. **DO NOT RETURN THE BLADE.**
