HARTZELL PROPELLER INC.
SERVICE BULLETIN
HC-SB-61-327

Propeller - Inspection of D-4511(L)(P) Spinner

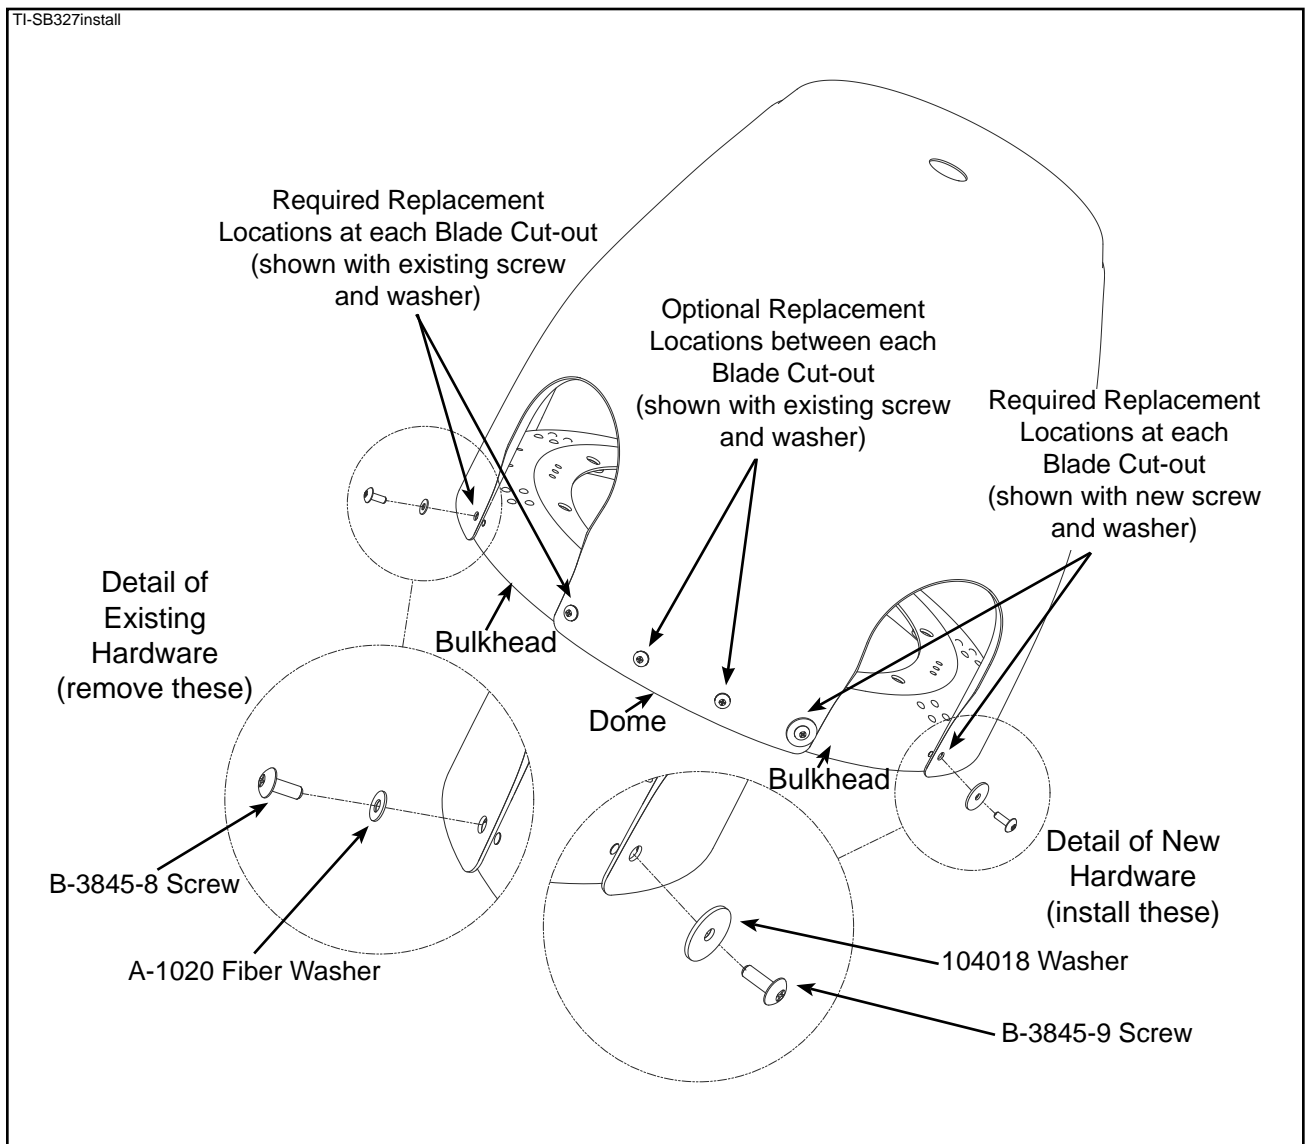
Location of Required and Optional 104018 Washers and B-3845-9 Screws

- (e) Using eight (8) of the 104018 washers and eight (8) of the B-3845-9 screws in the locations identified in Figure 1, as an alternative to eight (8) of the removed fiber washers and screws, install the spinner dome in accordance with Hartzell Owner's Manual 115N (61-00-15).
 - 1 Replacement of the washers and screws in only the eight (8) locations identified in Figure 1 are required for Terminating Action of this Service Bulletin.
 - 2 At the discretion of the owner/operator, all 16 removed fiber washers and screws may be replaced with the 104018 washer and the B-3845-9 screw.
 - 3 After installation is complete, discard all remaining washers and screws.
