HARTZELL PROPELLER INC.
SERVICE BULLETIN
HC-SB-61-373

**Propeller - Propeller Mounting Nut Torque Inspection
and Replacement**

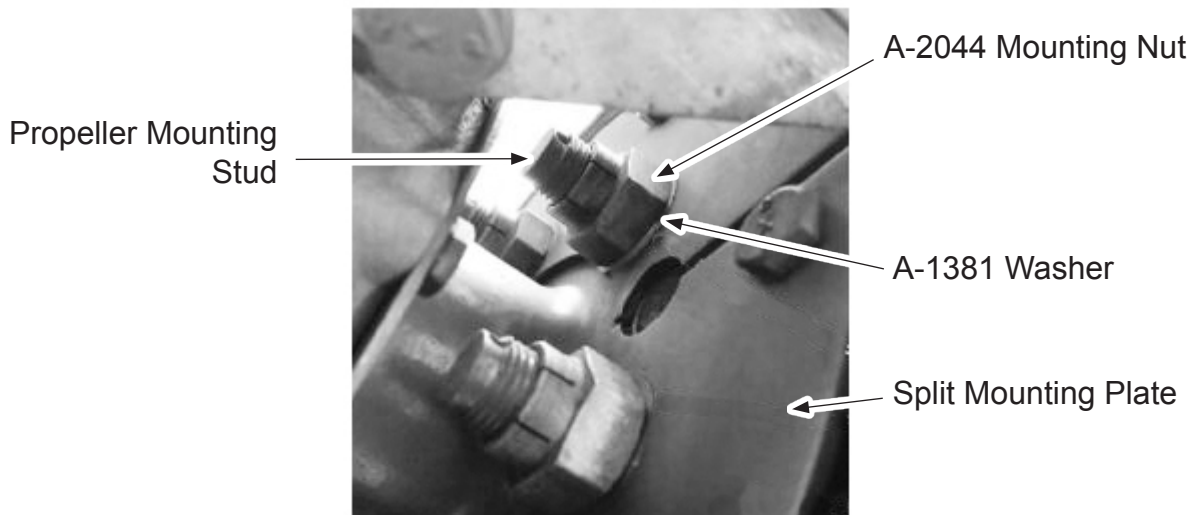
Propeller Mounting Studs/A-2044 Mounting Nuts
Figure 1

- (1) Textron Aviation has informed Hartzell Propeller Inc. that the affected propellers were installed with A-1381 washers under the A-2044 propeller mounting nuts.
 - (a) All of the affected propellers are equipped with a de-ice system that requires a split mounting plate for installation onto the engine flange. The A-1381 washers do not fit correctly against the split mounting plate and can deform when the A-2044 mounting nuts are torqued.
 - 1 Deformed A-1381 washers can cause the A-2044 mounting nuts to lose the required torque.
 - a If the A-2044 mounting nuts lose the required torque, the propeller can become loose on the engine flange and cause damage to the mounting studs and/or the hub.

Incorrect Installation

- 1 Remove and discard all six A-2044 mounting nuts and A-1381 washers.
 - 2 Install six new A-2044 mounting nuts in the correct sequence in accordance with Hartzell Propeller Inc. Owner's Manual 115N (61-00-15).

- a The installation torque for the A-2044 mounting nuts is 70-80 Ft-Lbs (95-108 N•m) dry.
- (6) Make a record in the propeller logbook indicating compliance with the propeller mounting nut torque inspection as terminating action for Hartzell Propeller Inc. Service Bulletin HC-SB-61-373.

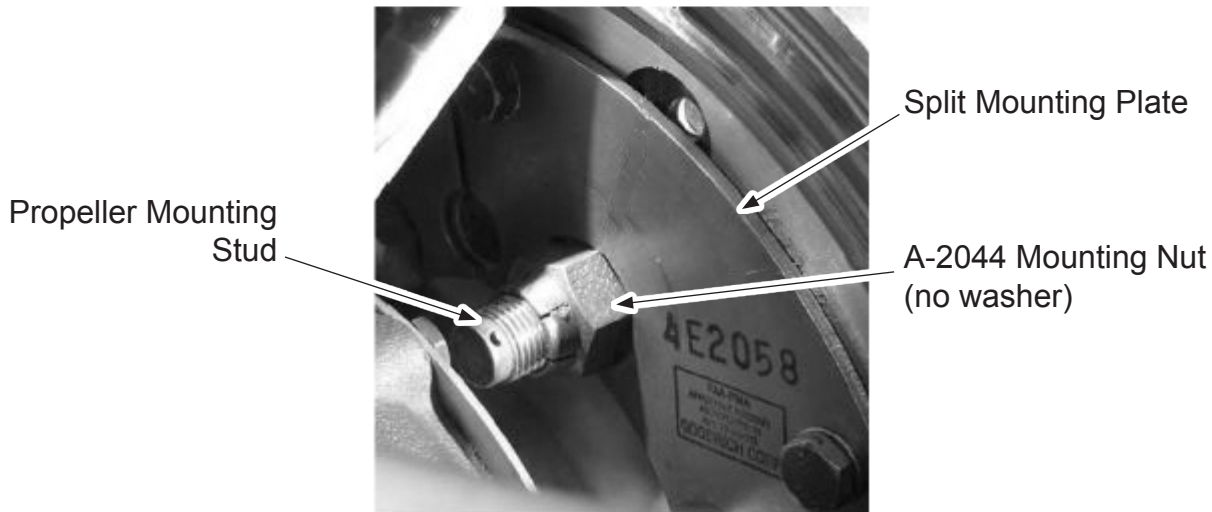
Correct Installation
