HARTZELL PROPELLER INC.
SERVICE BULLETIN
TRANSMITTAL SHEET
HC-SB-61-377
Propeller - Blade Seal Replacement

January 08, 2019

HARTZELL PROPELLER INC.
SERVICE BULLETIN
HC-SB-61-377
Propeller - Blade Seal Replacement

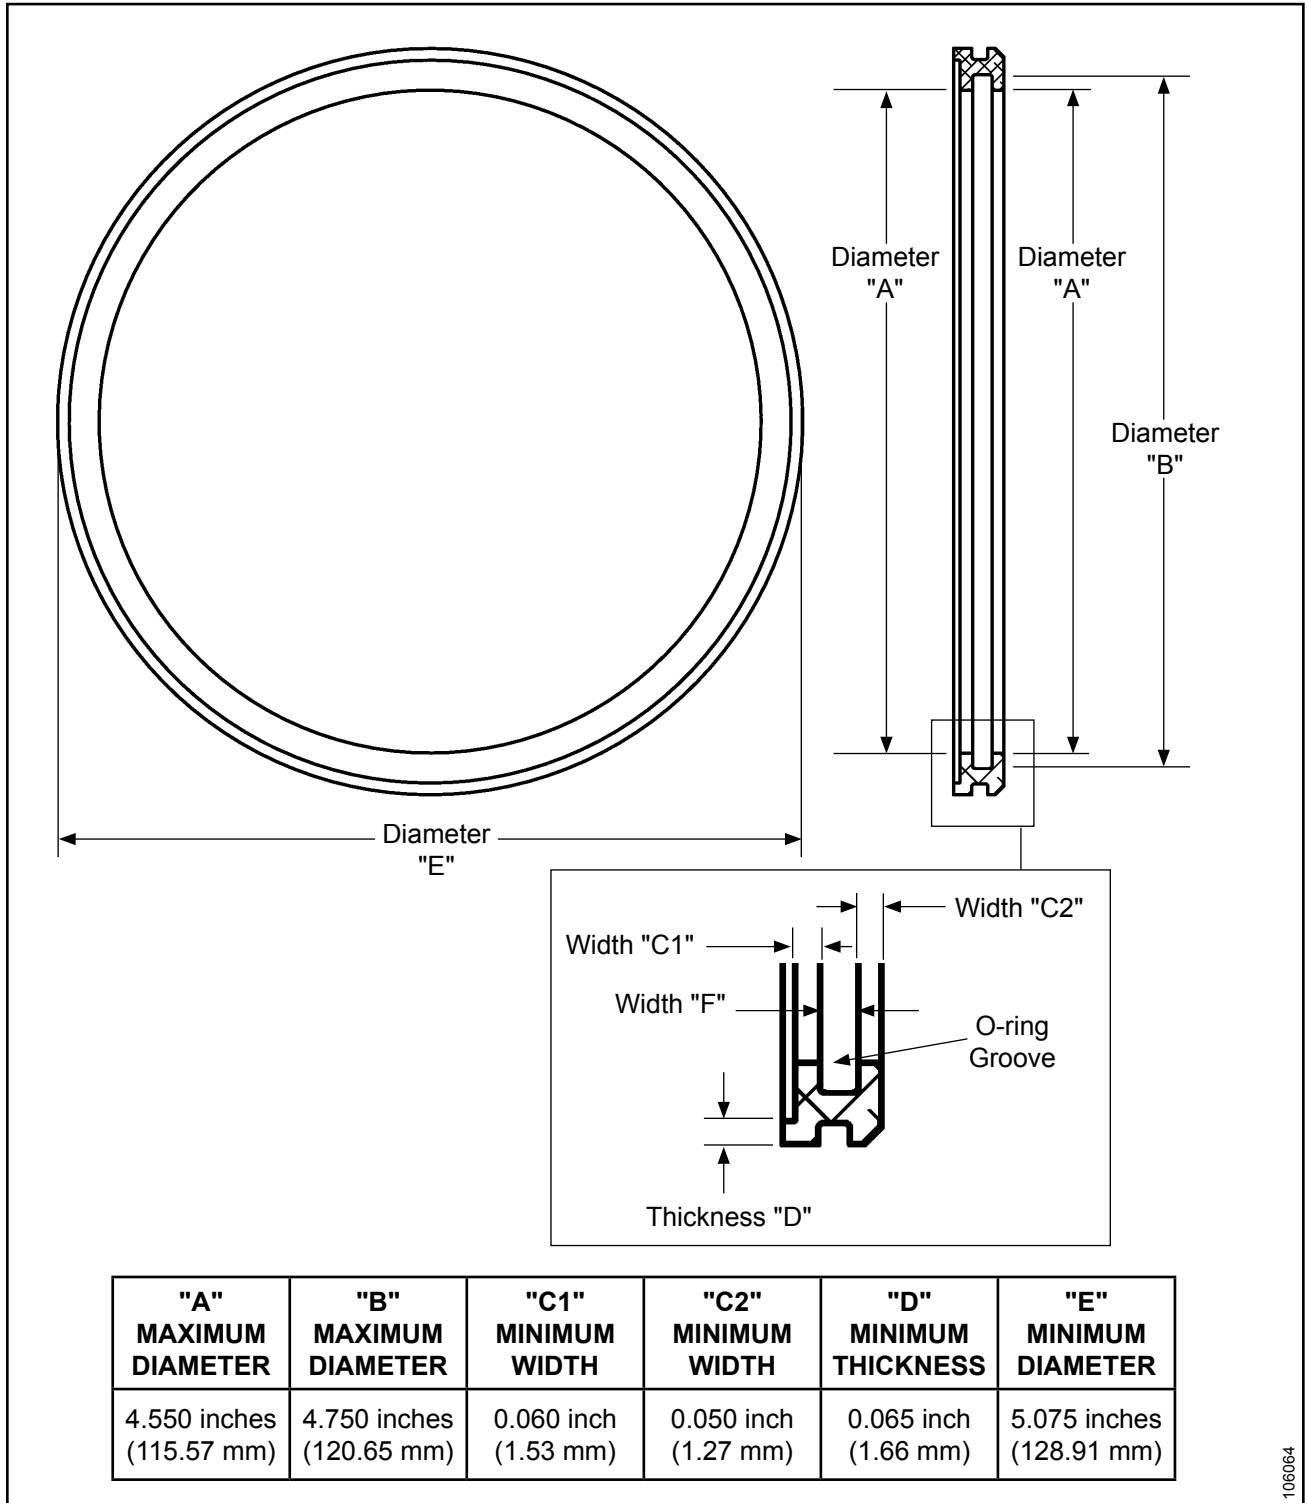
Blade Seal Inspection
Figure 1

Inspect	Serviceable Limits	Corrective Action
<u>BLADE SEAL</u>		
Refer to Figure 1		
(1) Visually examine the blade seal for corrosion, pitting, wear, or damage.	Corrosion is not permitted. If there is corrosion, remove it in accordance with the corrective action repair limits. If there is pitting, wear, or damage, measure the depth. The maximum permitted depth of pitting, wear, or damage is 0.007 inch (0.17 mm).	Using an abrasive pad CM47 or equivalent, polish to remove corrosion, pitting, wear, or damage to a maximum depth of 0.010 inch (0.25 mm). If the depth of corrosion, pitting, wear, damage, or repair is greater than the permitted corrective action limits, replace the blade seal.

(2) Measure the O-ring groove width "F".	The maximum permitted width of O-ring groove "F" is 0.175 inch (4.44 mm).	If the O-ring groove width "F" is greater than the permitted serviceable limits, replace the blade seal.

(3) Measure the O-ring groove width "F" for uniform width variation.	The maximum permitted width variation of O-ring groove "F" is 0.015 inch (0.38 mm).	If the width variation of O-ring groove "F" is greater than the permitted serviceable limits, replace the blade seal.

(4) Measure the pre-load plate seal housing features "A", "B", "C1", "C2", "D", and "E".	The permitted limits are given in the table in Figure 1.	If any measurement is not within the permitted serviceable limits, replace the blade seal.

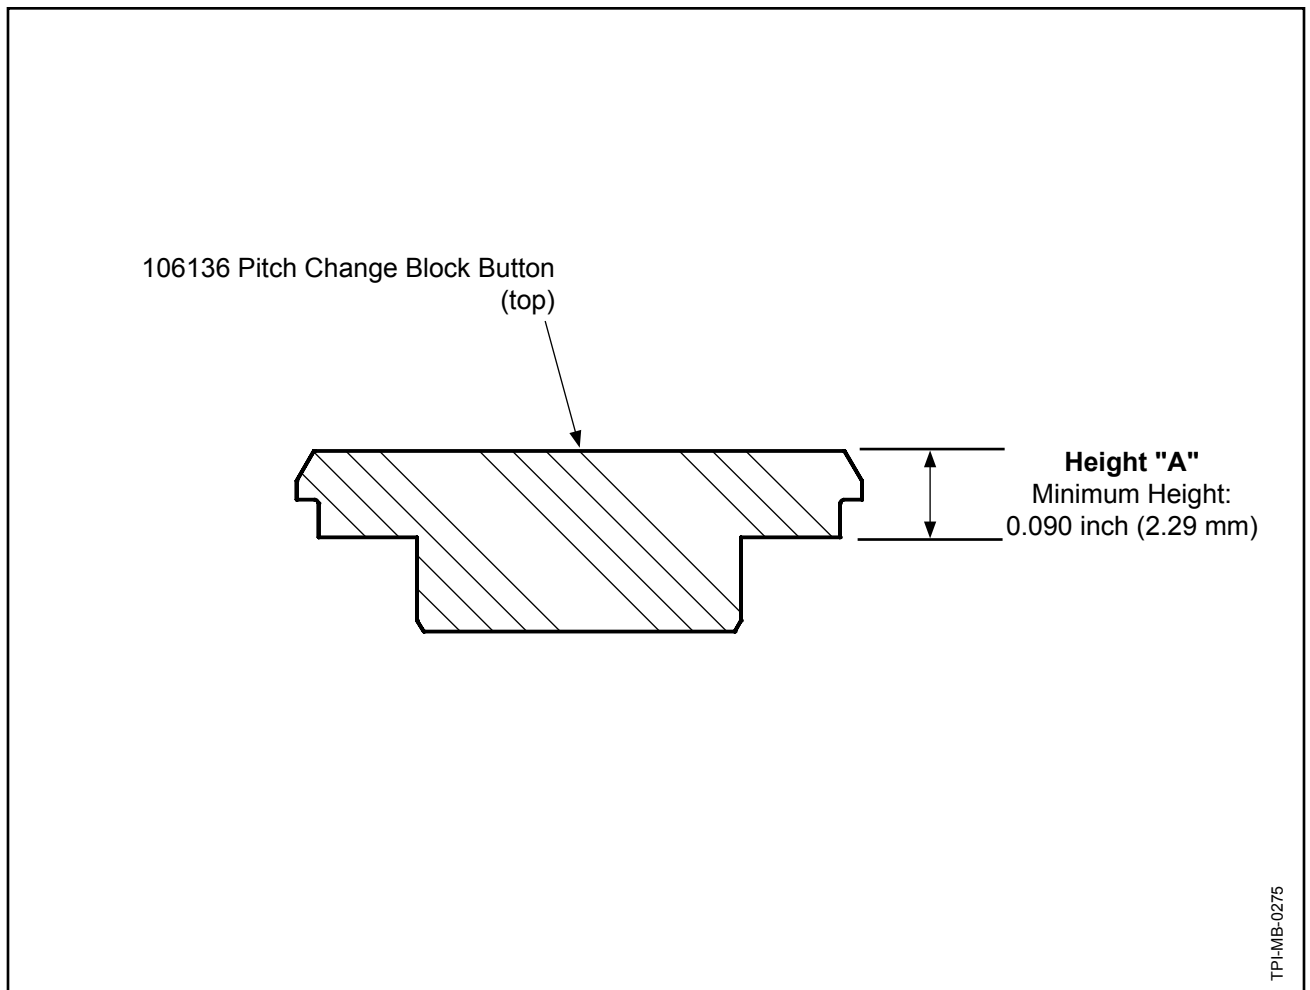
106136 Pitch Change Block Button Modification
Figure 2

- (2) Hartzell Propeller Inc. is introducing a redesigned 106136 pitch change block button that is thinner than the previous design. The thinner pitch change block button can improve the response rate of the propeller when going from high pitch to low pitch.
 - (a) The height "A" of the redesigned 106136 pitch change block button is 0.115 ±0.005 inch (2.92 ±0.12 mm). Refer to Figure 2.

- (1) To improve the response rate of the propeller when going from high pitch to low pitch, modify the 106136 pitch change block buttons in accordance with the following steps.
 - (a) Using an abrasive pad CM47, sandpaper, or equivalent, polish the top surface of the 106136 pitch change block button to reduce the height "A" of the button. Refer to Figure 2.
 - 1 The minimum permitted height "A" of the 106136 pitch change block button is 0.090 inch (2.29 mm).
