**HARTZELL PROPELLER INC.**  
**SERVICE BULLETIN**  
**TRANSMITTAL SHEET**  
**HC-SB-61-379**  
**Propeller - Counterweight Clamp Inspection**

November 28, 2017

**HARTZELL PROPELLER INC.**  
**SERVICE BULLETIN**  
**HC-SB-61-379**  
**Propeller - Counterweight Clamp Inspection**

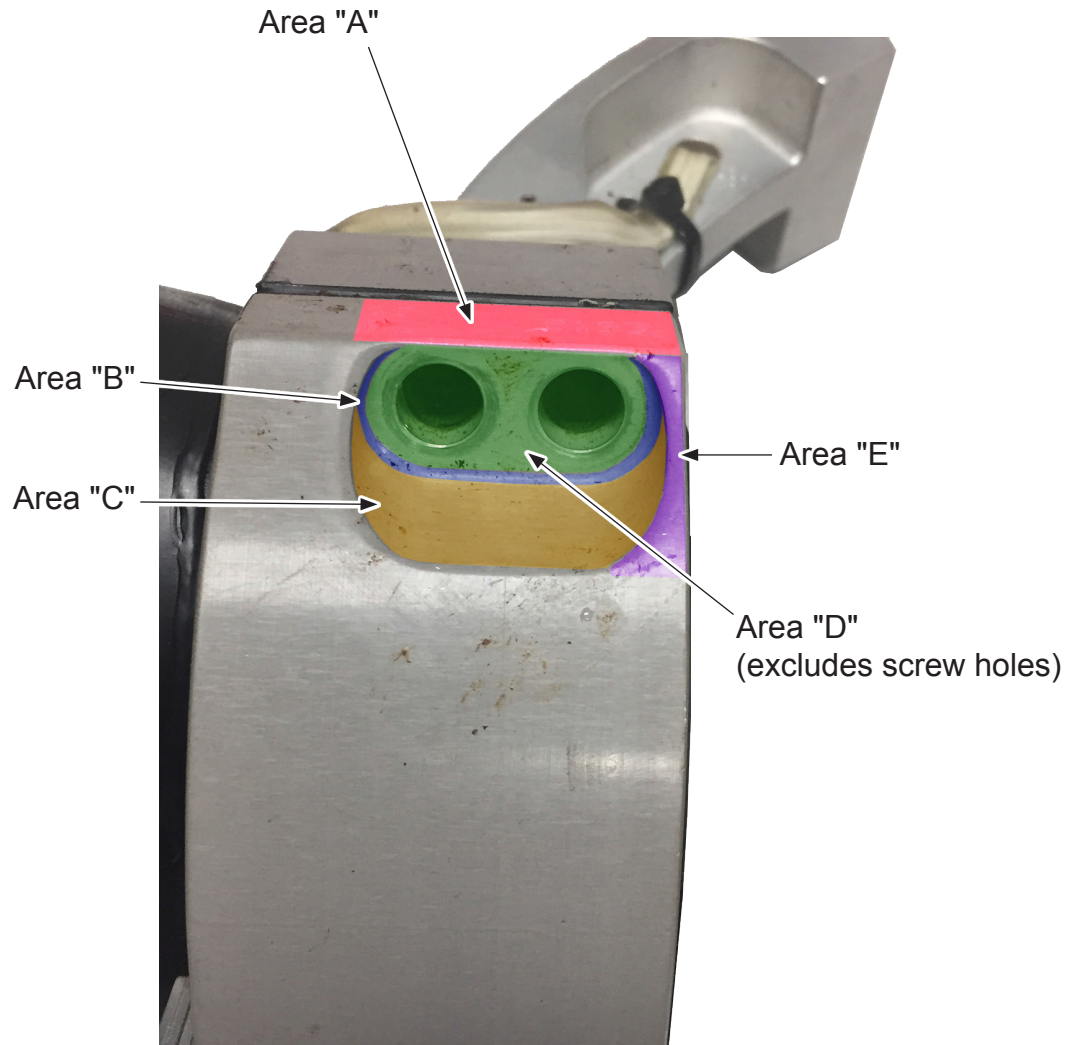
**Inspection Areas**  
**Figure 1**

- (a) Visually examine Areas A, B, C, D, and E of the counterweight clamps for cracks. Refer to Figure 1 for inspection areas and Figure 2 for an example of a cracked counterweight clamp.

- 1 Cracks have occurred in Area E on the counterweight clamp.
- 2 If a crack is found during the visual inspection, retire all five of the counterweight clamps in accordance with Hartzell Propeller Standard Practices Manual 202A (61-01-02).
  - a Replace all five of the counterweight clamps in accordance with the Accomplishment Instructions in this Service Bulletin before further flight.

- NOTE: Counterweight clamp/mounting hardware installation must be performed by a certified propeller repair station with the appropriate rating.
- (c) Visually examine Area C and Area E of the counterweight clamp (refer to Figure 1) for damage to the anodize coating that may have occurred during hardware installation.

- 1 If there is damage to the anodize coating, clean the damaged area using Stoddard solvent CM23 or equivalent, then apply Ardrox AV 30 to the damaged area in accordance with the manufacturer's instructions.

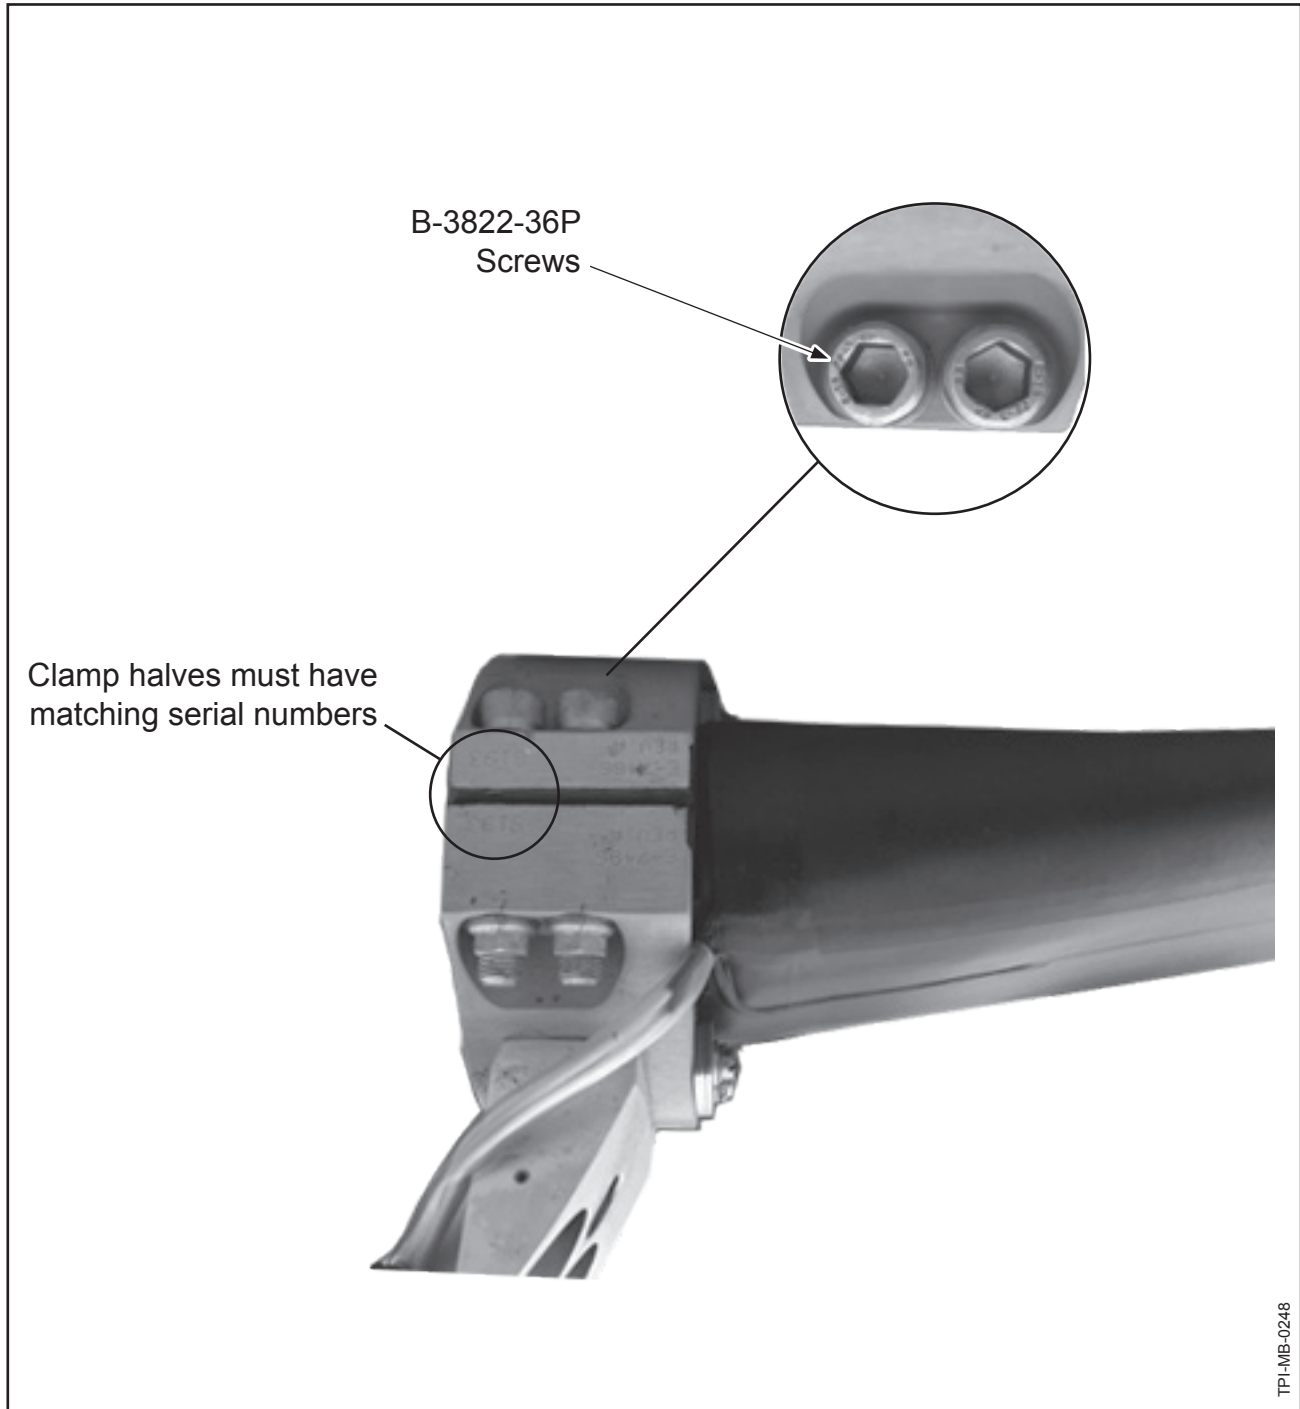
Counterweight Clamp/Screw Identification  
Figure 3

- (b) Visually examine the counterweight clamps and the associated hardware for the following:
- 1 Make sure that the counterweight clamps have matching serial numbers to indicate a matched set. Refer to Figure 3.

- 2 Check for loose or damaged counterweight clamp mounting hardware.
    - a Make sure that the correct counterweight clamp screws (B-3822-36P) are installed. Refer to Figure 3.

- a If required, install a new or serviceable counterweight clamp with matching serial numbers in accordance with the Accomplishment Instructions in this Service Bulletin before further flight.

- (1) Retire the counterweight clamp(s) with mismatched serial numbers in accordance with Hartzell Propeller Standard Practices Manual 202A (61-01-02).

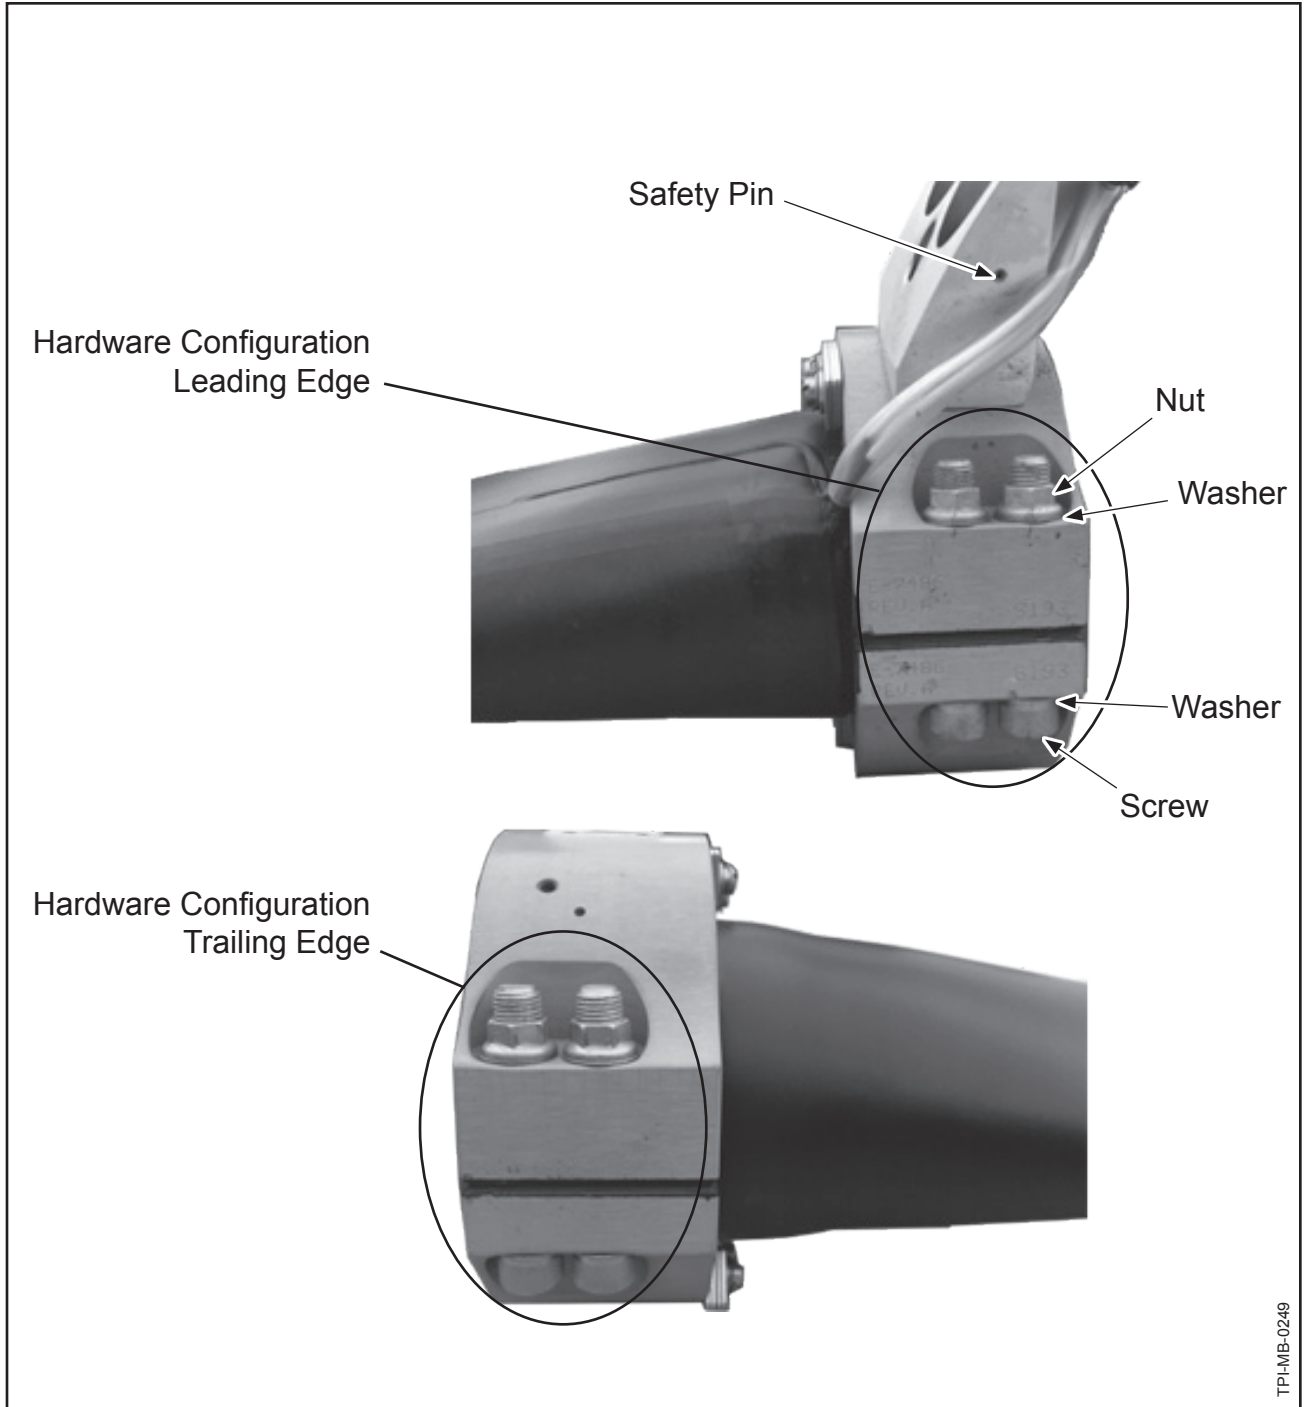
**Counterweight Clamp Hardware Configuration**  
**Figure 4**

- b Make sure that the counterweight clamp hardware is installed in the correct orientation. Refer to Figure 4.
    - c Make sure that the safety pins in the counterweight attachment bolts are installed. Refer to Figure 4.

- d Replace any missing, damaged, or incorrect mounting hardware in accordance with Hartzell Propeller Inc. Composite Propeller Blade Maintenance Manual 135F (61-13-35) before further flight. Refer to the Material Information section in this Service Bulletin for part number information.
