HARTZELL PROPELLER INC.
SERVICE BULLETIN
HC-SB-61-383
Propeller - 103559 Hub Shot Peening

- (1) Hartzell Propeller Inc. has revised the shot peening requirements for the 103559 hub unit used on the affected propellers.
 - (a) Hartzell now requires the surface of the hub flange radius and the bulkhead mounting area to be shot peened.
 - 1 Previously, Hartzell required masking material to be applied to the hub flange radius and bulkhead mounting area before shot peening.

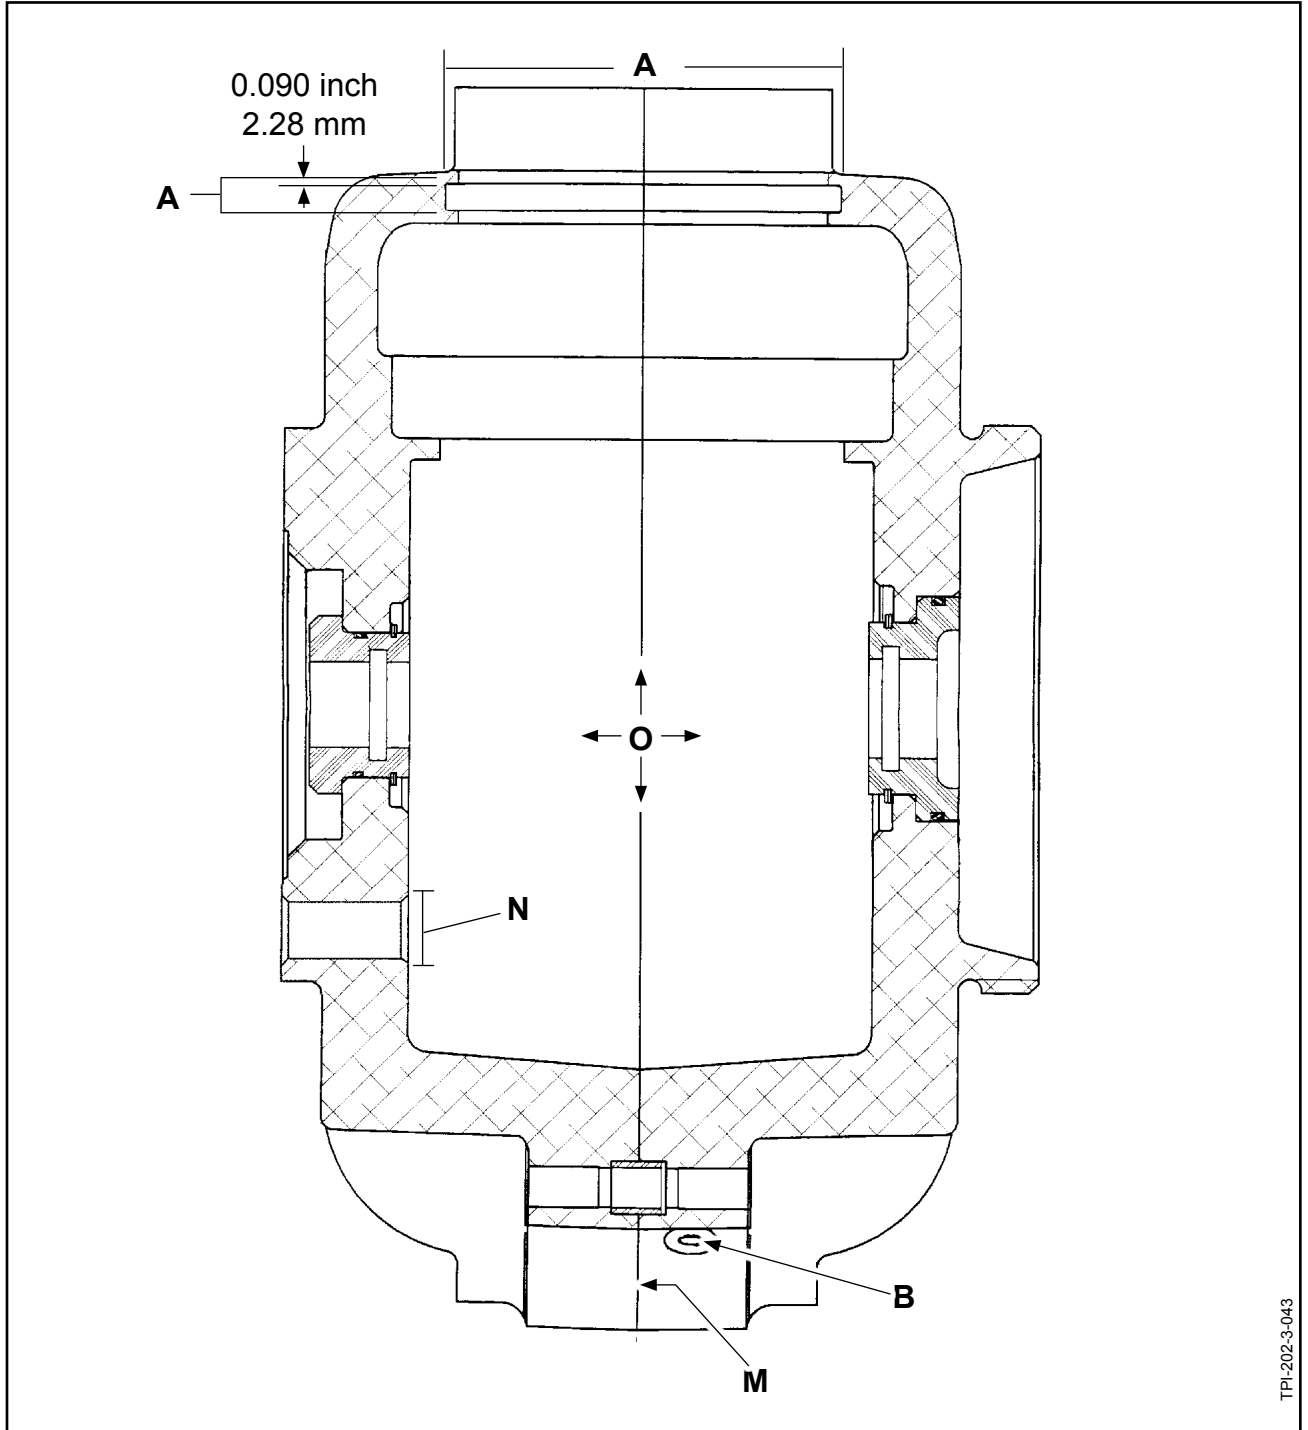
Shot Peen Masking for 103559 Lightweight Turbine Aluminum Hub
Figure 1

AREA	FIGURE	REQUIREMENT	SHOT PEEN
A	Figure 1	Do not shot peen within 0.090 inch (2.28 mm) of the blade O-ring seal groove on each hub socket.	X
B	Figure 1	Mask the threaded lubrication fitting holes for all shot peen operations. Incomplete coverage is acceptable around masked holes to 0.375 inch (9.52 mm) maximum wide area. There are four holes on each hub half.	X
C	Figure 2	Mask the bulkhead attachment threaded holes for all shot peen and paint operations. Incomplete coverage for shot peen is acceptable around masked holes to 0.090 inch (2.28 mm) maximum wide area. There are eight holes on engine-side hub half.	X
D	Figure 2	Mask the hub clamping bolt through holes for all shot peen operations. Incomplete coverage is acceptable around masked holes to 0.090 inch (2.28 mm) maximum wide area. There are 20 holes on each hub half.	X
E	Figure 2	Mask the threaded balance weight holes for all shot peen operations. Incomplete coverage is acceptable around masked holes to 0.375 inch (9.52 mm) maximum wide area. There are eight threaded holes on each hub half.	X

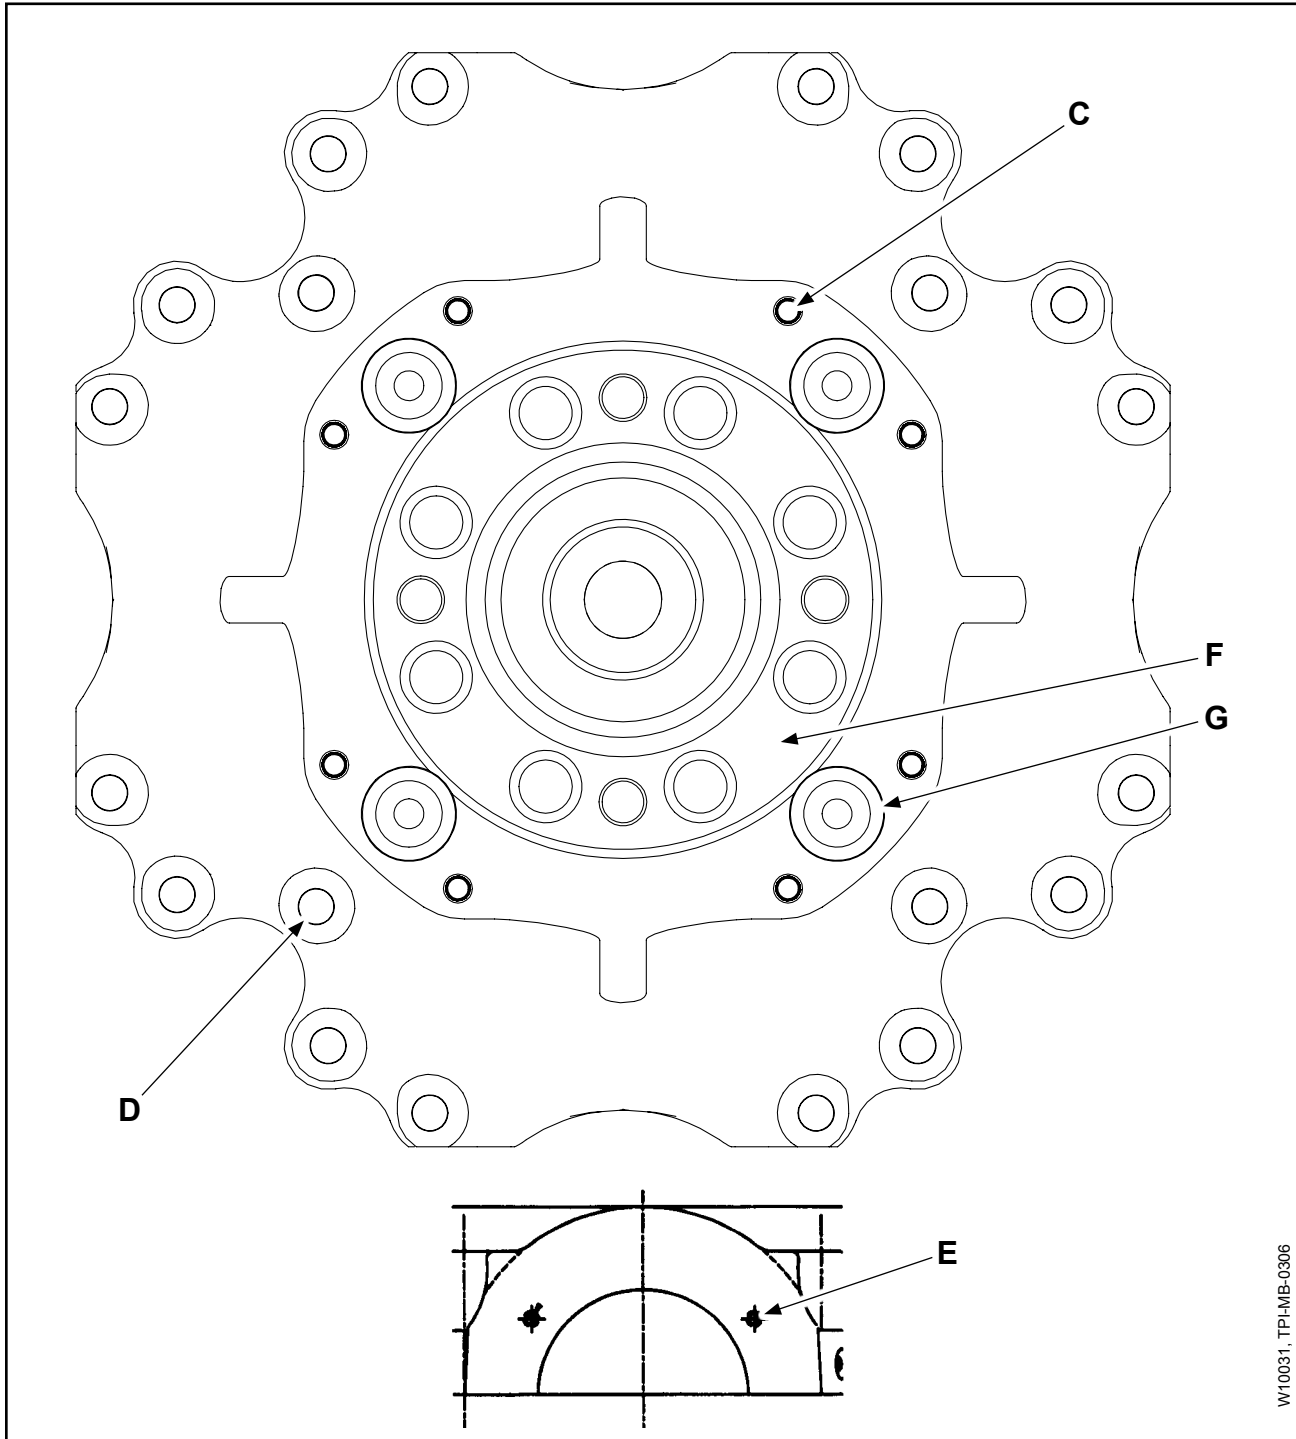
Shot Peen Masking for 103559 Lightweight Turbine Aluminum Hub
Figure 2

F	Figure 2	Mask the engine flange mating surface on the engine-side hub half for all shot peen and paint operations.	X
G	Figure 2	Mask the spring retainer 1.00 inch (25.4 mm) diameter to 0.325 ±0.025 inch (8.25 ±0.635 mm) height. Deburr edges after shot peening. There are four beta spring retainer holes on the engine-side hub half.	X
H	-	not applicable for shot peening	-
I	-	not applicable for shot peening	-
J	Figure 3	Mask the cylinder-side hub half from the centerline of the hub out to include the flat part of the hub for all shot peen operations.	X
K	-	not applicable for shot peening	-
L	-	not applicable for shot peening	-
M	Figure 1	Mask the hub parting surface for all shot peen and paint operations.	X
N	Figure 1	For the 103359 hub only, mask the 8 mounting bolt through holes that intersect with the inside surface.	--
O	Figure 1	Except for the hub bearing blade pockets, the inside surfaces are not shot peened. Masking for shot peening is specified in Figure 4 and Figure 5.	X

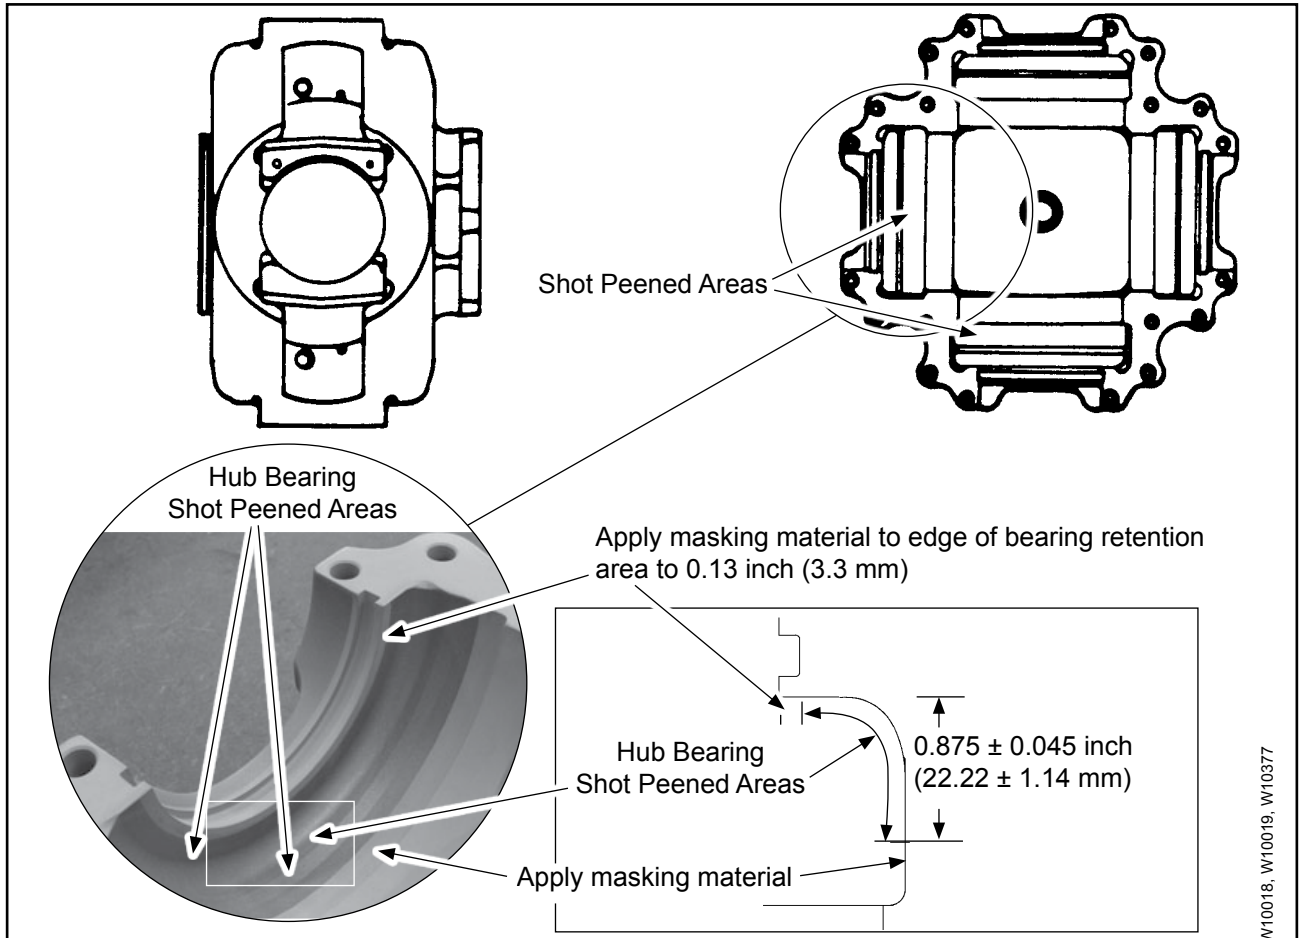
Shot Peening of 4 Blade Lightweight Turbine Aluminum Hubs
Figure 4

Shot peen the inside hub bearing area only, as shown in the figure above. Shot peen the entire outside of the hub, **EXCEPT: DO NOT** shot peen the flange face, O-ring grooves, bolt through holes, or any threaded areas. For additional masking requirements, refer to Table 1 in this Service Bulletin.

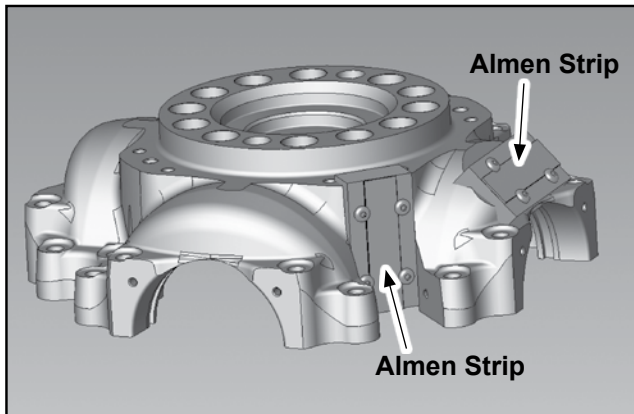
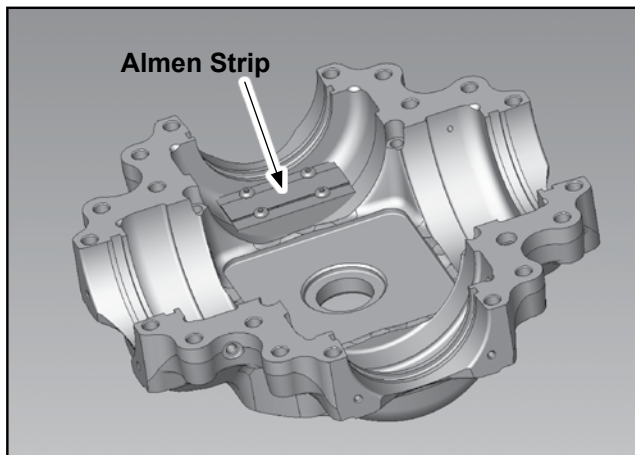
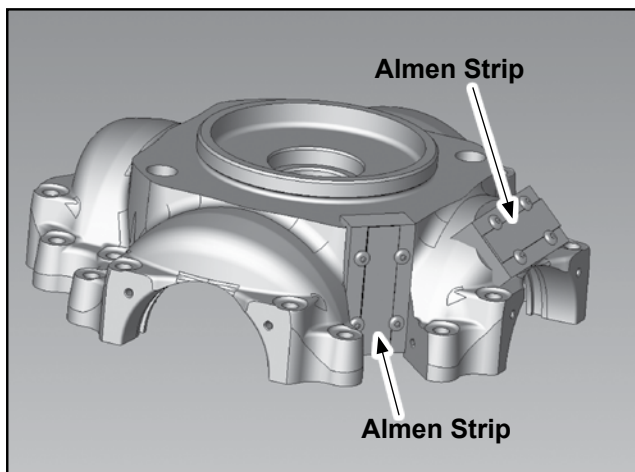
Almen Strip Locations for a 4 Blade Lightweight Turbine Aluminum Hubs
Figure 5

4 Blade Aluminum Hub, Flange Half

4 Blade Aluminum Hub, Internal
This location applies to each hub half.

4 Blade Aluminum Hub, Cylinder Half
There are a total of six Almen strip locations for the 4 blade aluminum hub.
