HARTZELL PROPELLER INC.

SERVICE BULLETIN

HC-SB-61-393

Propeller Mounting Nut/Torque Inspection

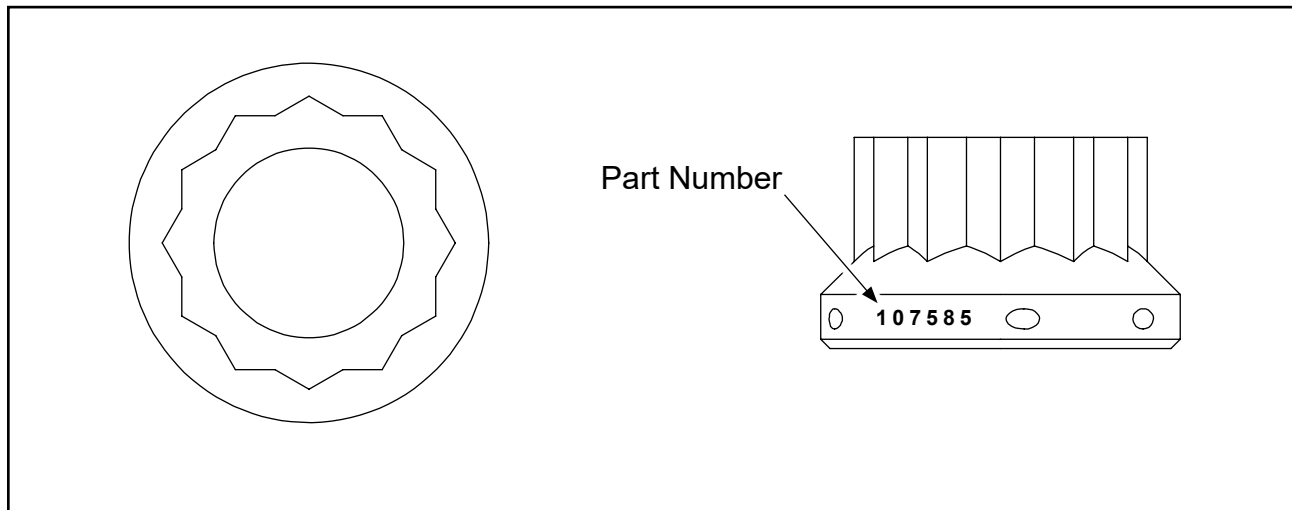
107585 Mounting Nut Identification
Figure 1

- 1 The mounting nut used on the affected propellers is p/n 107585.

NOTE: All of the affected propellers were packaged and shipped from Hartzell with the 107585 mounting nuts. The part number is stamped on the 107585 mounting nuts as shown in Figure 1 of this Service Bulletin.

- (b) If the breakaway torque on all eight of the mounting nuts is equal to or greater than 90 Ft-Lbs:
- 1 Completely loosen all eight mounting nuts.
 - a Check the part number of all eight mounting nuts. The affected propellers must use 107585 mounting nuts. Refer to Figure 1 in this Service Bulletin for part number location.
 - 2 Re-torque the mounting nuts in three steps. Use the torque specifications and sequence shown in Figure 3 of this Service Bulletin.
 - 3 Safety all eight mounting nuts with 0.032 inch (0.81 mm) minimum diameter stainless steel wire or equivalent aircraft safety cable. (Two nuts per safety).
