HARTZELL PROPELLER LLC

SERVICE INSTRUCTION

HC-SI-61-195

Hub Pilot Bore Inspection

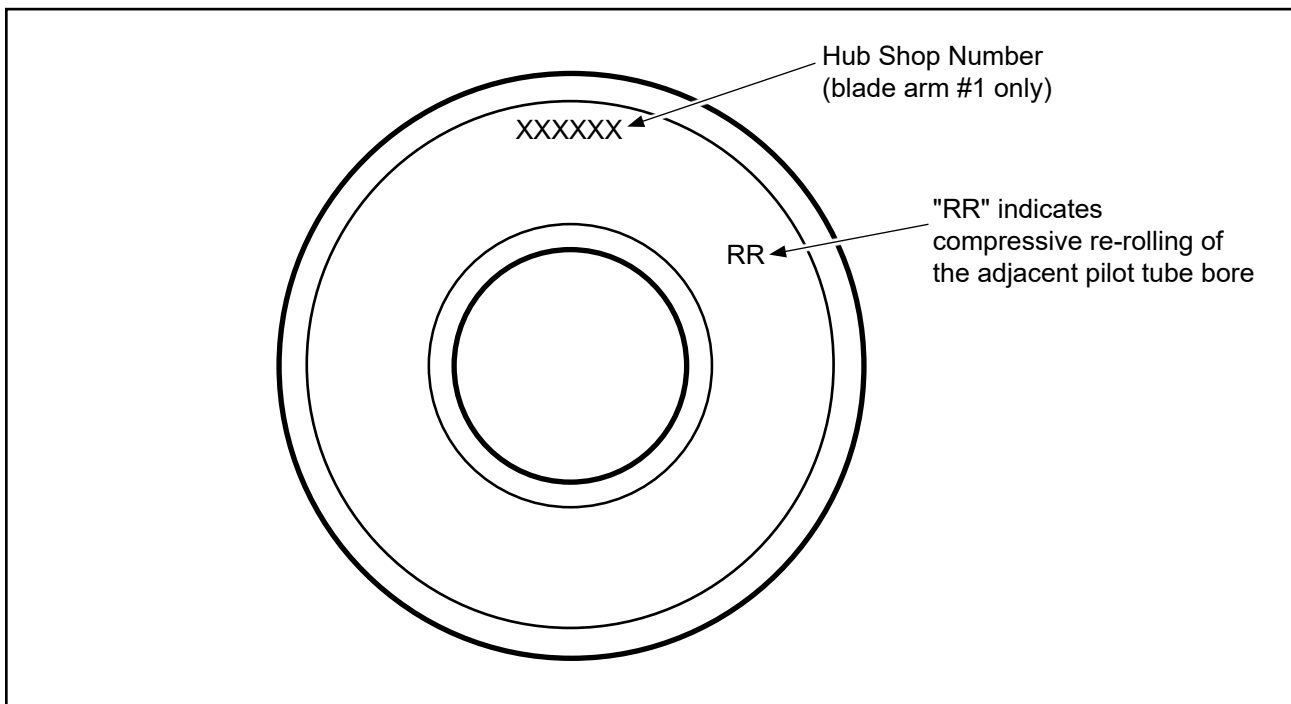
Hub Stamping Location
Figure 1

- (e) If the hub arem adjacent to the pilot tube bore has not been marked "RR" (see Figure 1), the bore diameter may not exceed 1.73005 inch (43.954 mm) for more than a total of 25% of the bore surface. If repair in excess of 1.7305 inch (43.954 mm) is required, return the hub to Hartzell Propeller for repair and compressive re-rolling of the hub pilot tube bore.

- 1 Any hub pilot tube bore that has been re-rolled will be marked "RR" adjacent to the pilot tube bore and returned to service. See Figure 1.
- (8) Perform magnetic particle inspection of the entire internal bore of the hub blade arms. Pay particular attention to the area in the bore from 0.2 to 1.5 inches (5.1 to 38.1 mm) from the bottom of the blade arm bore (the area near the end of the pilot tube, when installed). Perform magnetic particle inspection in accordance with the Magnetic Particle Inspection chapter of Hartell Propeller Standard Practices Manual 202A (61-01-02).

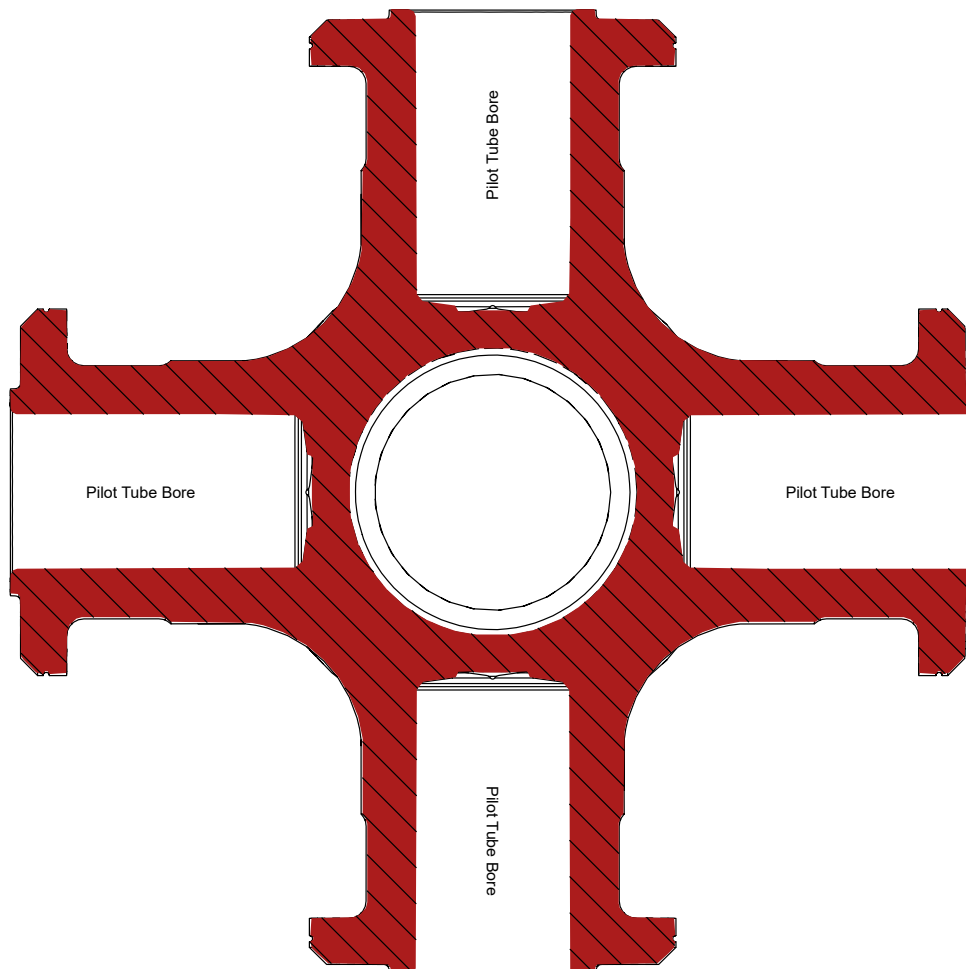
Pilot Tube Bore Indications
Figure 2

- (10) Retire any hub showing evidence of cracks or other unacceptable indications (i.e. non-repairable gouges, corrosion, etc.). Notify Hartzell Product Support and the FAA upon retirement of any hub that has compressive rolled internal bearing bores (identified with the addition of a third letter "A" in the hub serial number prefix, example: CDA1234). Use Figure 2 to indicate location of cracks or other unacceptable indications.

Indicate the location of cracks or other unacceptable indications on the figure below.
Include the following information:
