HARTZELL PROPELLER INC.
SERVICE LETTER
TRANSMITTAL SHEET
HC-SL-61-241
Propeller - New Blade Seal

February 2, 2015

Revision 3 is issued to change the following in the Service Letter:

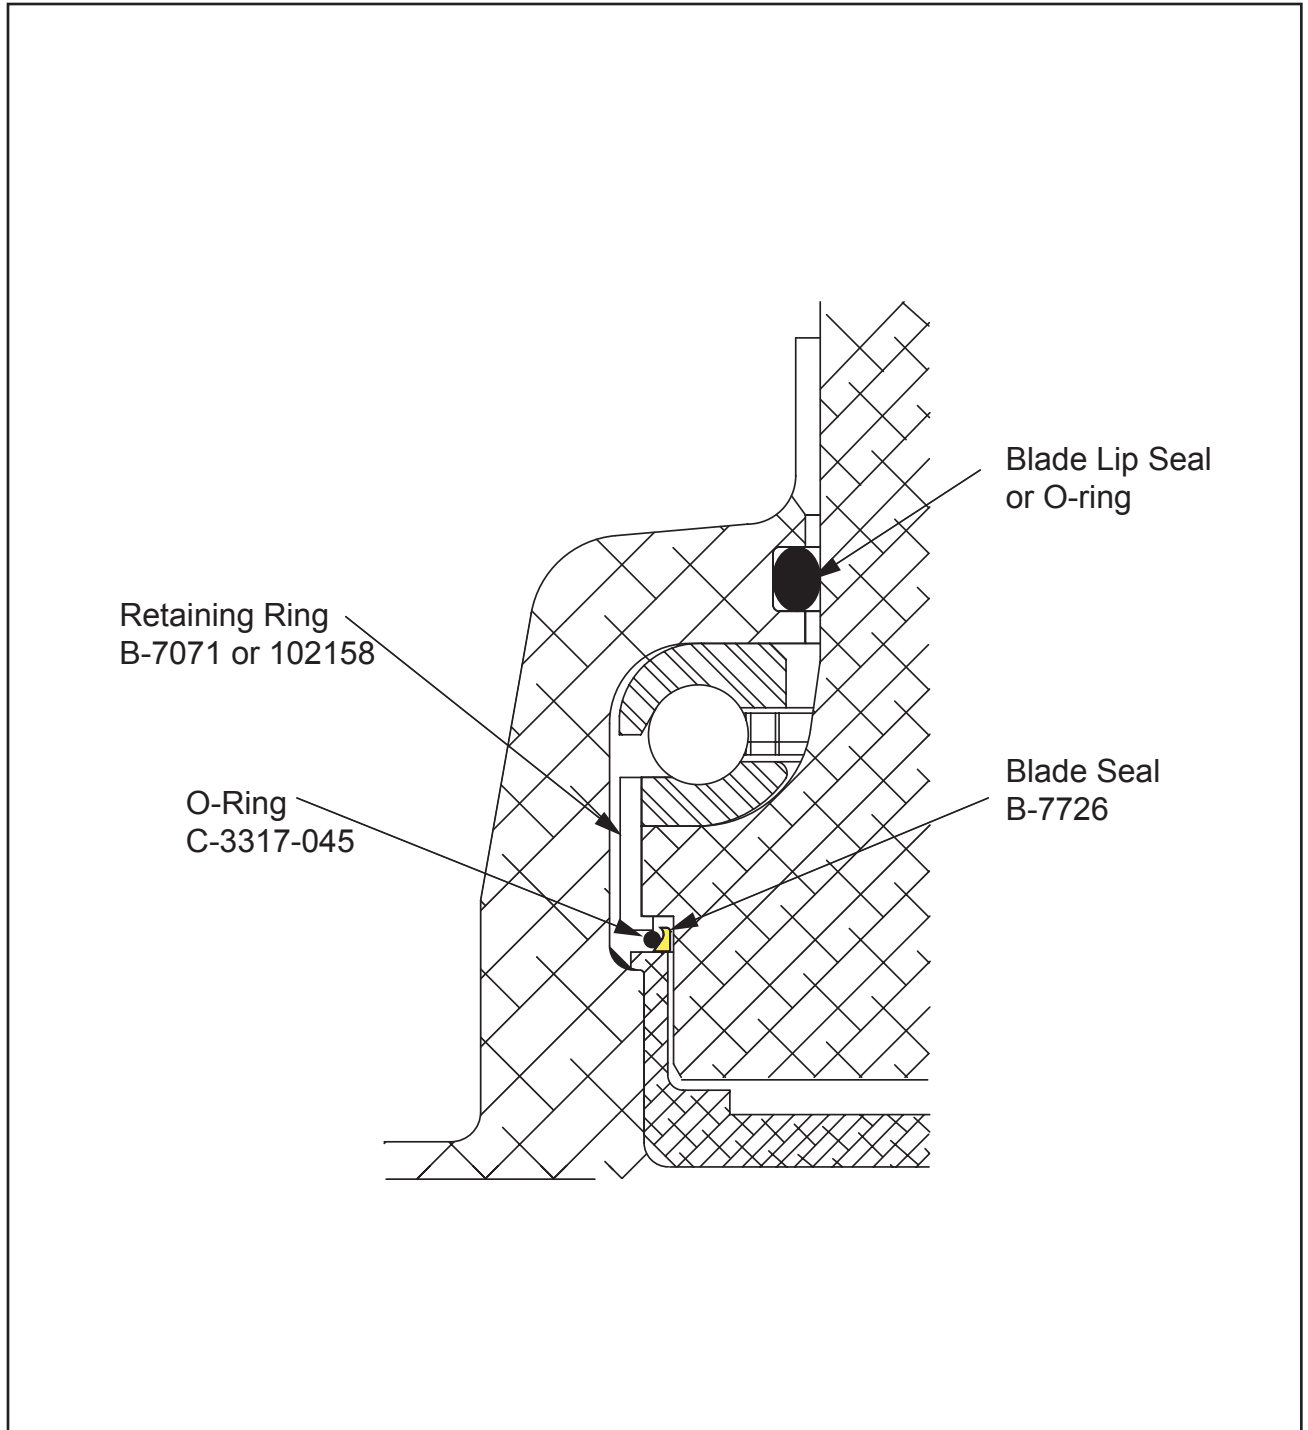
O-ring and Blade Seal Installation
Figure 1

- (1) The current propeller designs have a slip fit between the preload plate and the blade butt.
 - (a) If not properly serviced, this small gap may permit grease to enter the central hub cavity during the periodic lubrication of the blade retention area.
 - (b) Migration of the grease from the blade retention area to the hub central cavity can potentially cause grease leaks or vibration.
- (2) Hartzell Propeller Inc. has designed an internal blade butt seal that restricts migration of grease into the hub cavity. See Figure 1.

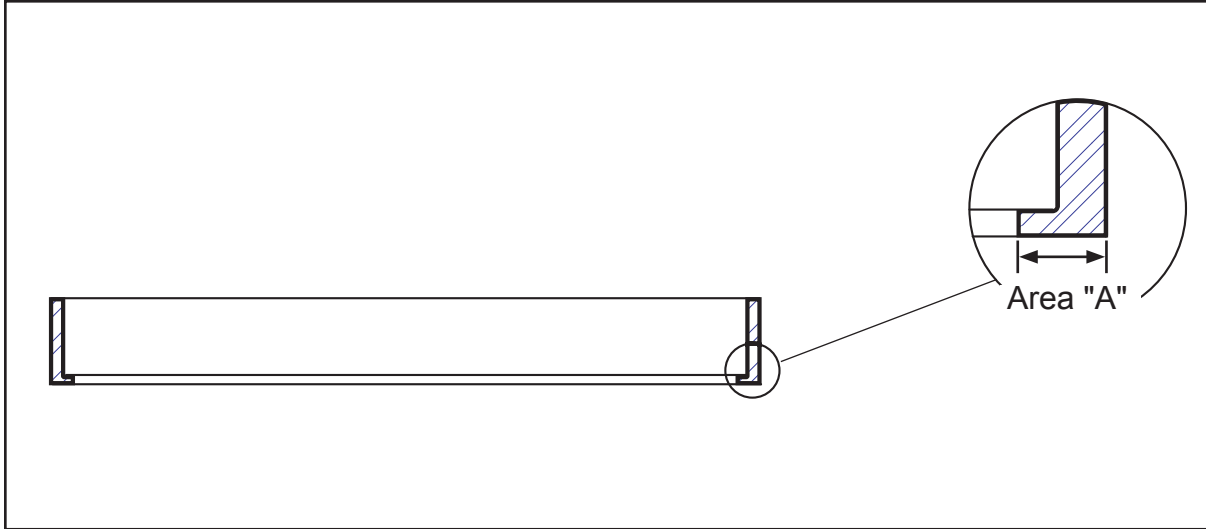
**Blade Retaining Ring Inspection
Figure 4**

<u>Inspect</u>	<u>Serviceable Limits</u>	<u>Corrective Action</u>
(a) Except for Area "A", visually examine the bearing retaining ring for corrosion and pitting. Refer to Figure 4.	Corrosion is not permitted. The maximum permitted depth of pitting is 0.005 inch (0.12 mm). Pitting must not interfere with the ability of the bearing retaining ring to fit tightly to the blade and the bearing race.	If there is corrosion, remove the corrosion using glass bead cleaning. Refer to the Cleaning chapter of Hartzell Propeller Inc. Standard Practices Manual 202A (61-01-02). If the corrosion or pitting is greater than the permitted serviceable limits, replace the bearing retaining ring.

(b) Visually examine the bearing retaining ring for corrosion, pitting, or wear in Area "A". Refer to Figure 4.	Corrosion, pitting, damage, or wear is not permitted.	If there is corrosion, pitting, or wear, replace the bearing retaining ring.

(c) Except for Area "A", visually examine the bearing retaining ring for wear, damage, or fretting. Refer to Figure 4.	The bearing retaining ring must fit tightly to the blade and the bearing race when installed over the blade and the bearing race.	If the wear, damage, or fretting is more than the permitted serviceable limits, replace the bearing retaining ring.

- (a) Installation of the B-7726 blade seal and the C-3317-045 O-ring is optional.
 - (b) When the B-7071 bearing retaining ring is used without the blade seal and O-ring, propeller assemblies may contain both the B-7071 and B-1041 bearing retaining rings.
- (4) Inventory of the B-1041 bearing retaining ring may be used until depleted.
 - (5) For identification purposes only, the dimension of Area "A" on the B-7071 is 0.153 inch (3.88 mm). The dimension of Area "A" on the B-1041 is 0.180 inch (4.57 mm). Refer to Figure 4.
 - (6) For identification purposes only, the dimension of Area "A" on the 102158 is 0.153 inch (3.88 mm). The dimension of Area "A" on the A-2204 is 0.180 inch (4.57 mm). Refer to Figure 4.

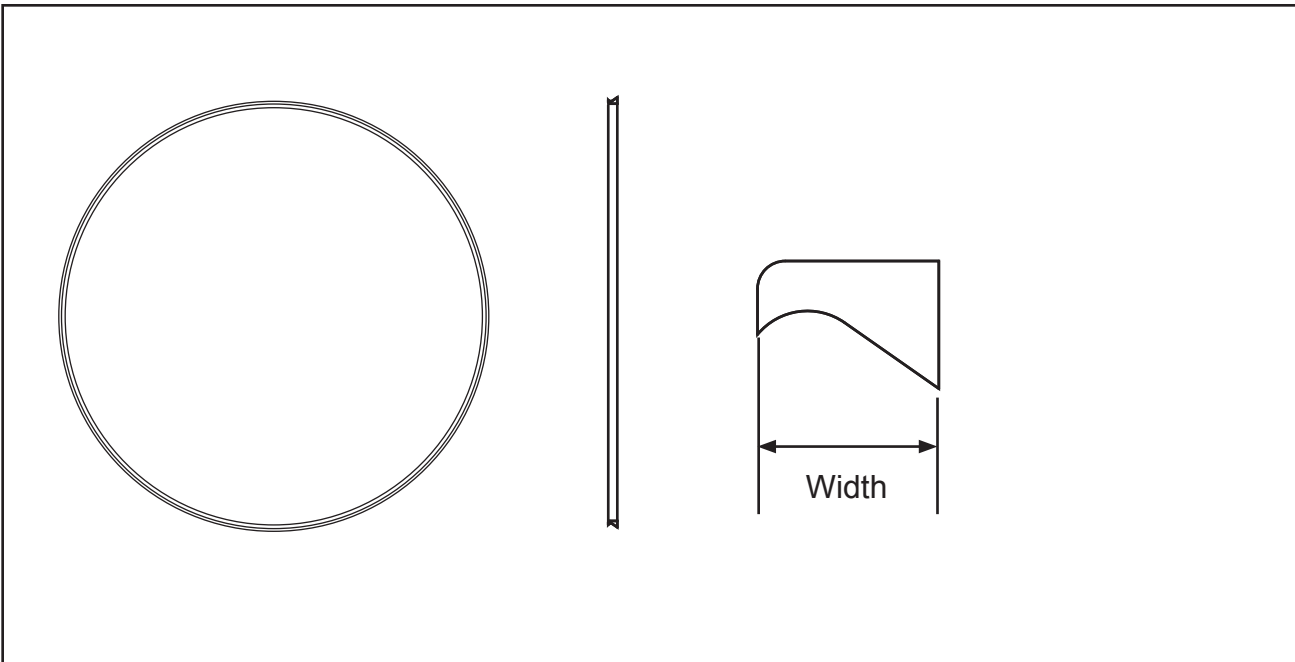
**B-7726 Blade Seal Width
Figure 5**

<u>Inspect</u>	<u>Serviceable Limits</u>	<u>Corrective Action</u>
(a) Using 10X magnification and an appropriate light source, visually examine the blade seal for damage, missing material, separation, or form irregularities of the continuous ring.	Damage, missing material, separation, or significant form irregularities are not permitted.	If the damage or other conditions are more than the permitted serviceable limits, replace the blade seal.
(b) Visually examine the width of the blade seal for wear. If there is wear, measure the width of the blade seal. Refer to Figure 5.	The minimum permitted width is 0.090 inches (2.29 mm).	If the width is less than the permitted serviceable limits, replace the blade seal.
