HARTZELL PROPELLER INC.
SERVICE LETTER
TRANSMITTAL SHEET
HC-SL-61-360

**Blade - Damage Evaluation for NC10245() Blades
Installed on (but not limited to) Pilatus PC-12 Aircraft**

August 01, 2018

HARTZELL PROPELLER INC.
SERVICE LETTER
HC-SL-61-360

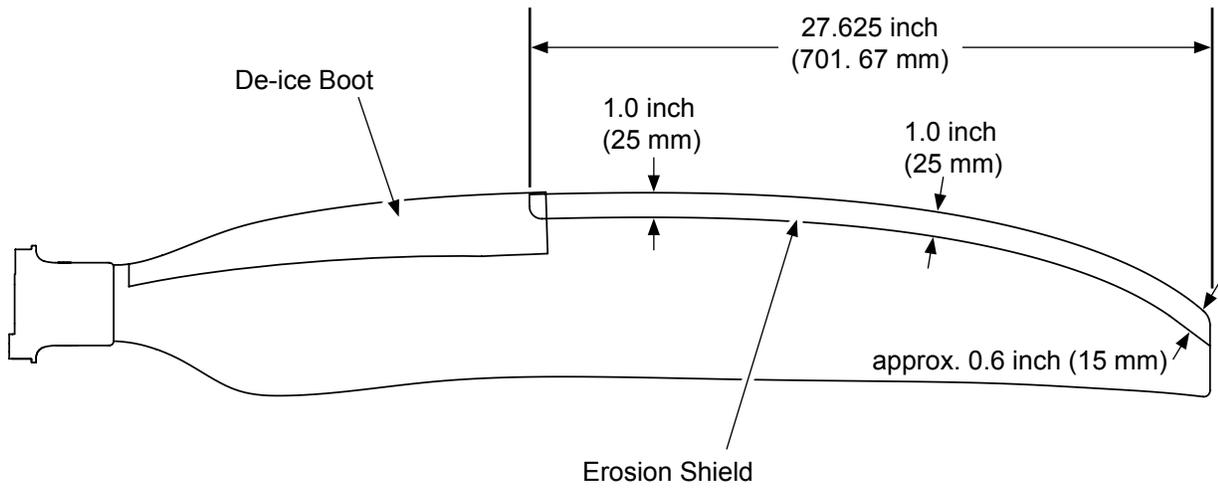
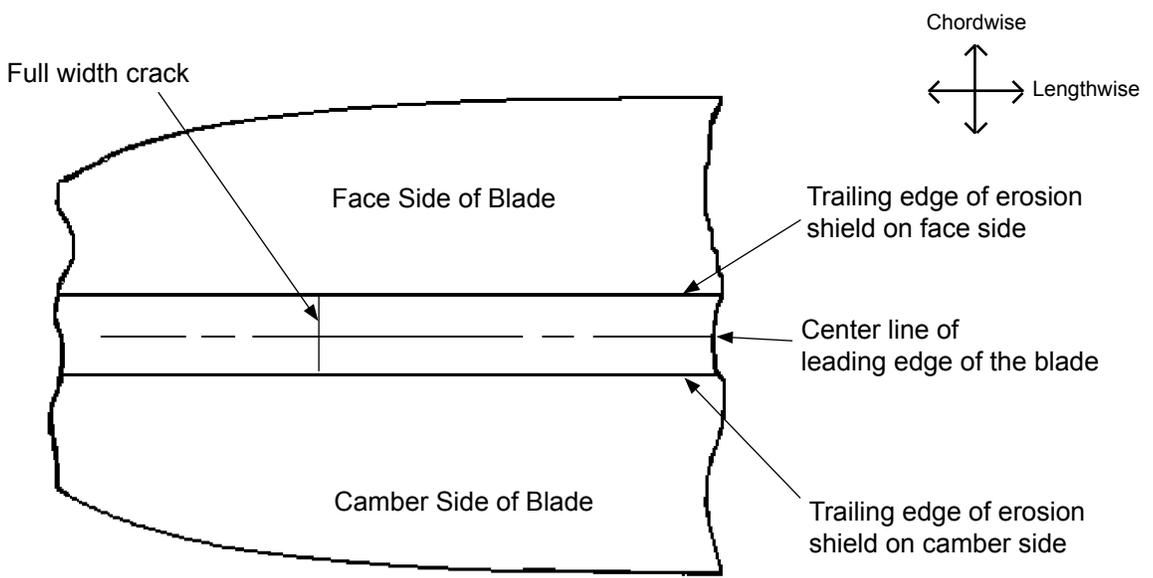
Interpretation of Erosion Shield Damage
Figure 1

When calculating the area of damage and the proximity to other damage, look at the erosion shield as a two dimensional shape, as if it were unfolded and spread flat where the face and camber sides of the blade could be viewed at the same time.

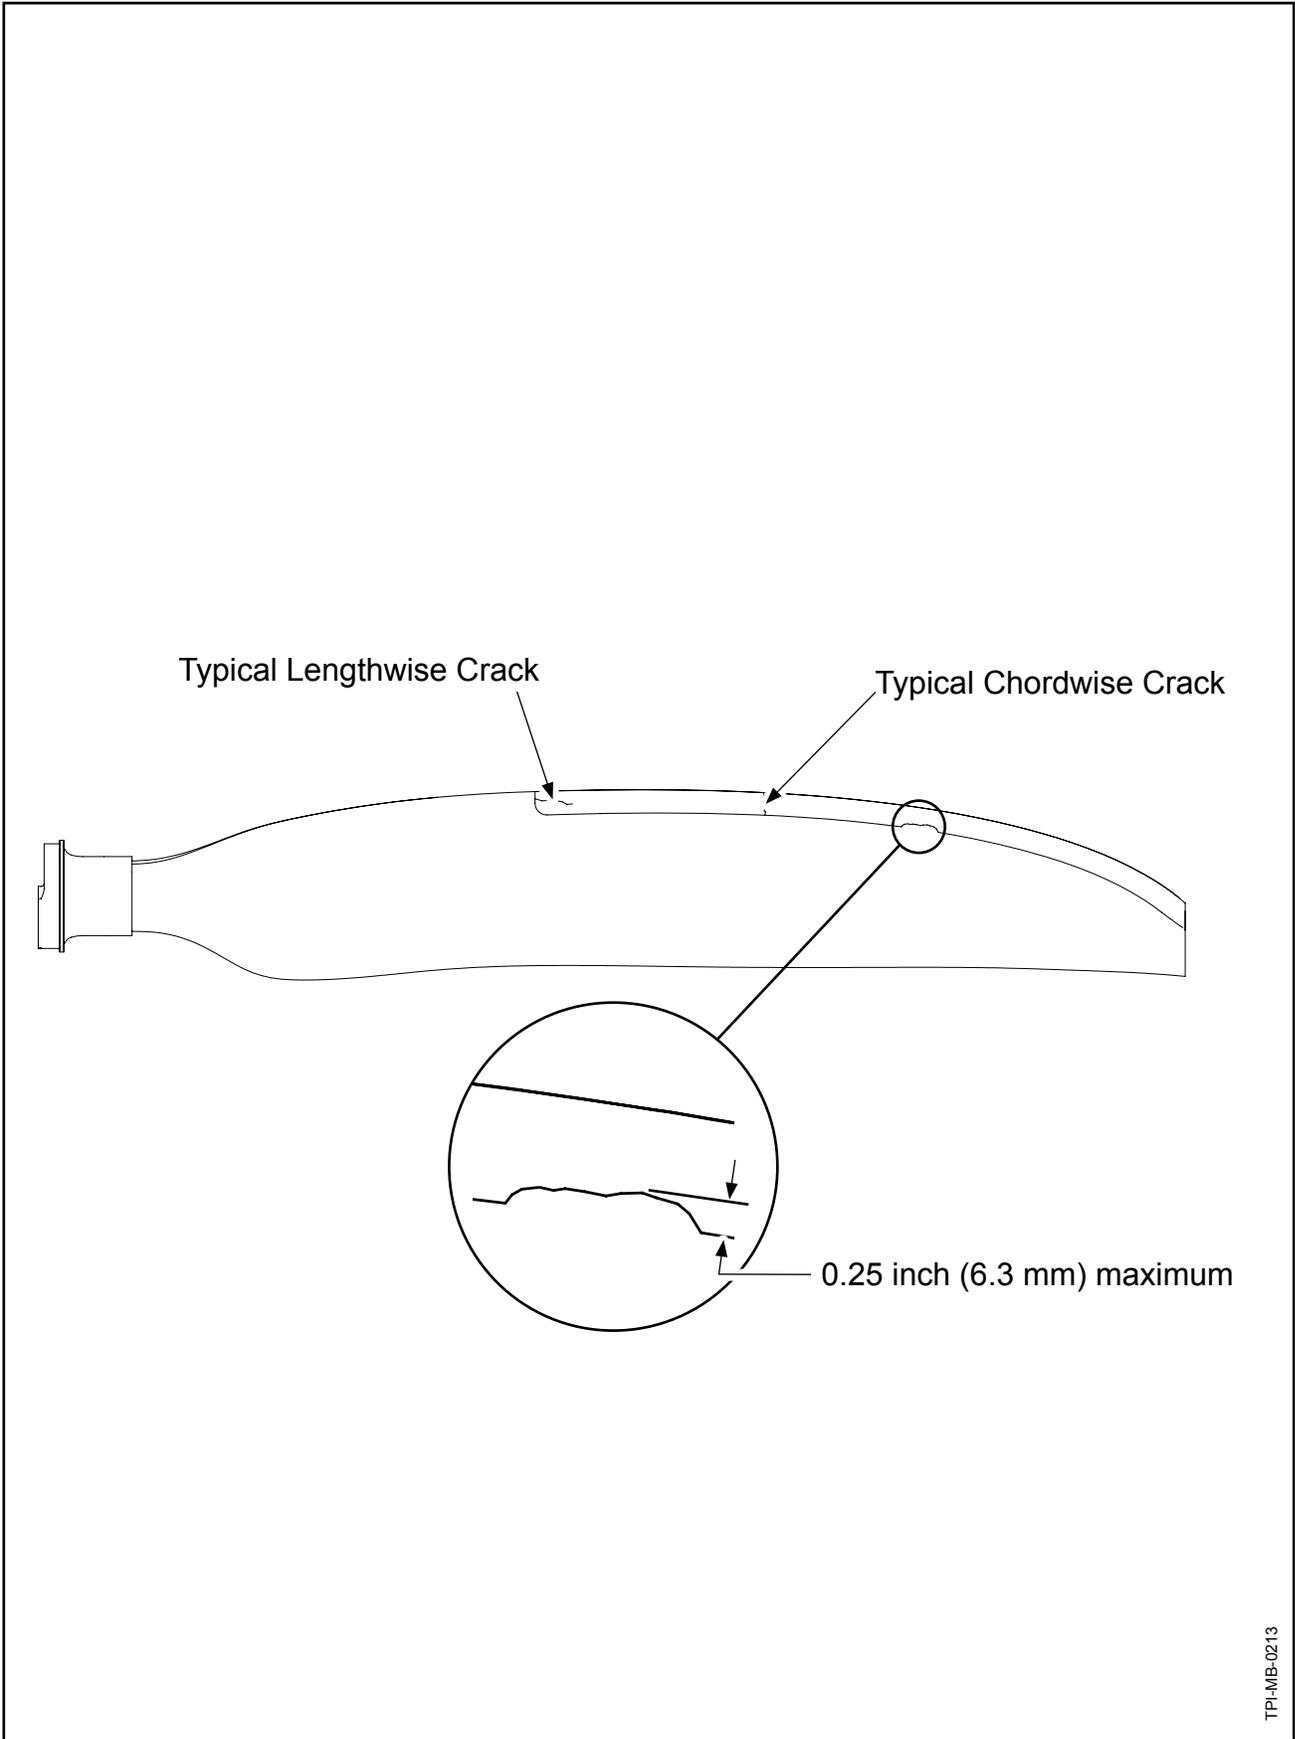
Missing Portions of Nickel Erosion Shield (Trail Side) and Typical Cracks
Figure 2

3. Nickel Erosion Shield - Area Missing Along the Trailing Edge of the Erosion Shield - For the Entire Erosion Shield	Pieces of material from the trailing edge of the erosion shield may be missing because of erosion or sanding performed during the erosion shield installation procedure. The missing area must be no farther than 0.25 inch (6.3 mm) from the trailing edge of the erosion shield. Refer to Figure 2 for an example of permitted missing material. Damage cannot be permanently repaired without replacement of the erosion shield, but within these limits, does not make the blade unairworthy. (Refer to Figure 1 and Figure 2)

5. Nickel Erosion Shield - Chordwise Crack - For All Areas that are NOT Covered by an External De-ice or Anti-icing Boot	Two full width, chordwise cracks may not be within 6.0 inches (153 mm) of each other. A full width, chordwise crack may not be within 6.0 inches (153 mm) of the blade tip. A full width, chordwise crack may not be within 1.0 inch (25 mm) of the outboard end of the de-ice or anti-icing boot. A full width chordwise crack may not be within 6.0 inches (153 mm) of the inboard end of the erosion shield. For a full width, chordwise crack that is in an area from 1.0 inch (25 mm) to 6.0 inches (153 mm) outboard of the end of the de-ice or anti-icing boot, the maximum permitted area of debond is 20% and the area of debond must not extend under the de-ice or anti-icing boot. (Refer to Figure 1 and Figure 2)

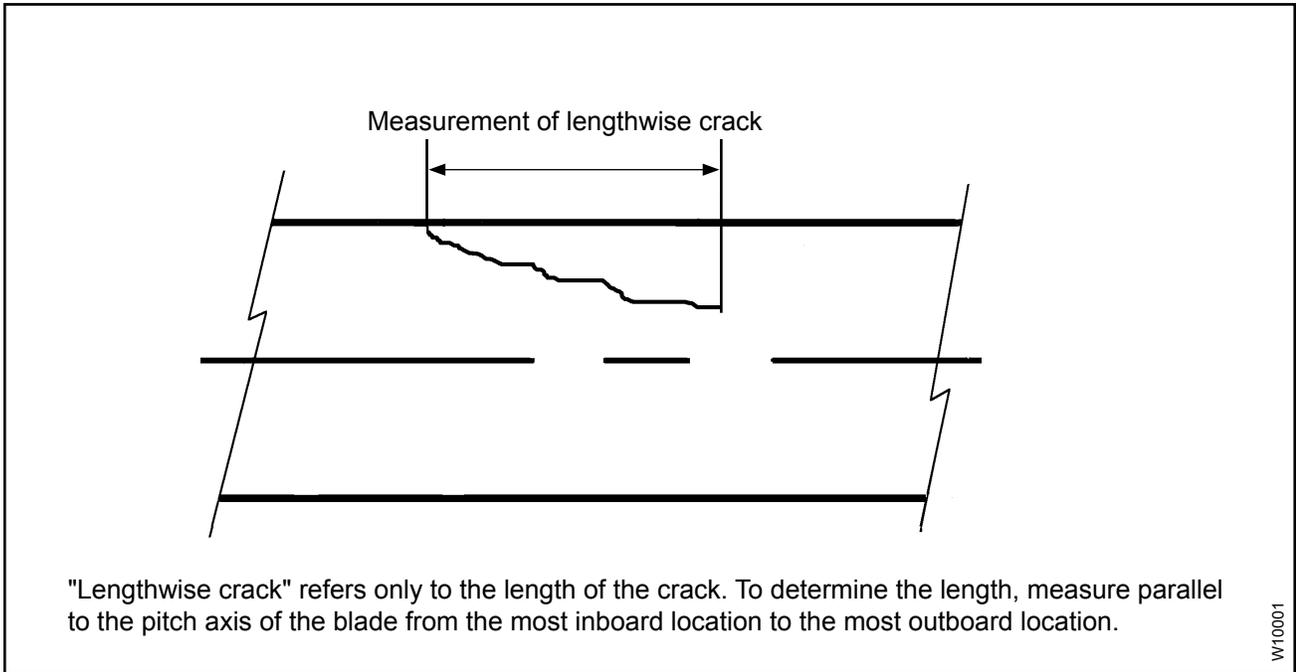
**Measuring Lengthwise Crack
Figure 3**

6. Nickel Erosion Shield - Lengthwise Cracks - For All Areas that are NOT Covered by an External De-ice or Anti-icing boot	The maximum permitted length of a crack is 2.0 inches (50 mm). Two lengthwise cracks may not be within the same linear length on the erosion shield. This includes cracks on opposite sides of the blade. Refer to Figure 4 for an example of a violation of this limit. (Refer to Figure 1, Figure 3, and Figure 4)

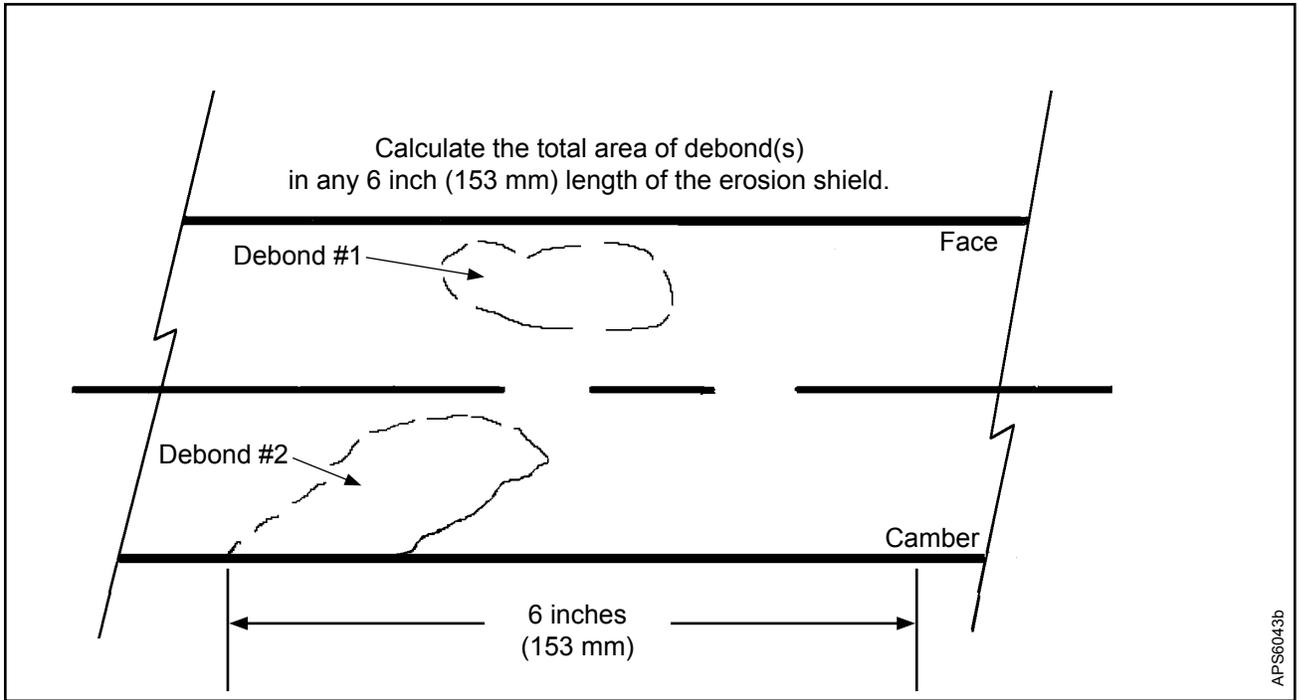
Erosion Shield Debonds
Figure 5

4. Nickel Erosion Shield - Debond - For All Areas that are NOT Covered by an External De-ice or Anti-icing Boot	A maximum of 20% of the erosion shield may be debonded in any 6 inch (153 mm) length of the erosion shield. (Refer to Figure 1 and Figure 5)

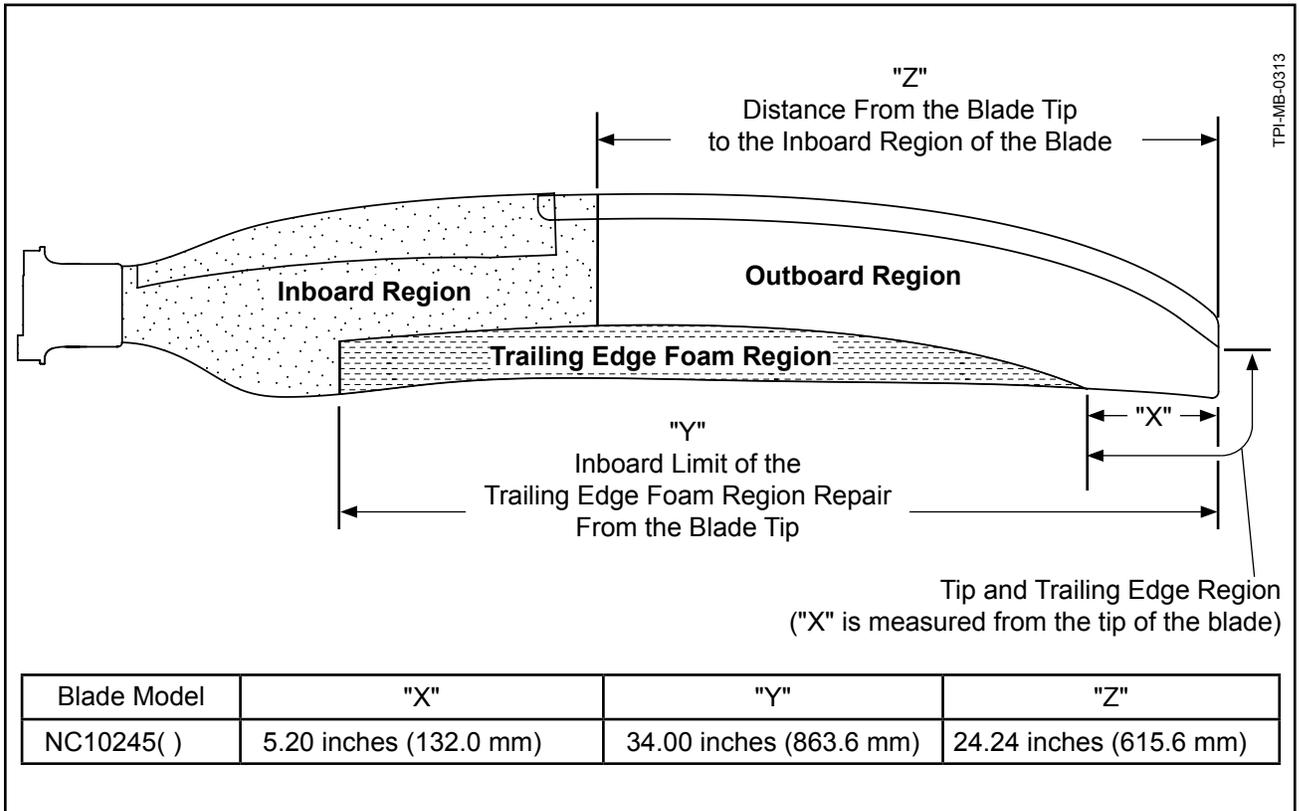
Repair Regions - NC10245() Blades
Figure 6

21. Gouge or Loss of Composite Material - Outboard Region of the Blade	The maximum permitted diameter or equivalent area (0.20 sq. inch or 129 sq. mm) of a gouge or loss of material is 0.500 inch (12.70 mm). The maximum permitted length of a gouge or loss of material is 2.5 inches (63 mm). The maximum permitted depth of a gouge or loss of material is 0.020 inch (0.50 mm). (Refer to Figure 6)

22. Gouge or Loss of Composite Material - Trailing Edge Foam and Leading Edge Foam Regions of the Blade	The maximum permitted diameter or equivalent area of a gouge or loss of composite material is 0.500 inch (12.70 mm). The maximum permitted length is 2.5 inch (63 mm). The maximum permitted depth is 0.020 inch (0.50 mm). Exposed foam or a delamination is not permitted. (Refer to Figure 6)

23. Gouge or Loss of Composite Material - Inboard Region of the Blade	A gouge or loss of composite material on the inboard region of the blade is unairworthy. (Refer to Figure 6)

24. Delamination - Outboard Region of the Blade	The maximum permitted area of delamination is 2.0 sq. inches (1290 sq. mm). (Refer to Figure 6)
26. Delamination - Trailing Edge Foam and Leading Edge Foam Regions of the Blade	The maximum permitted area of delamination is 2.0 sq. inch (1290 sq.mm). (Refer to Figure 6)

27. Delamination - Inboard Region of the Blade	A delamination on the inboard region of the blade is unairworthy. (Refer to Figure 6)

DAMAGE TYPE	AIRWORTHY DAMAGE LIMITS
28. Split Trailing Edge - Tip and Trailing Edge Region of the Blade	The maximum permitted depth of a split area is 0.5 inch (12 mm). The maximum permitted length is 6.0 inches (152 mm). Damaged fibers or exposed foam are not permitted. (Refer to Figure 6)

29. Split Trailing Edge - Inboard Region	A split trailing edge on the inboard region of the blade is unairworthy. (Refer to Figure 6)
30. Crushed or Cracked Trailing Edge - Inboard Region of the Blade	A crushed or cracked trailing edge on the inboard region of the blade is unairworthy. (Refer to Figure 6)

31. Crushed or Cracked Trailing Edge - Outboard and Tip Regions of the Blade	The maximum permitted depth of a crushed or cracked area is 0.25 inch (6.3 mm). The maximum permitted length of a crushed or cracked area is 2.0 inches (50 mm). (Refer to Figure 6)

32. Crushed or Cracked Trailing Edge - Trailing Edge Foam Region	The maximum permitted depth of a crushed or cracked area is 0.25 inch (6.3 mm). The maximum permitted length of a crushed or cracked area is 2.0 inches (50 mm). (Refer to Figure 6)

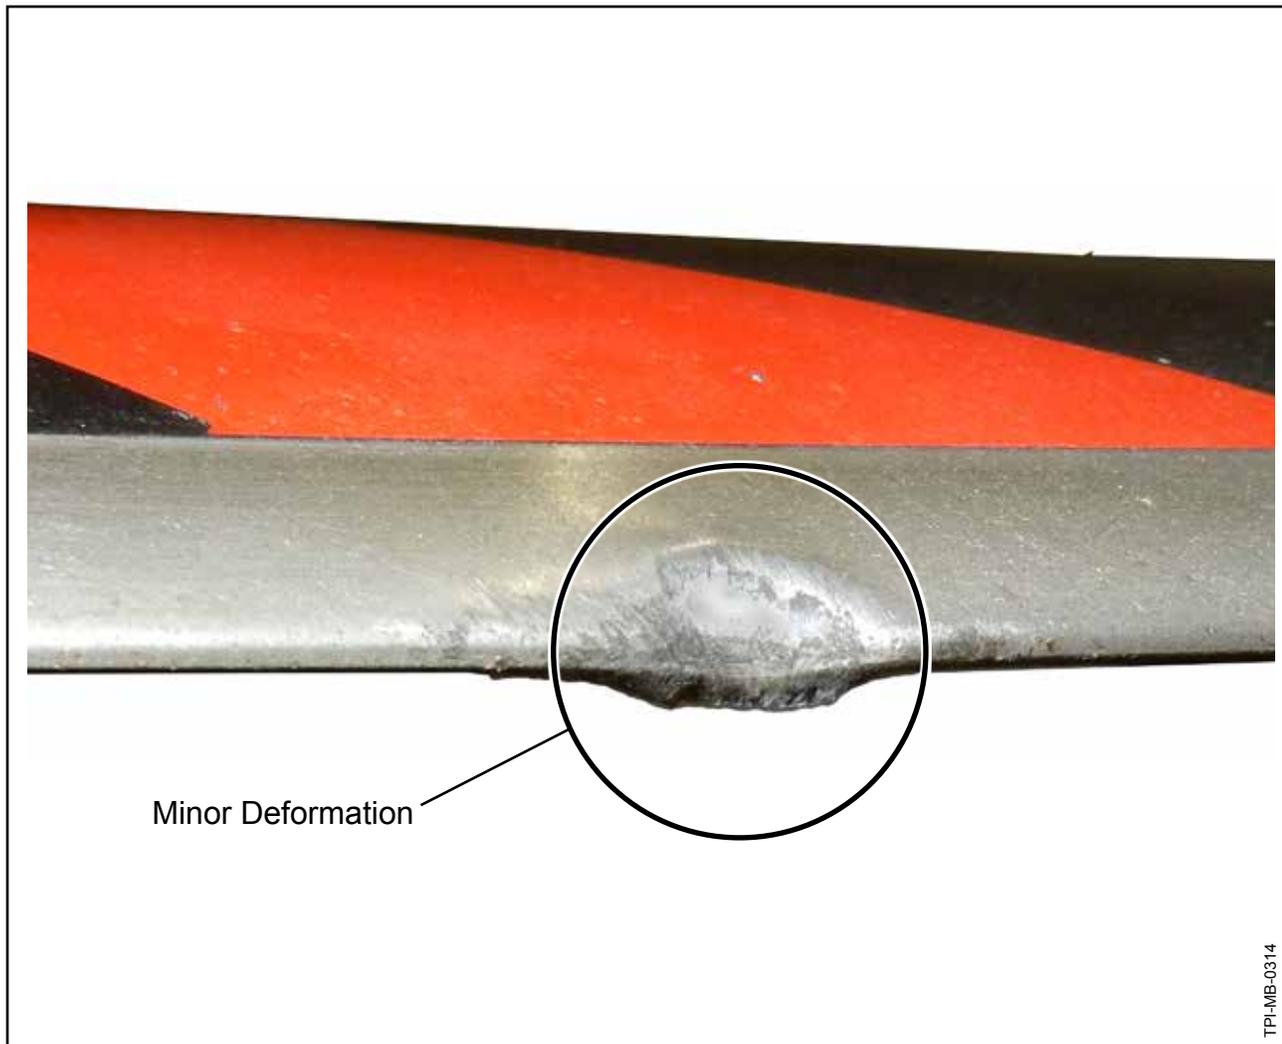
**Minor Deformation
Figure 7**

DAMAGE TYPE	AIRWORTHY DAMAGE LIMITS
1. Nickel Erosion Shield - Minor Deformation - For the Entire Erosion Shield	Erosion shield deformations caused by impact damage or erosion that does not penetrate through the shield is permitted. Erosion shield deformations caused by impact or erosion that have penetrated the erosion shield are airworthy if any related crack, gouge, and debond does not exceed the airworthy limits specified for each condition in this table.

- (1) Minor Deformation of the Erosion Shield - (Table 1: Damage Type 1)
 - (a) A dent on the erosion shield that does not include any exposed composite material or missing areas of the erosion shield.

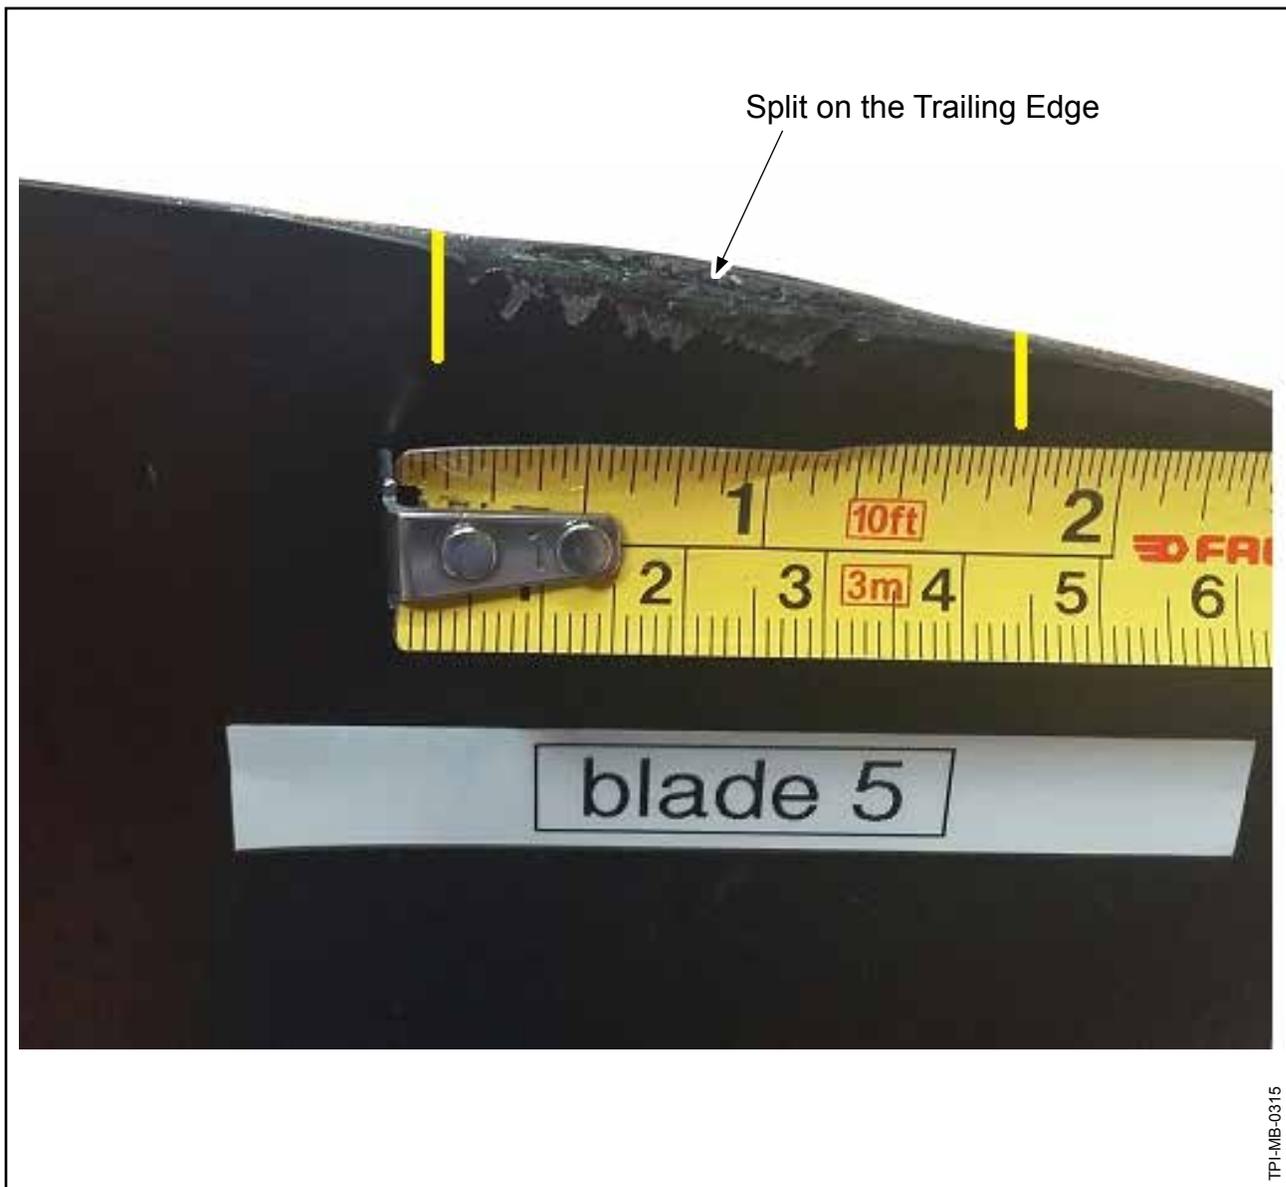
**Split Trailing Edge
Figure 8**

- (2) Split Trailing Edge - (Table 1: Damage Types 28 and 29)
- (a) Delamination of a composite blade extending to the blade surface, normally found near the trailing edge or tip of the blade.
Refer to the example shown in Figure 8.

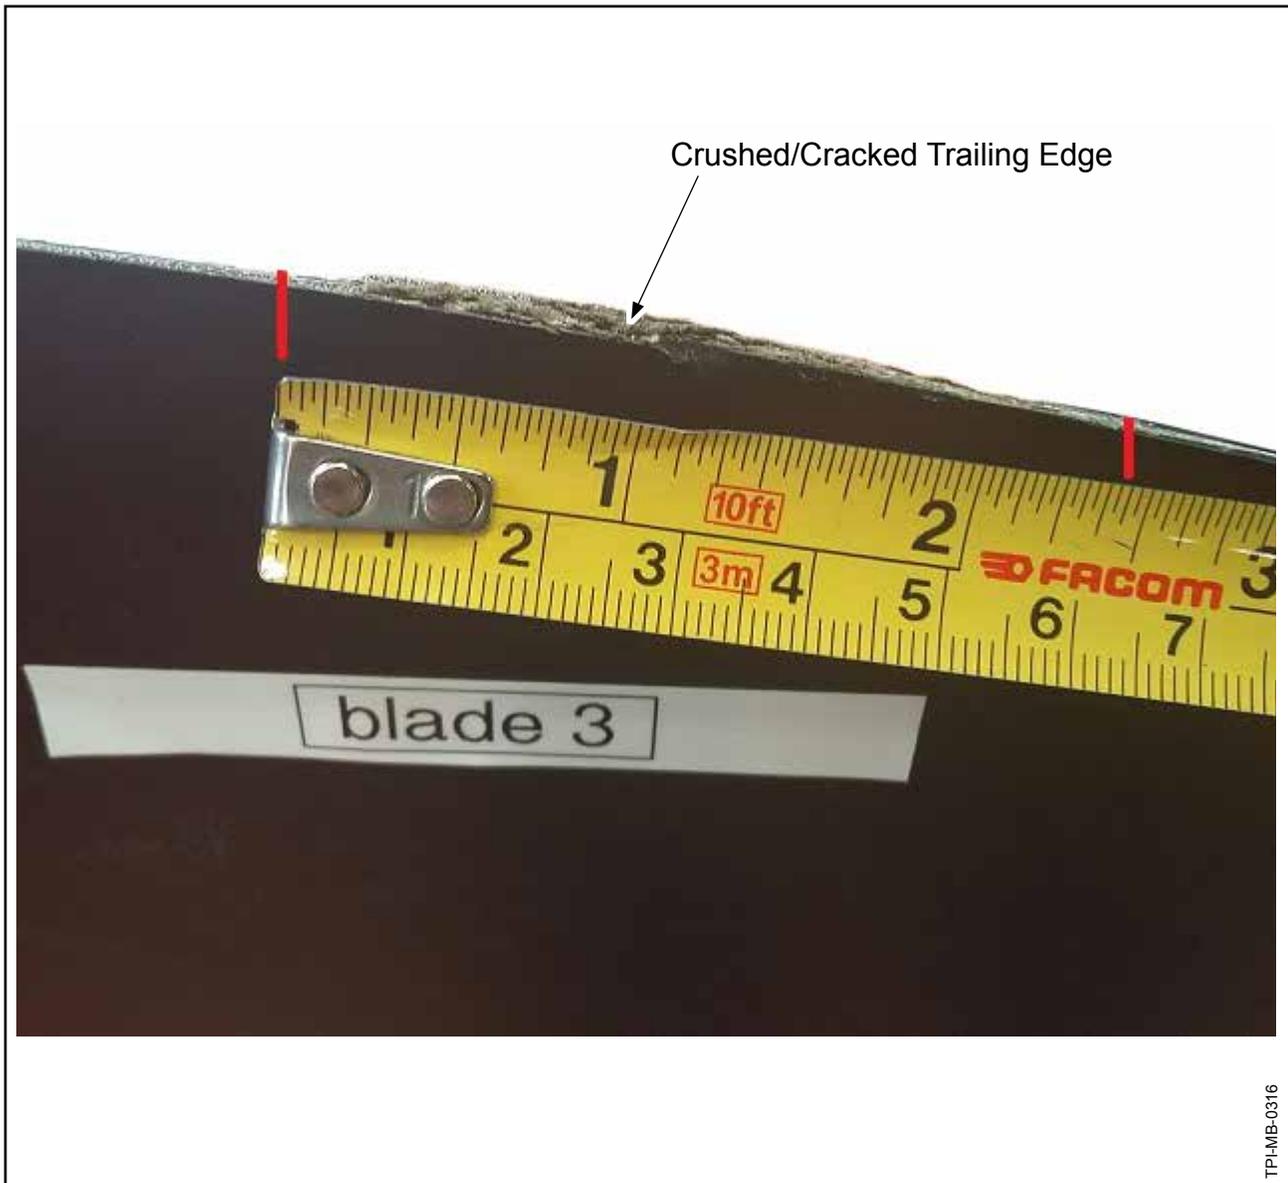
Crushed/Cracked Trailing Edge
Figure 9

- (3) Crushed/Cracked Trailing Edge - (Table 1: Damage Types 30, 31, and 32)
 - (a) A trailing edge that has been crushed/cracked due to impact.

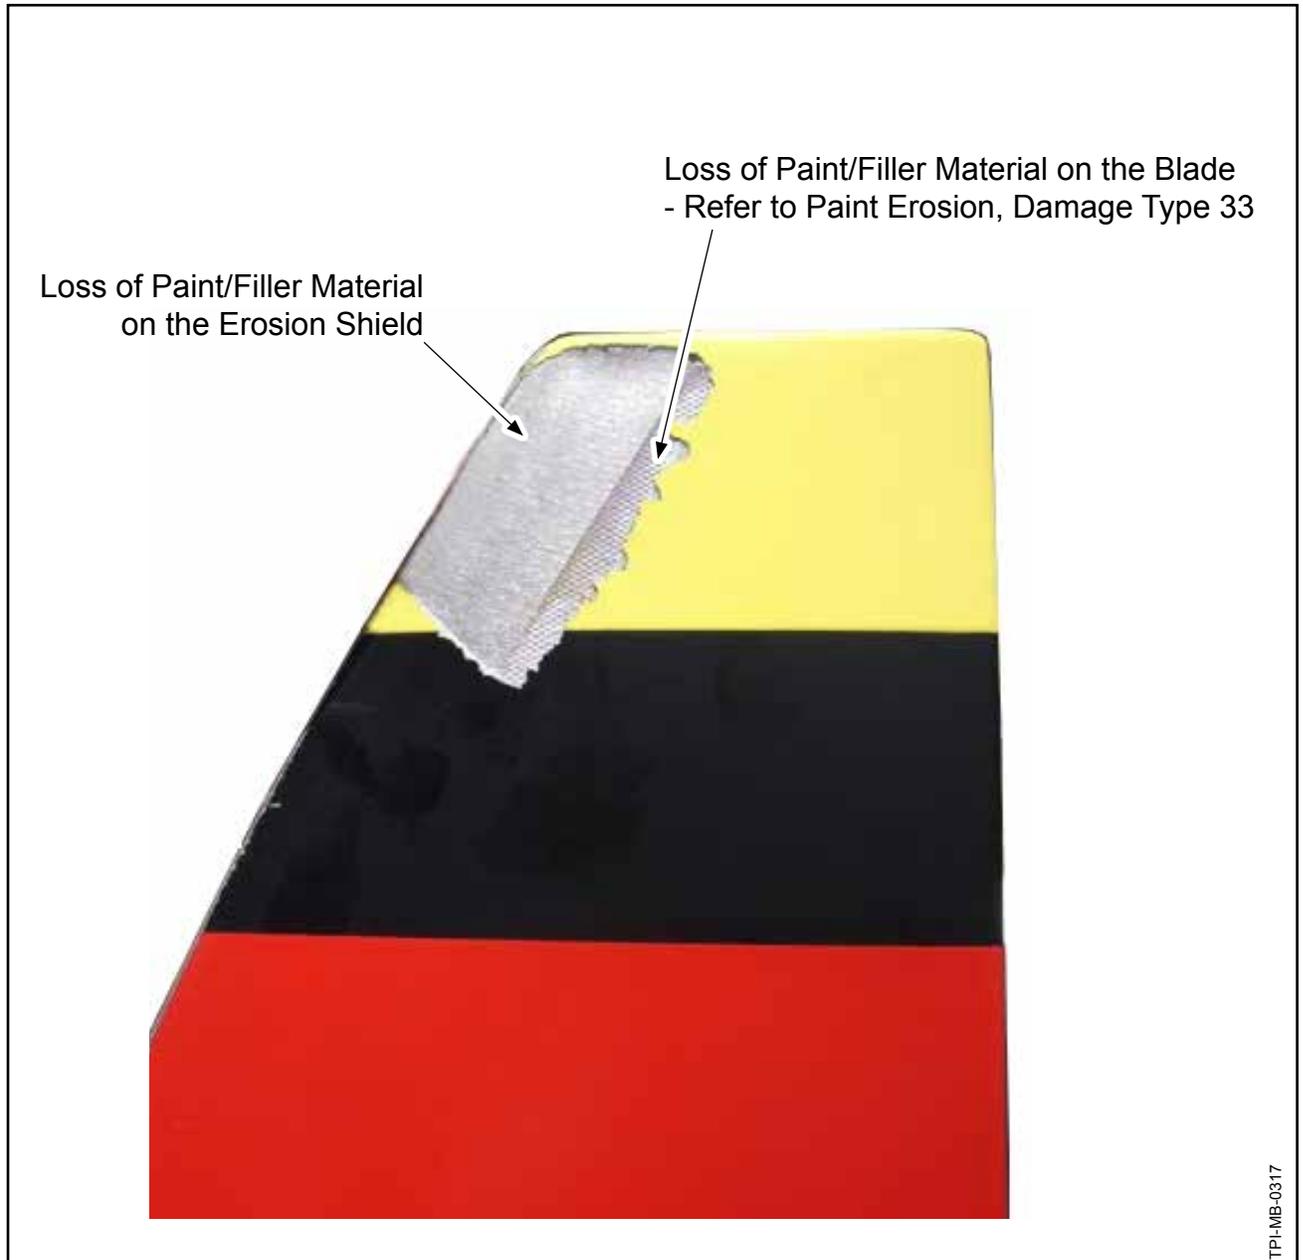
**Loss of Paint/Filler Material on the Erosion Shield
Figure 10**

34. Loss of Paint and/or Filler Material - For the Erosion Shield ONLY	Paint and/or filler material may be missing from the entire area of the erosion shield and the blade is airworthy.

- (4) Loss of Paint/Filler Material on the Erosion Shield - (Table 1: Damage Type 34)
(a) Missing paint/filler material that exposes the metal erosion shield.

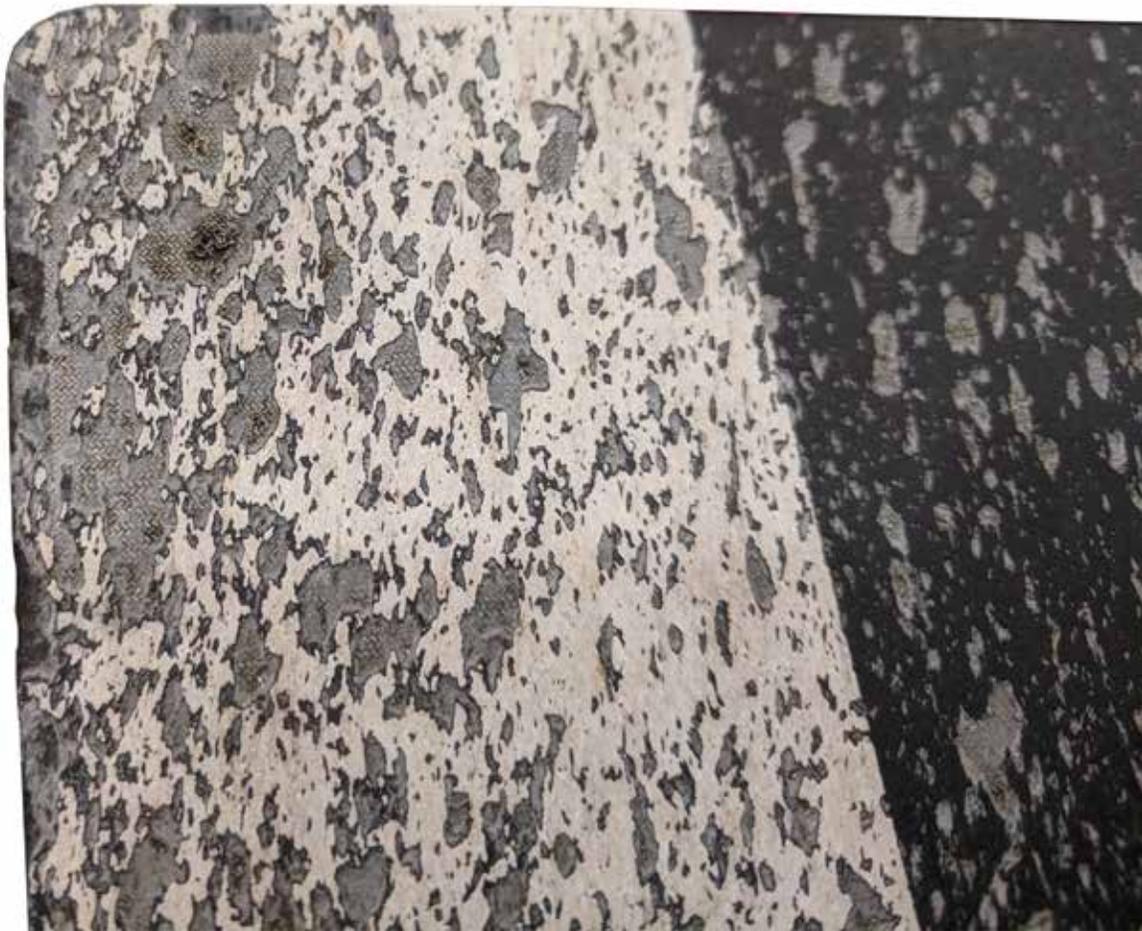
**Paint Erosion
Figure 11**

33. Paint Erosion - for the Entire Blade	For the areas of the blade where there is composite material, the maximum permitted exposure of the composite material and/or of the primer filler is 5.0 sq. inches (3225 sq. mm). <u>NOTE:</u> This limit does not refer to the primer sealer (gray layer). For the areas of the blade where there is an erosion shield, paint may be missing from the entire area of the erosion shield and the blade is airworthy. For maintenance scheduling purposes, propellers with blades that show more than 5.0 sq. inches (3225 sq. mm) of paint erosion, may continue operation for an additional 250 hours or 1 (one) month, whichever occurs first.

- (5) Paint Erosion - (Table 1: Damage Type 33)
- (a) Gradual wearing away or deterioration of the paint caused by action of the elements. Refer to the example shown in Figure 11.

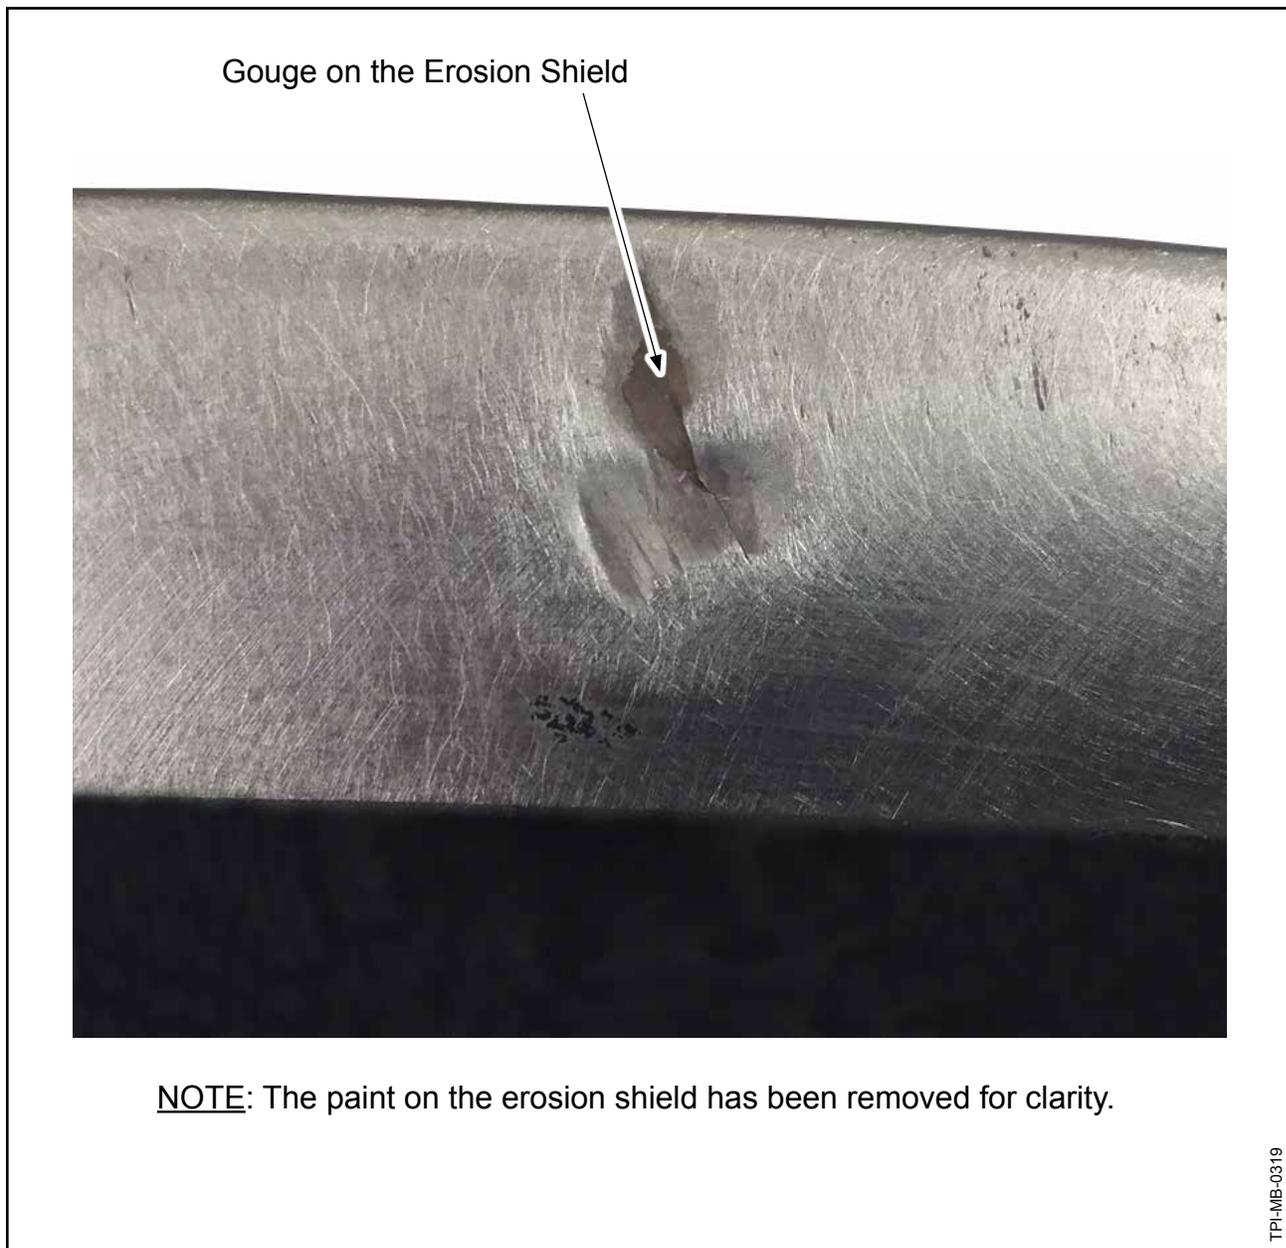
**Gouge on the Erosion Shield
Figure 12**

2. Nickel Erosion Shield - Gouge - For the Entire Erosion Shield	Exposed foam is not permitted. The maximum permitted total accumulated area of gouges through the erosion shield is 0.25 sq. inch (161.2 sq. mm). The maximum permitted depth of damage to the blade surface below the erosion shield is 0.020 inch (0.50 mm). NOTE: This is two layers of composite material. Damage cannot be permanently repaired without replacement of the erosion shield, but within these limits, does not make the blade unairworthy.

- (6) Gouge on the Erosion Shield - (Table 1: Damage Type 2)
 - (a) Impact damage on the erosion shield where metal has been removed.
Refer to the example shown in Figure 12.

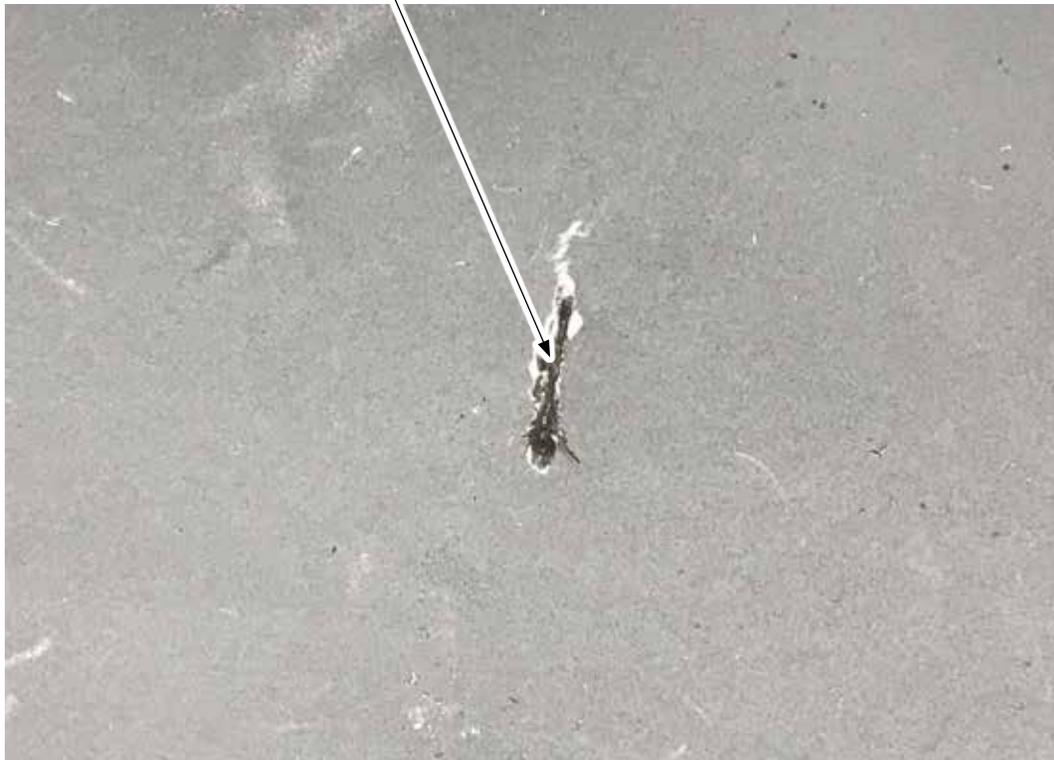
**Gouge or Loss of Composite Material - all areas except the erosion shield
Figure 13**

- (7) Gouge or Loss of Composite Material - all areas except erosion shield -
(Table 1: Damage Types 21, 22, and 23)
 - (a) Impact damage to the blade surface area where composite material has
been removed. Refer to the example shown in Figure 13.

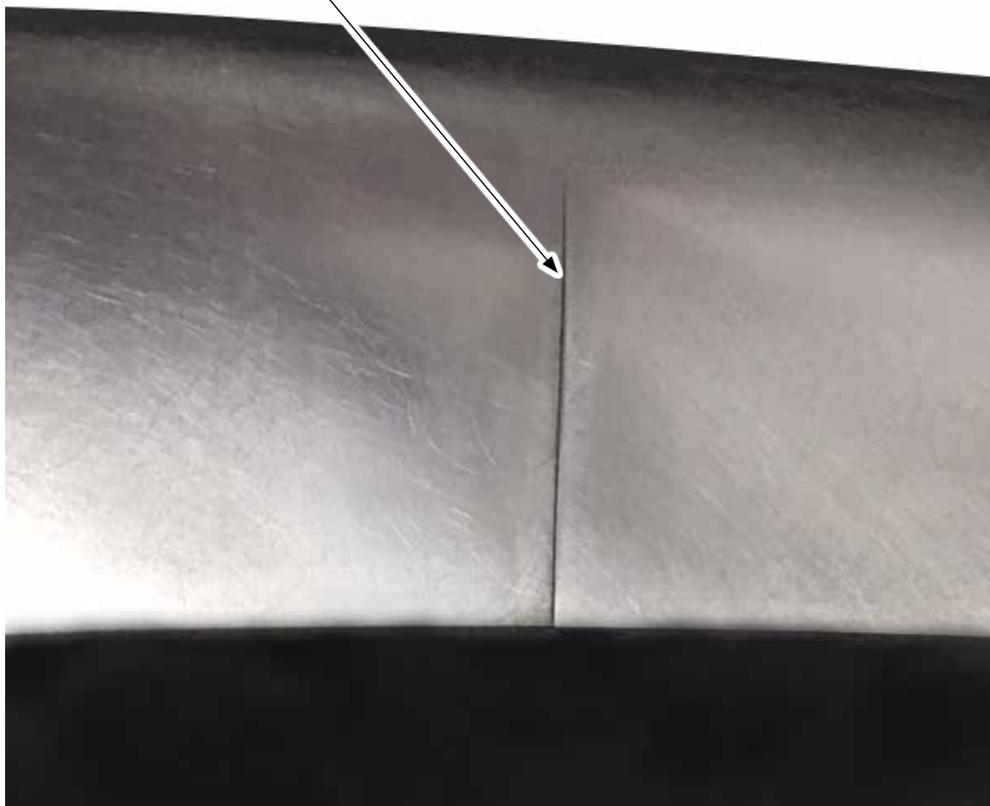
Chordwise Crack in the Erosion Shield
Figure 14

- (8) Chordwise Crack in the Erosion Shield - (Table 1: Damage Type 5)
- (a) A separation within a material, usually visible as a narrow opening at the surface that is approximately perpendicular to the leading edge of the blade. Refer to the example shown in Figure 14.

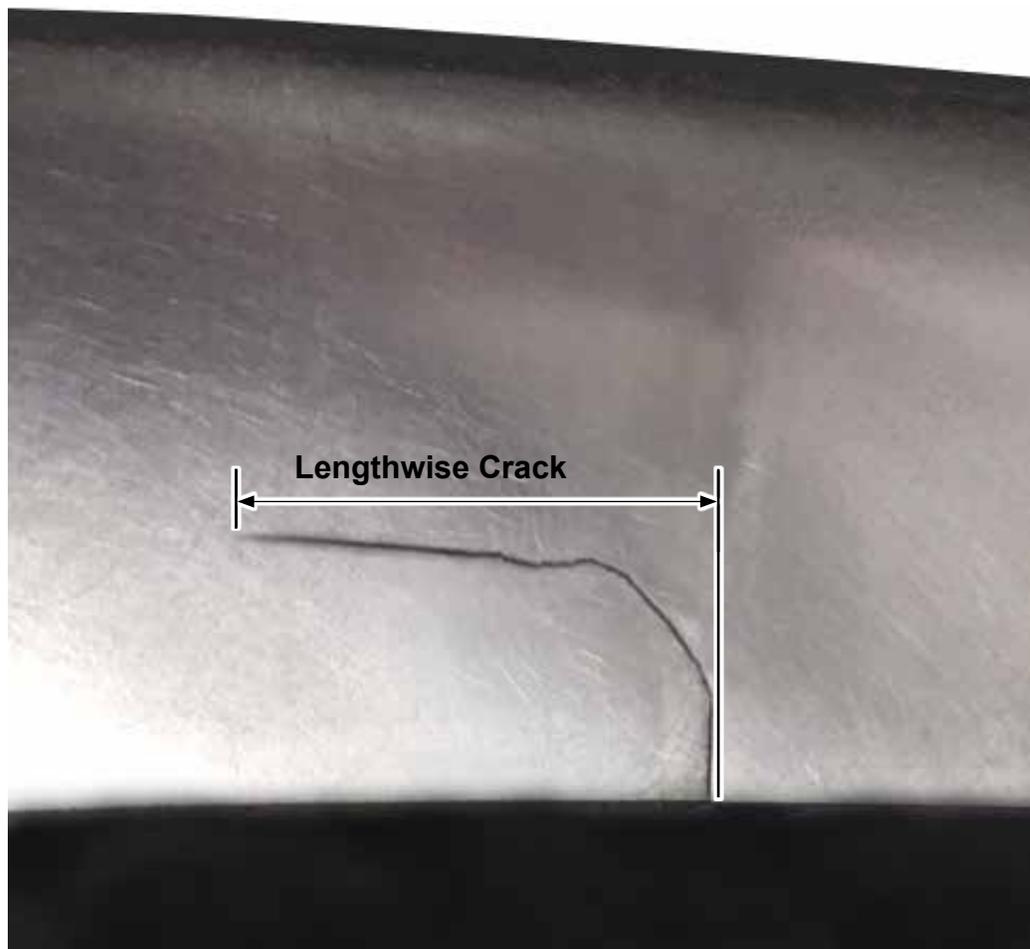
Lengthwise Crack in the Erosion Shield
Figure 15

- (9) Lengthwise Crack in the Erosion Shield - (Table 1: Damage Type 6)
- (a) Irregularly shaped separation within a material, usually visible as a narrow opening at the surface that runs approximately parallel to the leading edge of the blade. Refer to the example shown in Figure 15.
