HARTZELL PROPELLER INC.
ALERT SERVICE BULLETIN
TRANSMITTAL SHEET
HC-ASB-61-313
Propeller - Counterweight Slug Bolt Inspection

July 15, 2009

Propeller Model: Various Document No. HC-ASB-61-313 Revision: 3

Component Part Number: B-3386-14H Date of Issue: Nov 17/08 Rev. Date: Jul 15/09

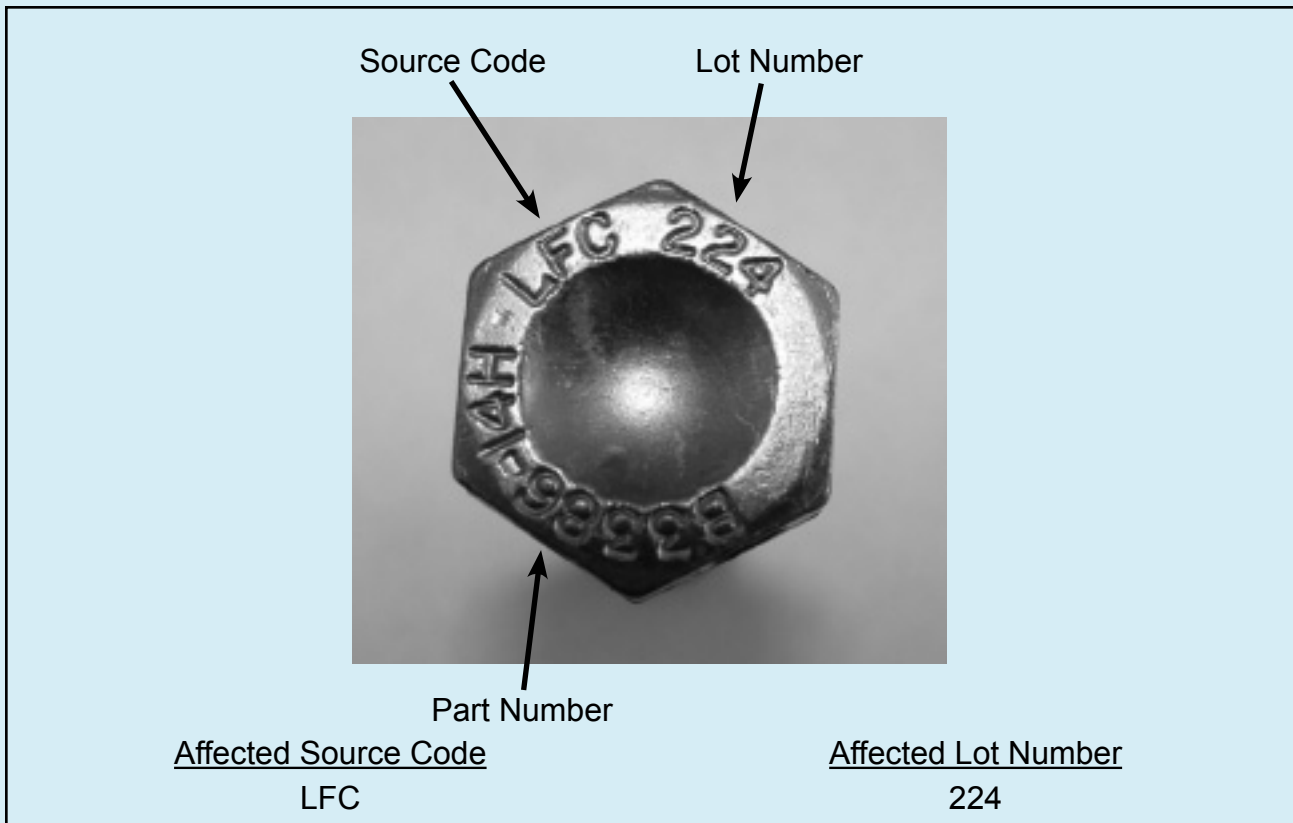
Counterweight Slug Attachment Bolt Identification
Figure 1

- (a) Locate the counterweight slug attachment bolts. Refer to Figure 2.
- (b) Inspect each B-3386-14H counterweight slug attachment bolt on the propeller for the affected LFC manufacturing lot. Refer to Figure 1.
 - 1 Bolts marked from another source code or lot number other than 224 are not affected by this Alert Service Bulletin.
 - 2 If only one counterweight slug attachment bolt on a counterweight slug is from the affected LFC manufacturing lot 224, both bolts may require replacement.
 - 3 Visually inspect all LFC manufacturing lot 224 counterweight slug attachment bolts for the following obvious signs of failure:

- (1) Inspect each B-3386-14H counterweight slug attachment bolt for the affected LFC manufacturing lot number. See Figure 1.
 - (a) Bolts marked from another source code or lot number other than 224 are not affected by this Alert Service Bulletin.
- (2) Immediately quarantine all affected bolts.

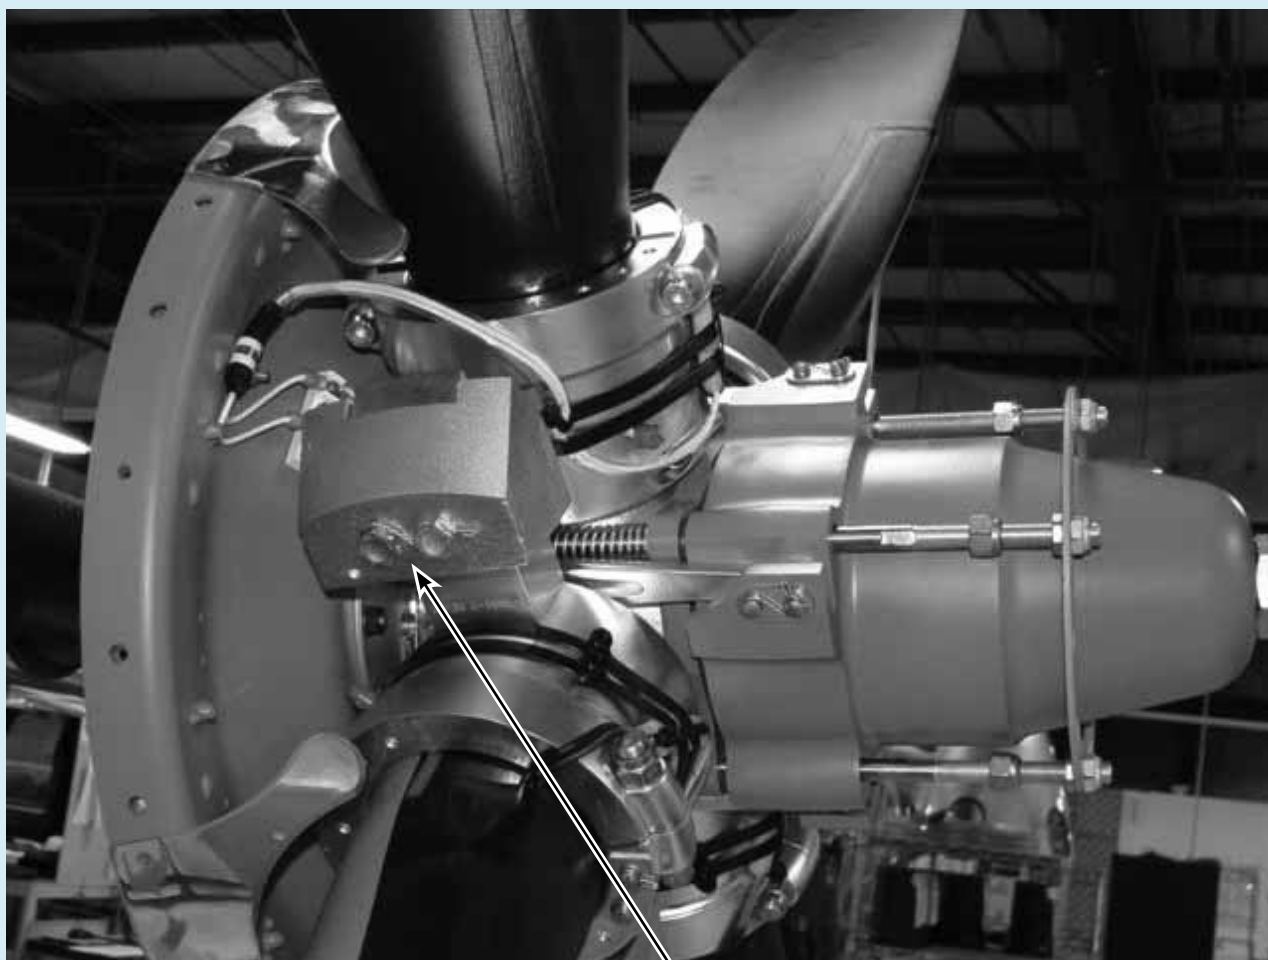
Counterweight Slug Attachment Bolt Location

- a An obviously bent shaft.
- b Any obvious cracking.
- c The head of the bolt is separated from the shaft.

Inspect B-3386-14H bolts in this location
on each blade (two bolts per blade)

- 1 Cut and remove the safety wire between the two B-3386-14H counterweight slug attachment bolts that attach the counterweight slug to the counterweight.
- 2 If only one of the counterweight slug attachment bolts on a slug must be replaced in accordance with step 3.A.(3)(b) of this Alert Service Bulletin:
 - a Remove the affected counterweight slug attachment bolt from the counterweight slug unit.

- c Install one new B-3386-14H bolt that is not from LFC manufacturing lot 224 in the hole where the original bolt has been removed.
 - d Using a calibrated torque wrench, torque the bolt to 36 ft-lb (48.8 N•m) dry torque.
